# **T-Level Technical Qualification in Building Services Engineering for Construction - Heating Engineering**

## **Centre Standardisation Materials**

Heating engineering (8710-35/36) (355)

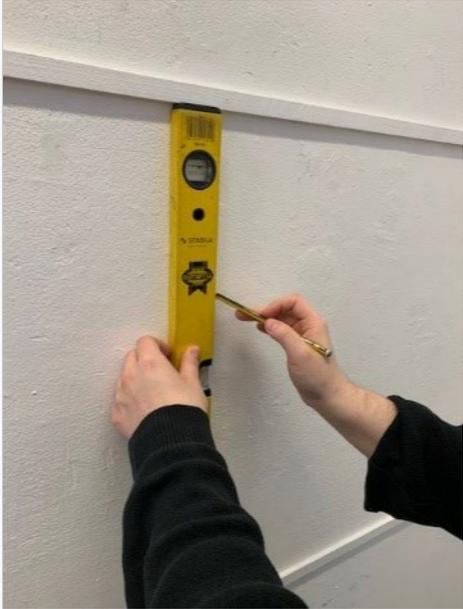
Evidence description	Photo
<p><b>Photograph 1</b></p> <p>Candidate marking out a work area using a spirit level to provide a straight and vertical line on the first attempt.</p>

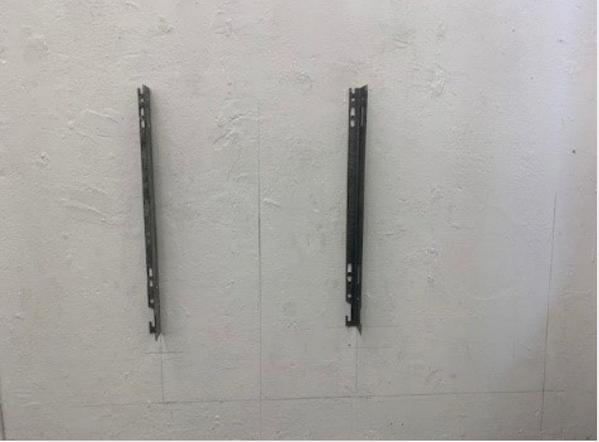
A close-up photograph showing a person's hands using a yellow spirit level against a white wall. The person is holding a pencil and marking a vertical line on the wall, ensuring it is perfectly straight and vertical.
<p><b>Photograph 2</b></p> <p>Work area shows accurate and clear marking out on work surface.</p>

A photograph showing two vertical metal brackets mounted on a white wall. The wall has clear vertical lines marked on it, indicating the accurate and clear marking out of the work area.

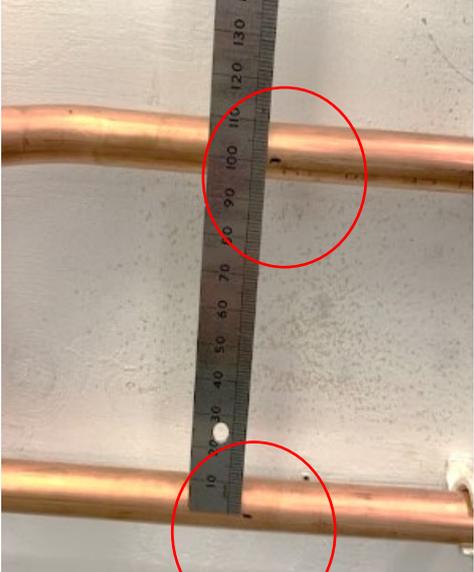
Evidence description	Photo
<p><b>Photograph 3</b></p> <p>Finished installation showing finished pipework and component positioning which demonstrates the aesthetics of the completed installation.</p>

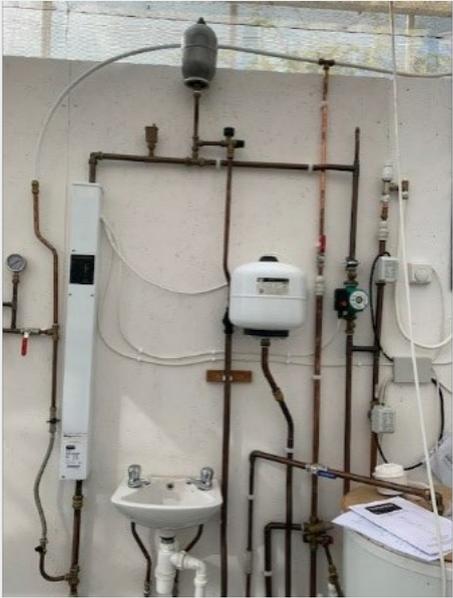
<p><b>Photograph 4a</b></p>

- Tolerances have been met for the measurement of pipework – **Photograph 3.**
- Finished installation showing finished pipework and component positioning which demonstrates the aesthetics of the completed installation – **Photographs 4a-e, 5 and 6**
- Use of tools (bending and cutting equipment) and piping skills – **Photograph 7**
- Results of tool usage – **Photograph 8**
- Soldering/soldered fittings to show that heat mats have been used and no burn/scorch marks to the wall/or burn marks to the wall to support the assessors making of the jointing process – **Photograph 9**
- Use/type of clips – **Photograph 10**

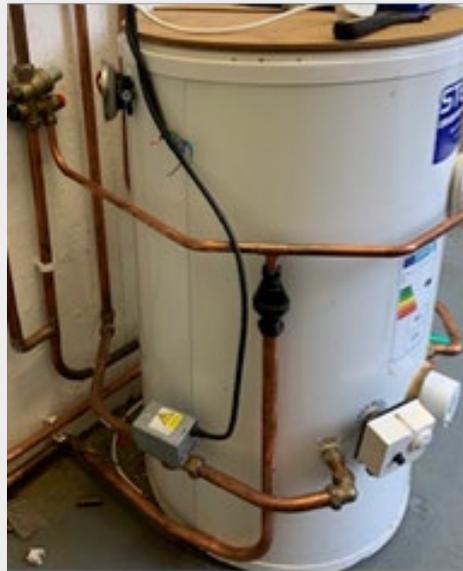
**Photograph 5**

Copper pipework installation

Pipework installed to the required tolerance ( $\pm 2\text{mm}$ ). Bends have been completed to a high standard with no signs of throating or rippling

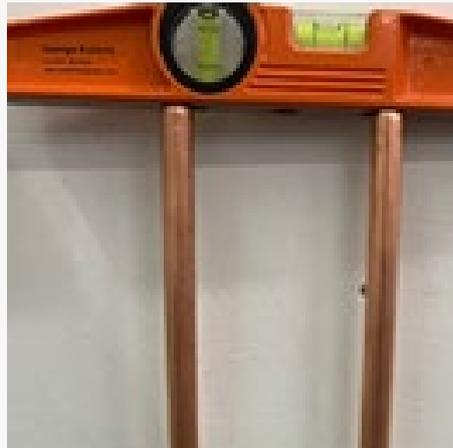
**Photograph 6**

Pipework level

Pipework level and within tolerance ( $\pm 2\text{mm}$ )

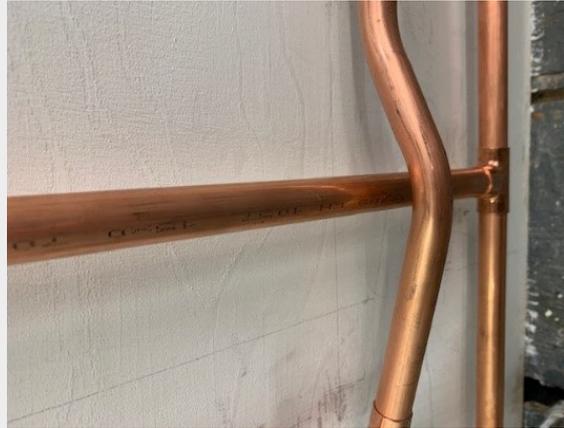
### Photograph 7

Use of tools (bending and cutting equipment) and piping skills.

Fabricated Passover with appropriate clearance. no signs of throating or rippling

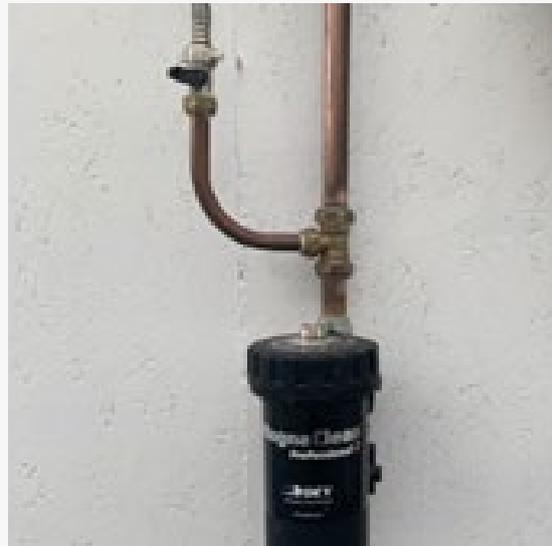
### Photograph 8

Results of tool usage

Component fitted correctly with no signs of toll marks from installation.

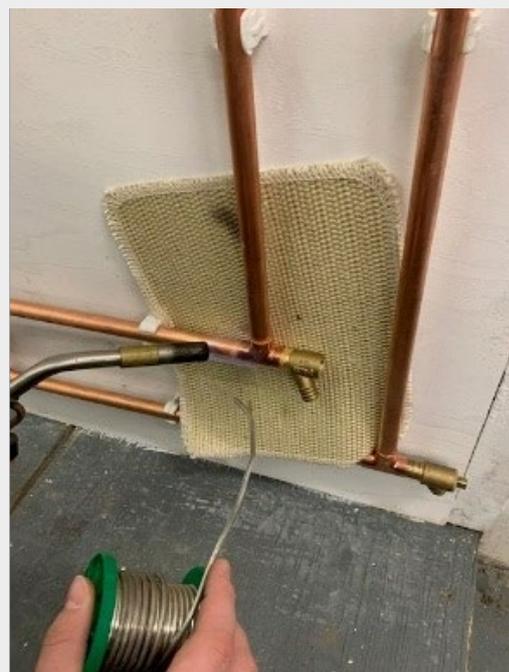
### Photograph 9

Soldering/soldered fittings to show that heat mats have been used and no burn/scorch marks to the wall/or burn marks to the wall to support the assessors making of the jointing process.

Correct use of blow lamp, safe soldering correct selection of solder, protection of customer property with heat mat centrally positioned. Removal of vulnerable heat sensitive components before soldering commences.

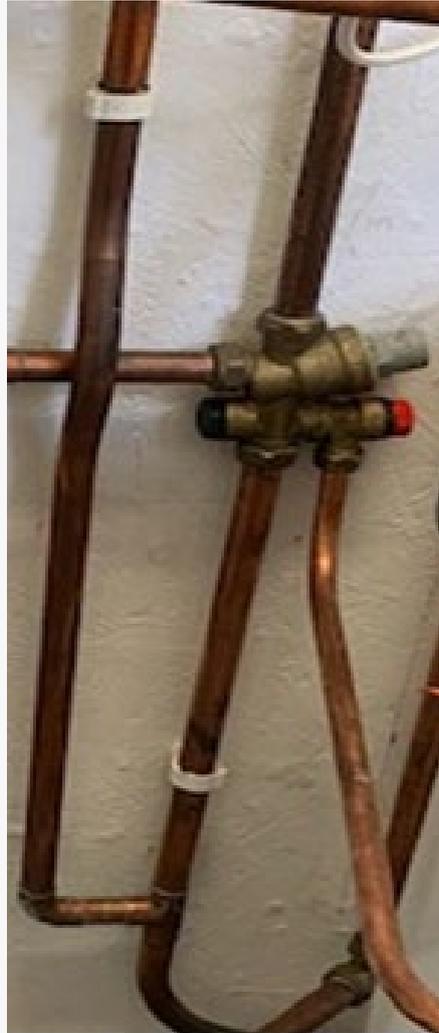
### Photograph 10

Use/type of clips

Pipework level and adequately clipped with appropriate spacing. Pipework fabricated without the use of additional fittings.

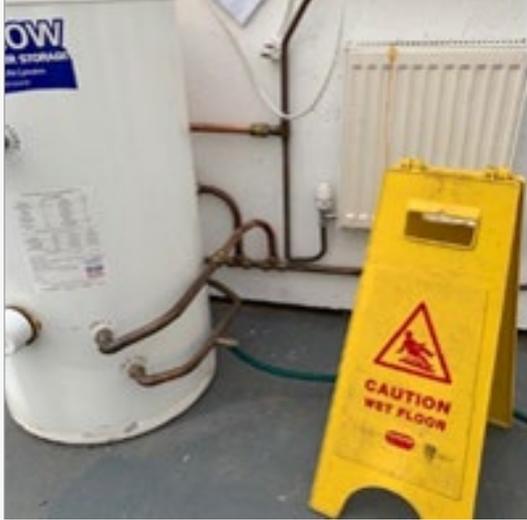
Evidence description	Photo
<p><b>Photograph 11</b></p> <p>The system being drained down safely and economically to the correct location.</p> <p>Preparation for draining down: correct equipment and drain point used to drain down system pipework for decommissioning activities.</p> <p>Use of correct signage.</p>

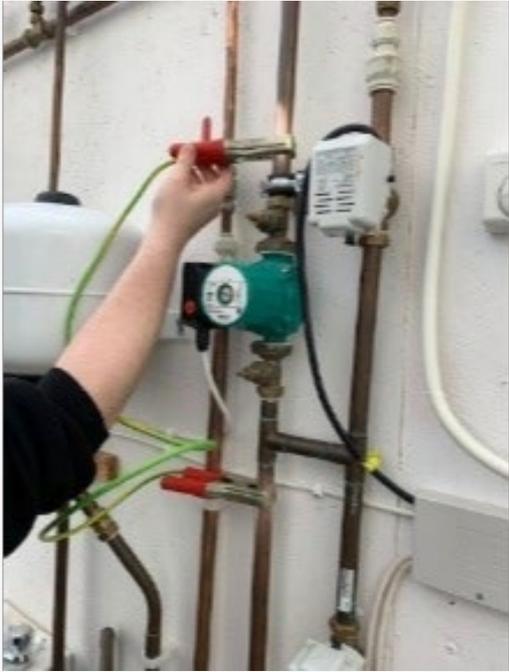
Evidence description	Photo
<p><b>Photograph 14</b></p> <p>Results of tool usage.</p> <p>Component fitted correctly with no signs of tool marks from installation of the replacement component.</p>

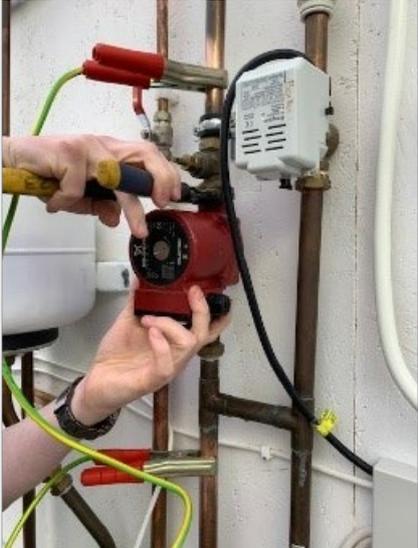
<p><b>Photograph 15</b></p> <p>Sequence of photos which show the replacing and removal of the faulty component, and reinstallation of the new component.</p> <p>Loosening of faulty component.</p>

- Results of tool usage – **Photograph 14**
- Sequence of photos which show the replacing and removal of the faulty component, and reinstallation of the new component – **Photographs 15, 16, 17, 18 and 19**
- System on completion of all works – **Photograph 20**

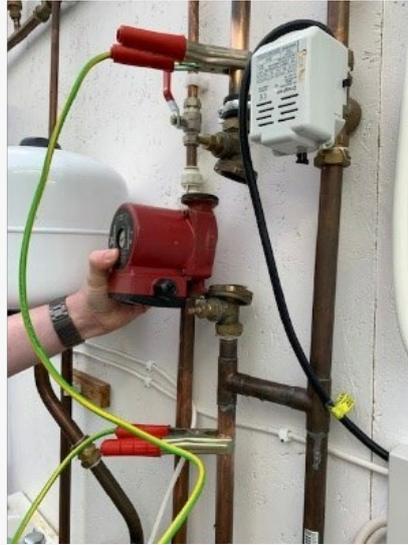
**Photograph 16**

Removal of faulty component.

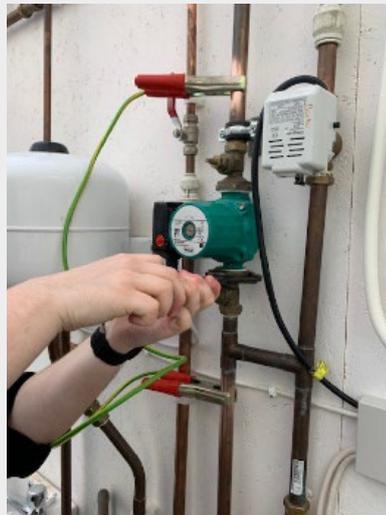
17.

Replacement of component.

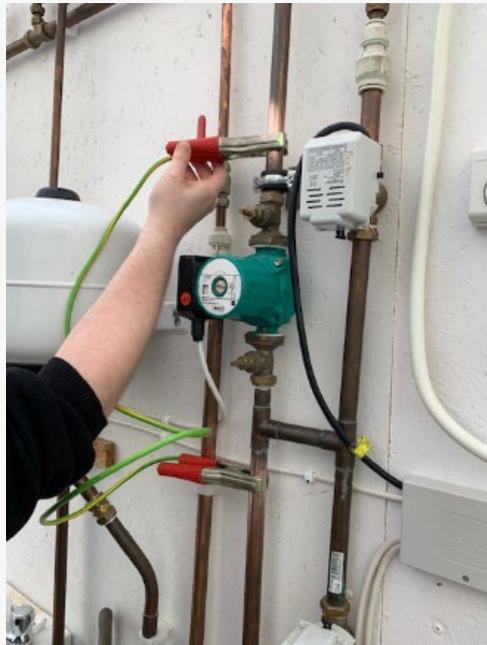
**Photograph 20**

System on completion of all works.

Repair completed and work area left tidy.

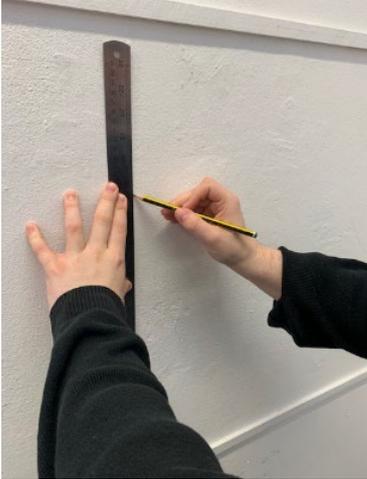
Evidence description	Photo
<p><b>Photograph 1</b></p> <p>Candidate marking out a work area using a straight edge that is not the approved method.</p>

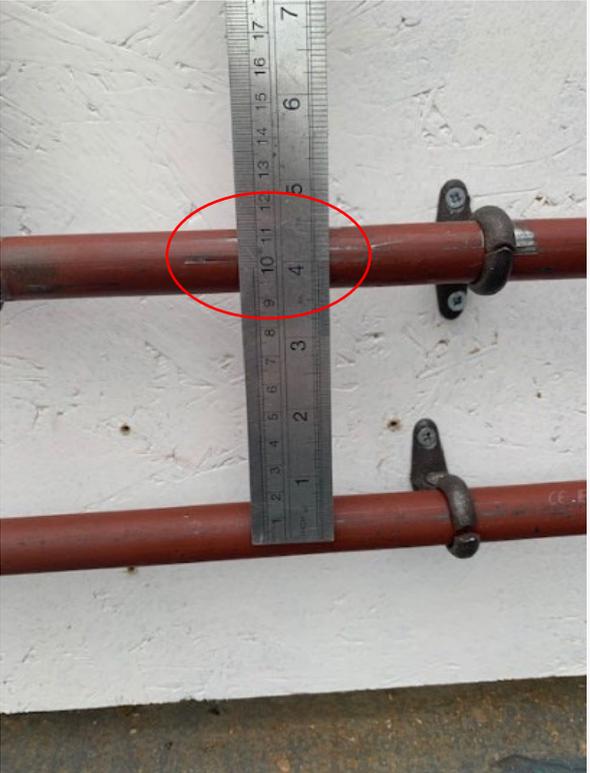
Evidence description	Photo
<p><b>Photograph 3</b></p> <p>Tolerances (<math>\pm 5\text{mm}</math>) have been met during the installation of pipework.</p>

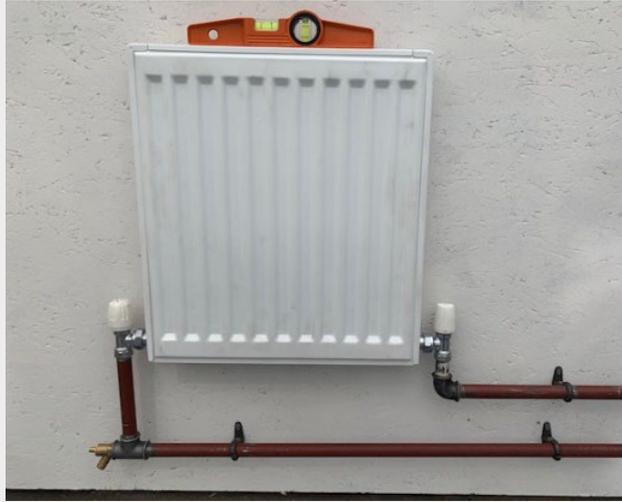
### Photograph 4a

Finished installation showing finished pipework and component positioning which demonstrates the aesthetics of the completed installation. Visible signs of pipework damage that are not straight or horizontal/vertical and bends that are not properly formed. None of which stops the system operating correctly.

Finished installation and associated pipework including the installation of both functional and safety controls.

Overall aesthetics of the installation have been met.

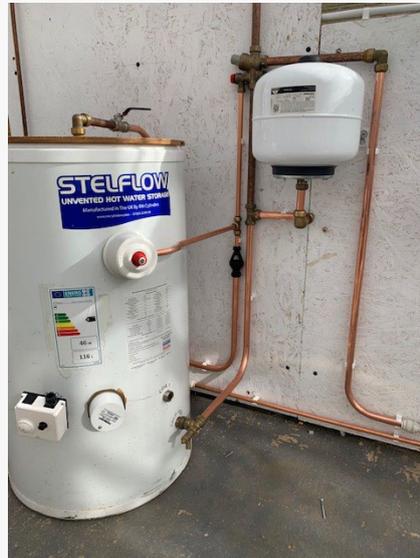
### Photograph 4b

- Tolerances have been met for the measurement of pipework. Photos may show any excess/ waste materials caused by inaccurate measurements – **Photograph 3**
- Finished installation showing finished pipework and component positioning which demonstrates the aesthetics of the completed installation. Visible signs of pipework damage that are not straight or horizontal/vertical and bends that are not properly formed. None of which stops the system operating correctly – **Photographs 4a, 4b, 4c, 4d, 4e, 5 and 6**
- Use of tools (bending and cutting equipment) and piping skills. Photos may show pipework cut offs – **Photograph 7**
- Results of tool usage. Photos may show tooling marks – **Photograph 8**

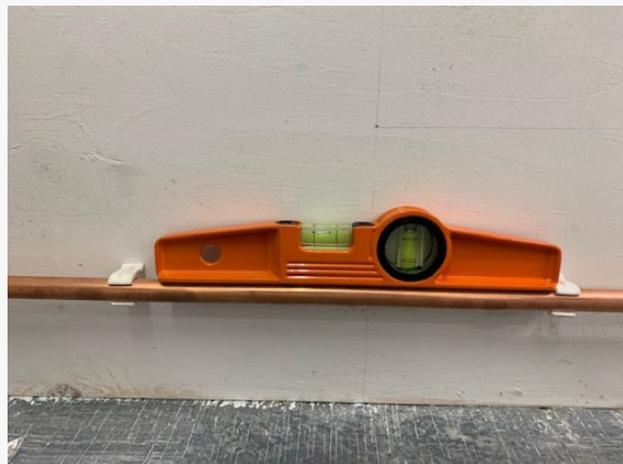
**Photograph 5**

Pipework not level but within tolerance.

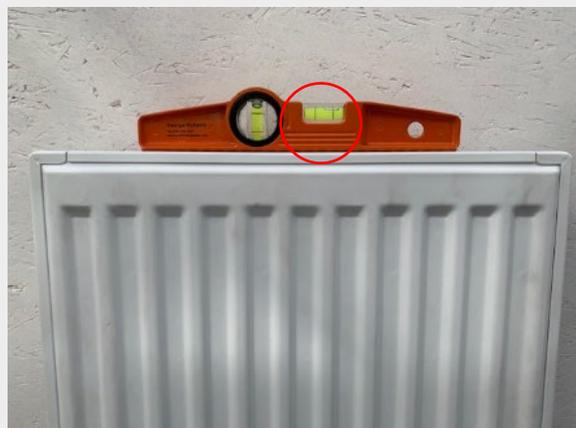
**Photograph 6**

Pipework level  
Pipework level and within tolerance (+/-2mm)

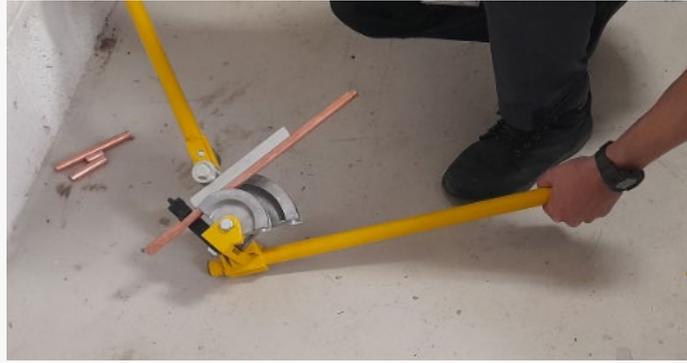
### Photograph 7

Use of tools (bending and cutting equipment) and piping skills. Photos may show pipework cut offs.

The correct operation/use of pipe bend machine and pipe cutting tools.

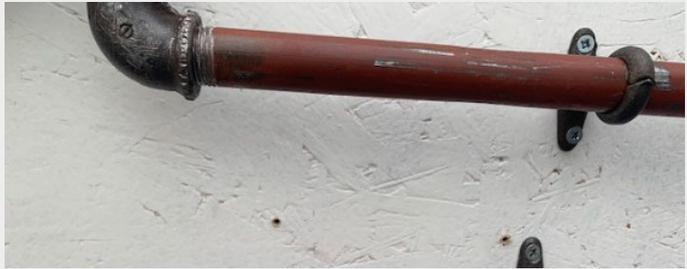
### Photograph 8

Results of tool usage

Component fitted correctly with signs of tool marks from installation.

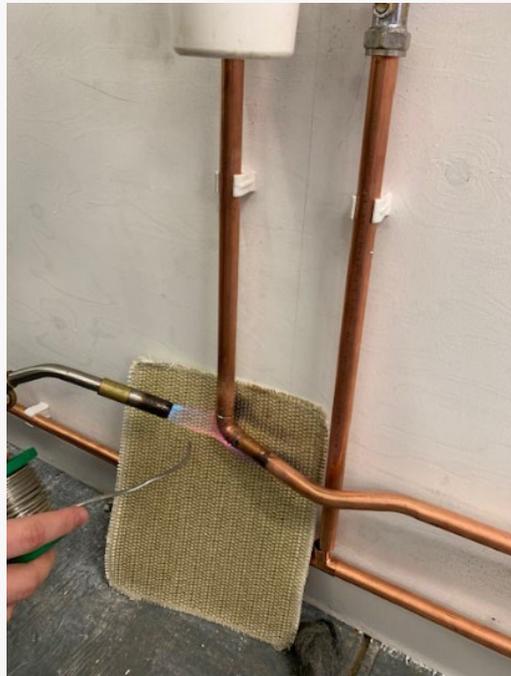
### Photograph 9

Soldering/soldered fittings to show that heat mats have been used and no burn/scorch marks to the wall/or burn marks to the wall to support the assessors making of the jointing process.

Correct use of blow lamp, safe soldering, correct selection of solder and protection of customer property although heat mat not centrally positioned.

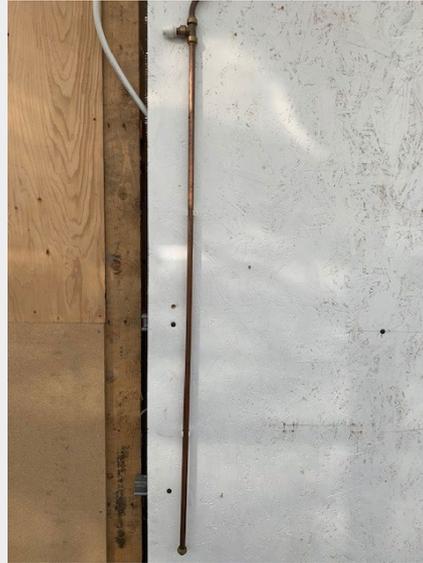
### Photograph 10

Use/type of clips. Photos may show clips that are not equally spaced or installed in line.

Incorrect clipped pipe, not plumb.

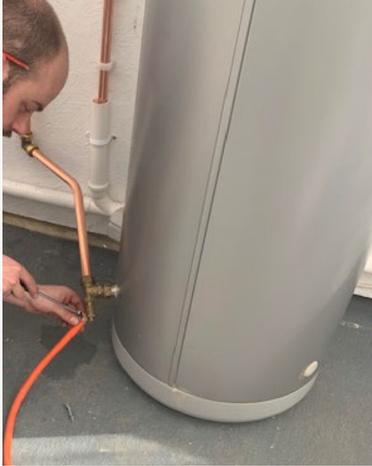
Evidence description	Photo
<p><b>Photograph 11</b></p> <p>The system being drained down safely and economically to the correct location.</p> <p>Preparation for draining down: correct equipment and drain point used to drain down system pipework for decommissioning activities.</p>

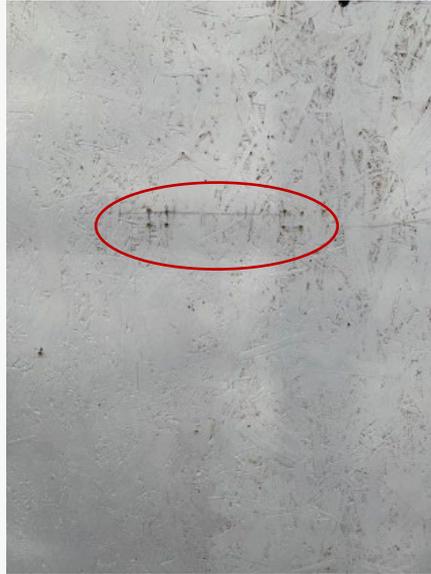
### Photograph 13

The finish of the working area after decommissioning following filling and repainting of surfaces

Some holes and marks still evident from complete decommissioning of pipework.

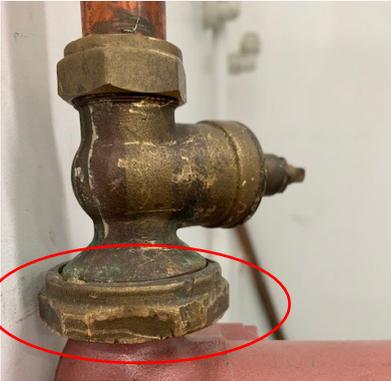
Evidence description	Photo
<p><b>Photograph 14</b></p> <p>Results of tool usage.</p> <p>Component fitted correctly with signs of tool marks from installation of replacement component.</p>

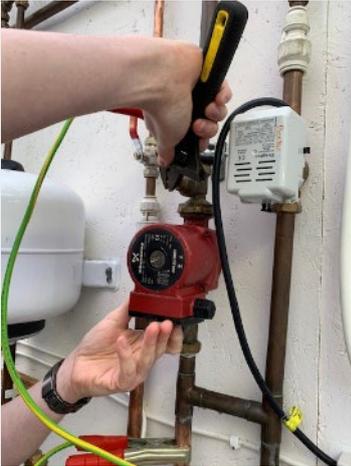
<p><b>Photograph 15 and 16</b></p> <p>Sequence of photos which show the replacing and removal of the faulty component, and reinstallation of the new component.</p> <p>Loosening of faulty component.</p>	<p>15.</p>

- Results of tool usage. Photos may show tooling marks – **Photograph 14**
- Sequence of photos which show the replacing and removal of the faulty component, and reinstallation of the new component – **Photographs 15, 16, 17, 18 and 19**
- System on completion of all works – **Photograph 20**

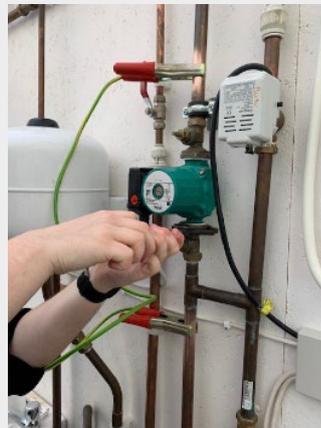
18.

Replacement of component.

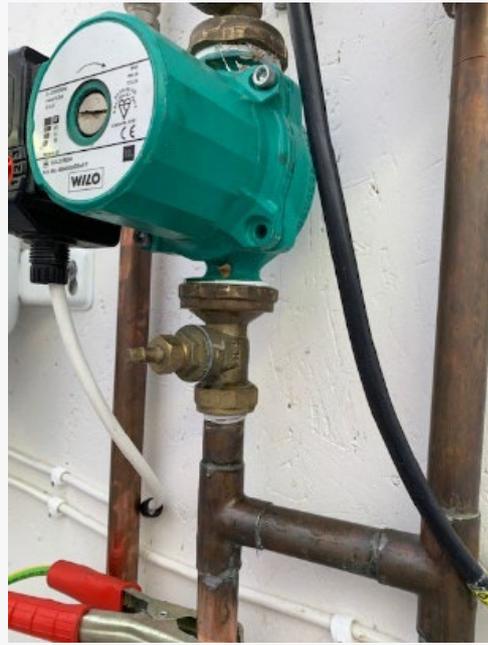
### Photograph 20

System on completion of all works.

Repair completed with signs of leaks which have been repaired.
