T Level Technical Qualification in Onsite Construction

Bricklaying

**Guide standard exemplification material
Threshold competence – Sample 2021**

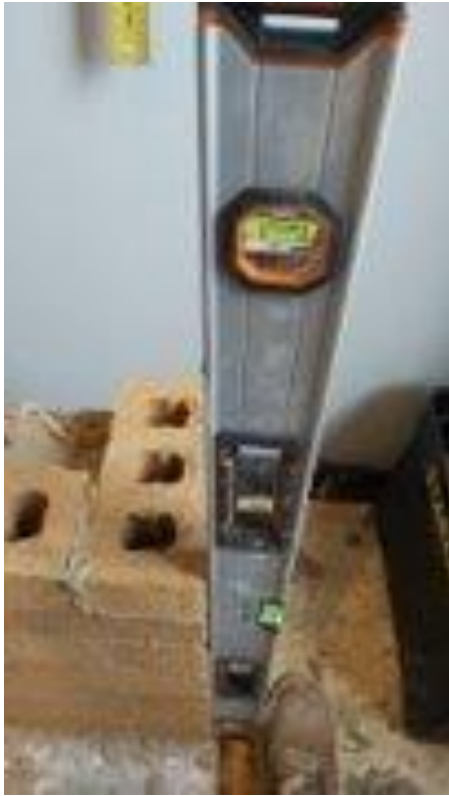
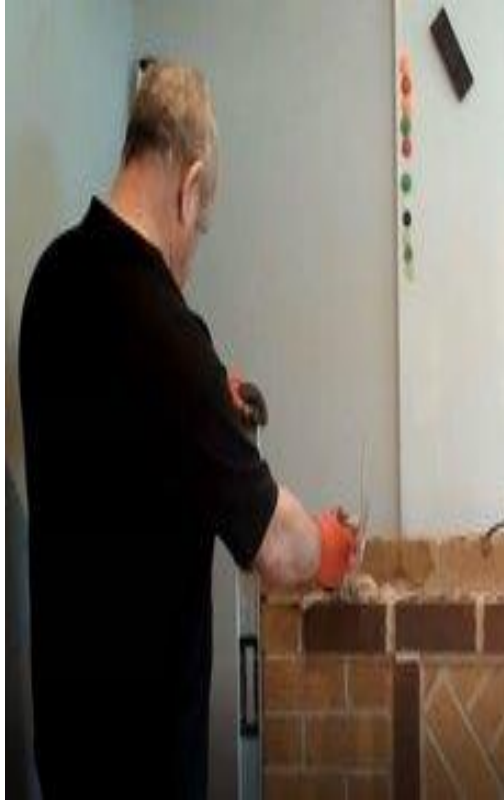
Photographs 1 and 2 showing plumb being checked, at intervals through task (during construction).

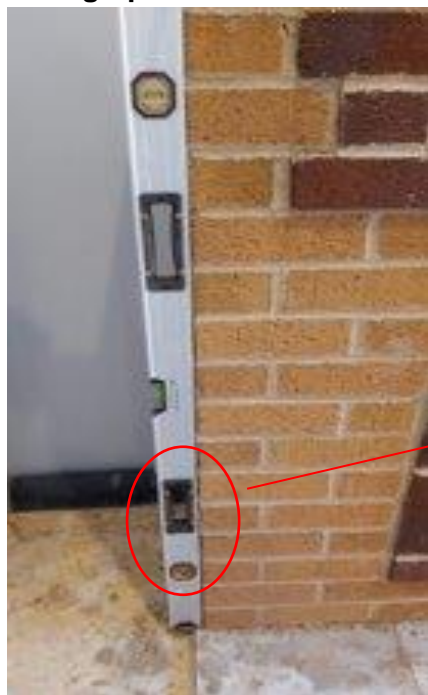
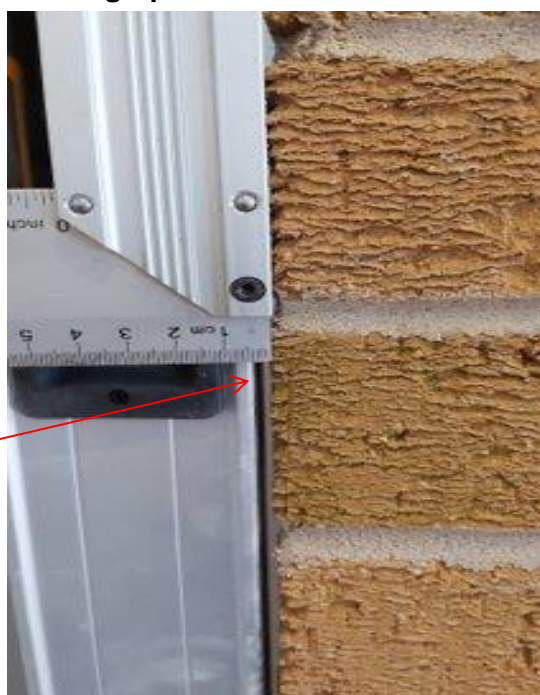
Photographs 3 and 4 showing plumb tolerances on the decorative panel

Appendix 1 Photographs 3 and 4 showing plumb points are maintained across required areas to within tolerance of +/- 4mm

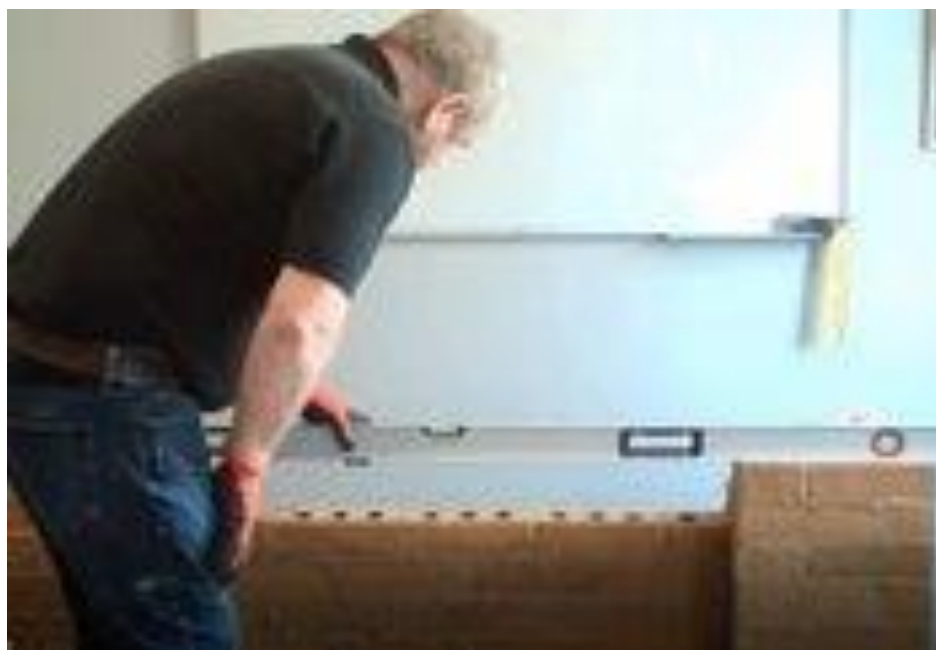
Appendix 2 Photograph 5 showing level work conducted by candidate
Appendix 3

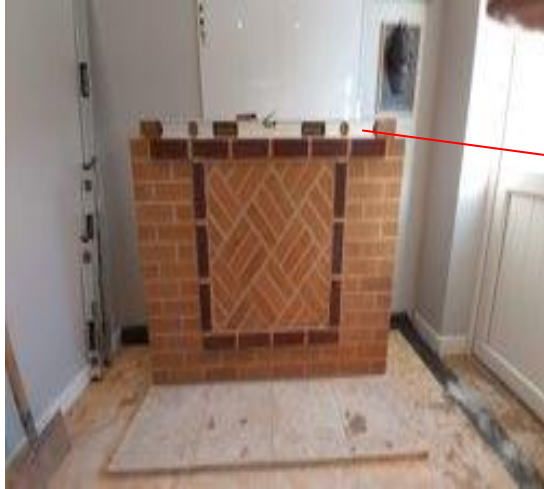
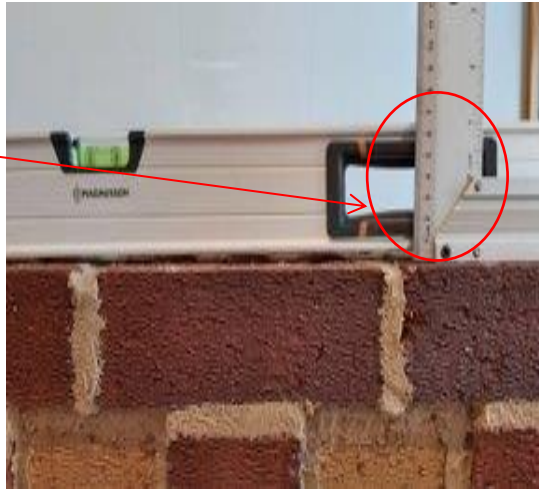
Photographs 6 and 7 showing level tolerance

Photographs 6 and 7 showing tolerance within +/- 5mm

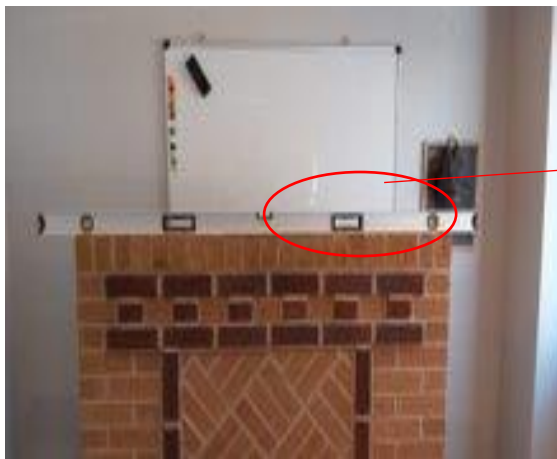
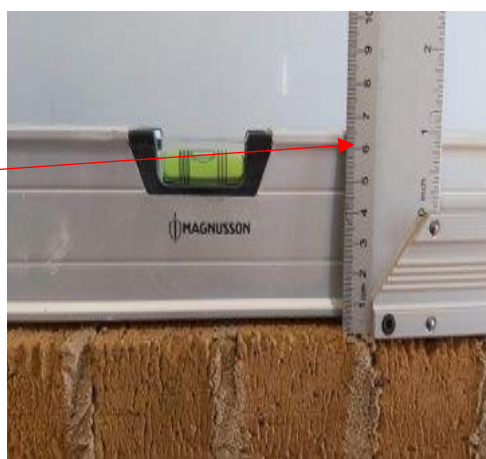
Photographs 8 and 9 showing the work is levelled through the courses and the top of the wall

Photographs 8 and 9 showing tolerances finished to within +/- 5mm tolerance

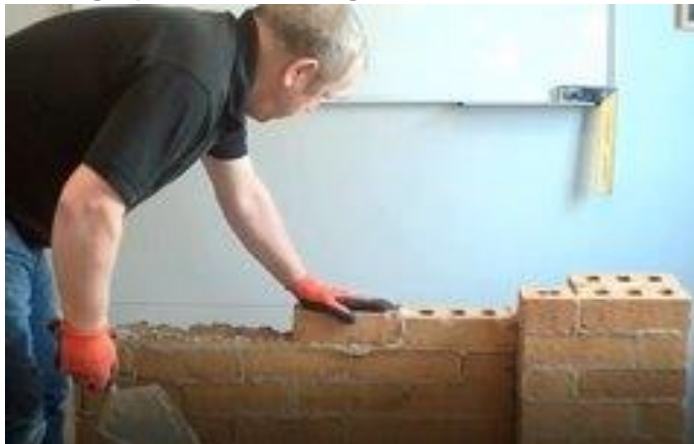
Photograph 10 – showing line work

Photograph 10 shows lining in rear elevation: showing consistency

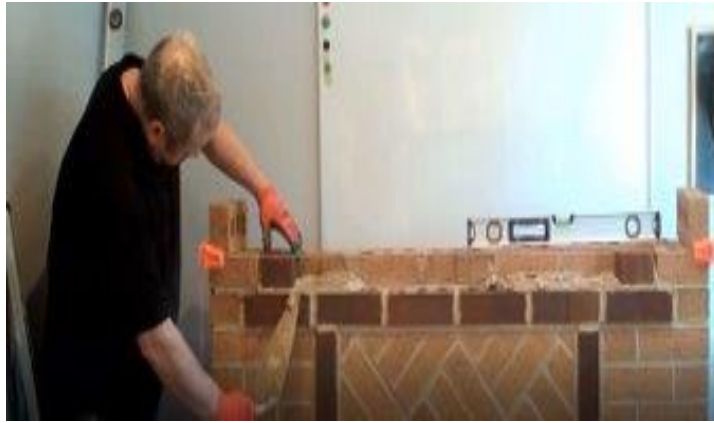
Photograph 11 shows
lining dentil course:
showing consistency

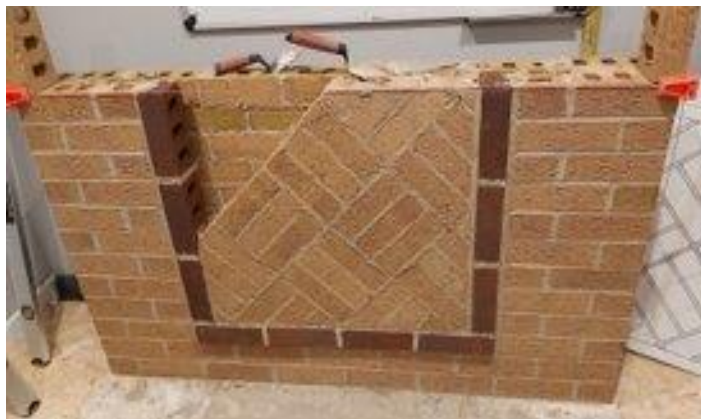
Photograph 12 shows
lining in top of decorative
panel (basketweave):
showing consistency

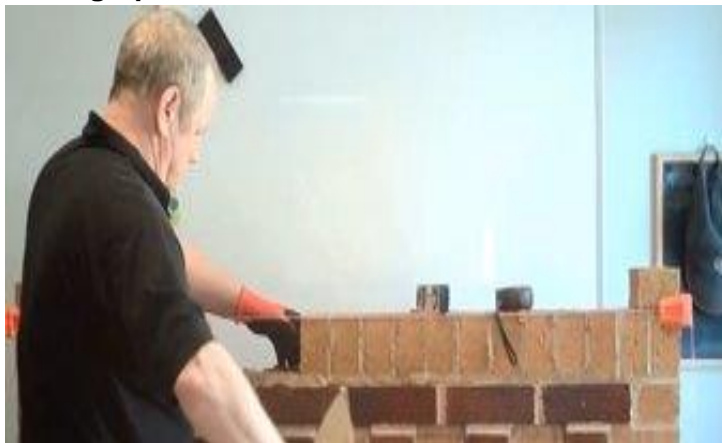
Photograph 13

Photograph13 shows
lining in brick on edge:
showing consistency

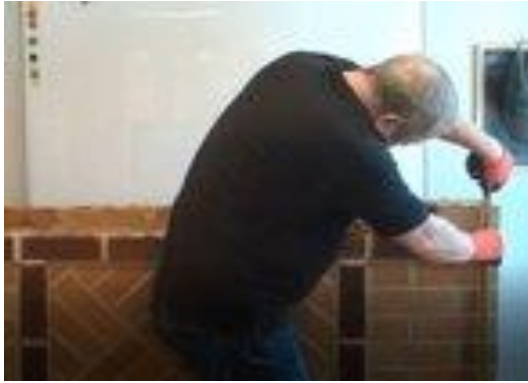
Photograph 14 showing candidate checking gauge work as they work

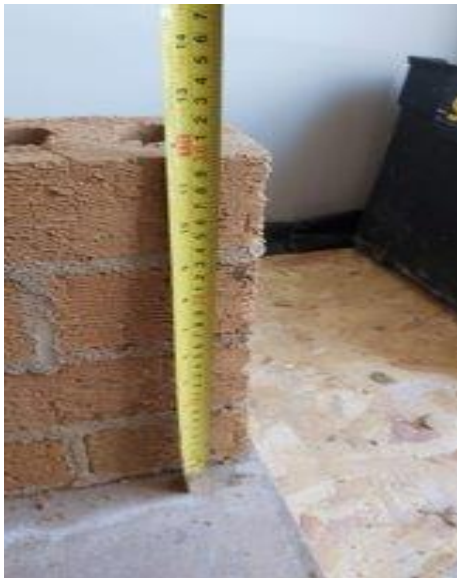
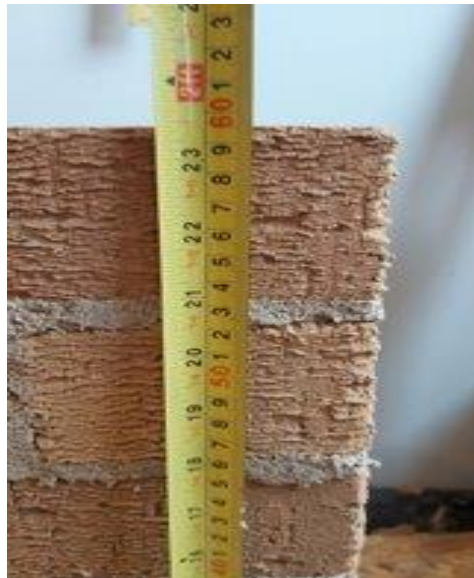
Photographs 15 and 16 showing walling remained slightly below gauge throughout the full height of the walling

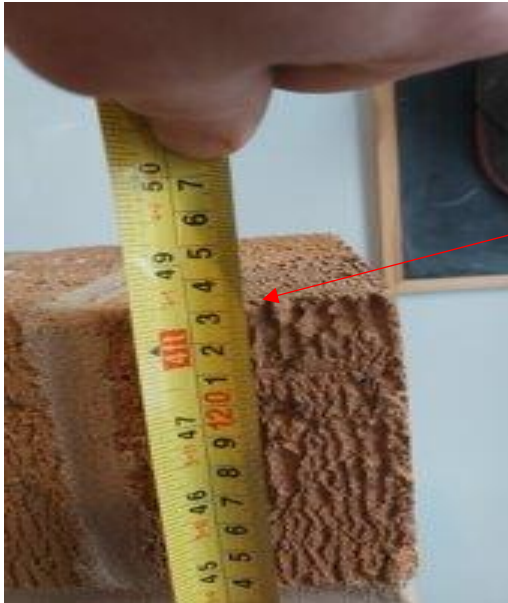
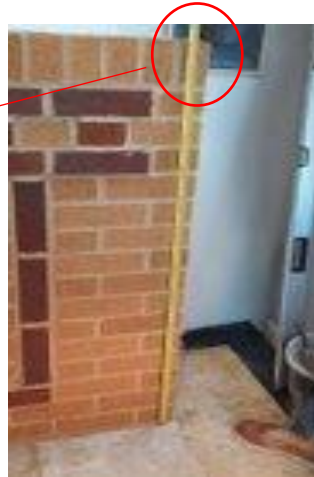
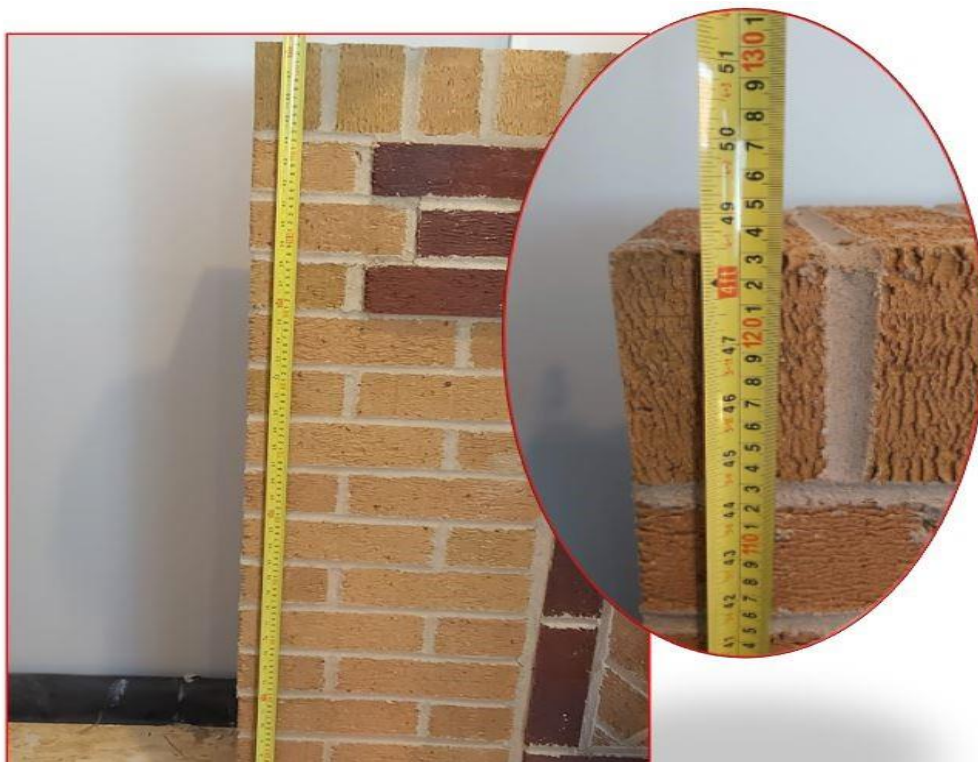
Photographs 17 – 19 showing final gauge work with final gauge height of wall 1,237mm against a given measurement of 1,237mm within the 5mm tolerance and there is consistency for most of the time in the joint thickness over the construction

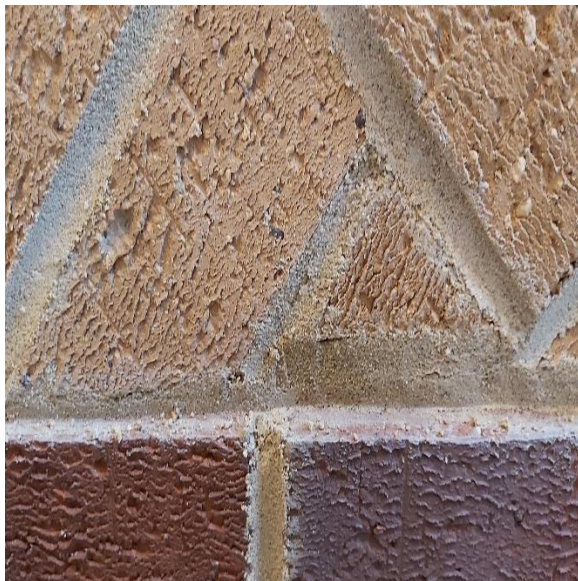
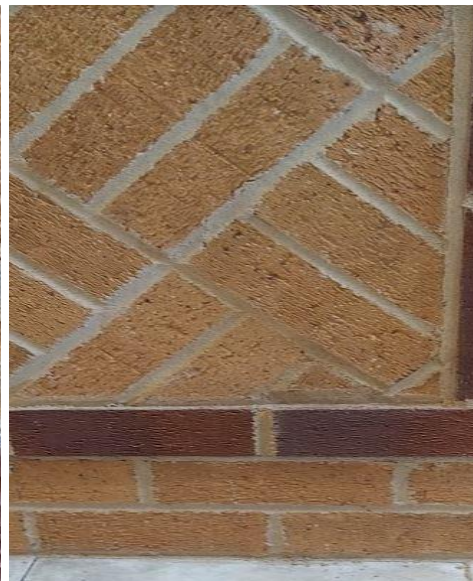
Photographs 20 and 21– detailing cutting error of brick to panel edge

Photographs 20 and 21 showing accurate cutting bar one small lapse on the ledge, but this has not affected the overall finish.

Note: Video details tolerances met to support photographic evidence and errors which include incorrectly cut brick, mortar smudge on dentil and error on edge of panel.

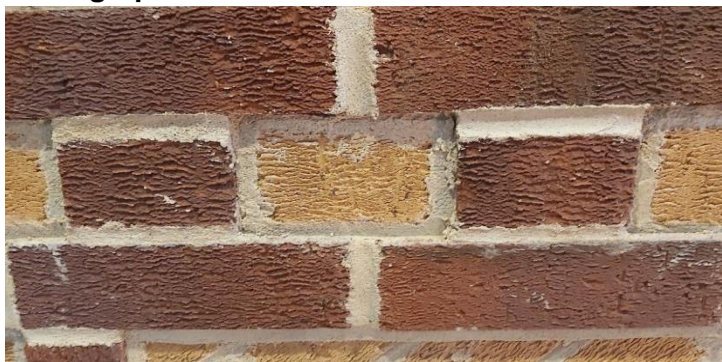
Photograph 22 showing slight mortar smudging on dentil course

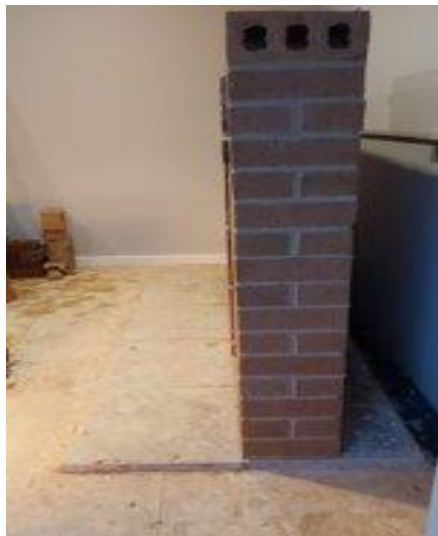
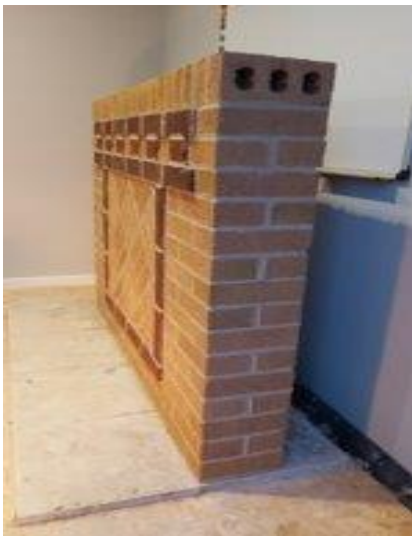
Photographs 23 and 24 showing side elevation of panel completed to a good standard with only minor errors (detailed in Video 3 TC)

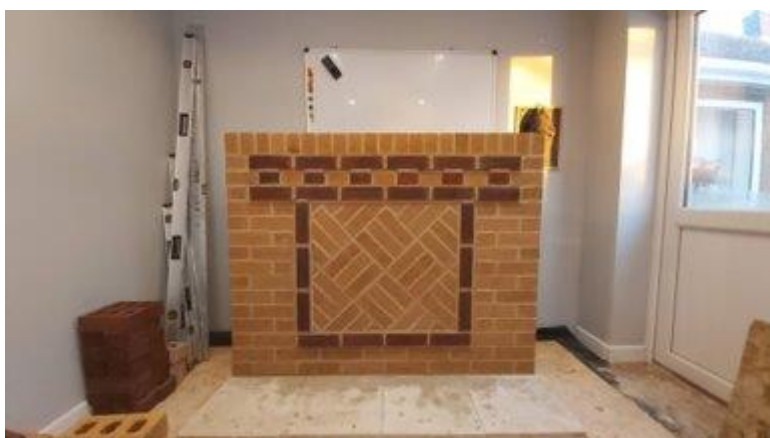
Photograph 25
Front elevation

Photograph 25 showing front elevation of panel completed to a good standard with only minor errors (detailed in Video 3 TC)

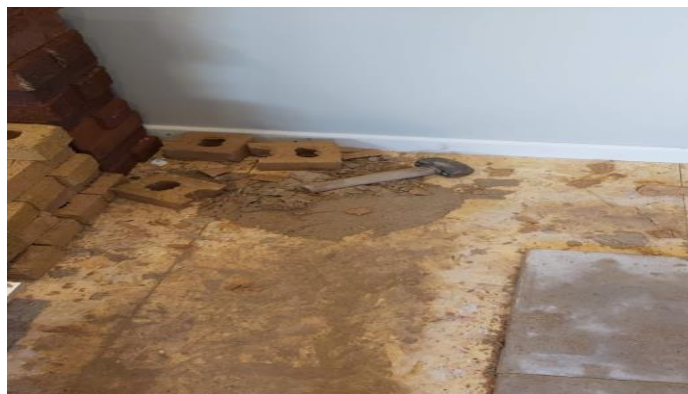
Photograph 29 – small omission to clean area: debris built up in middle of task

Photographs 26-31 showing area was kept tidy and clean through the task and waste was disposed correctly and regularly bar one small omission where debris (photograph 29) built up at middle stage of task

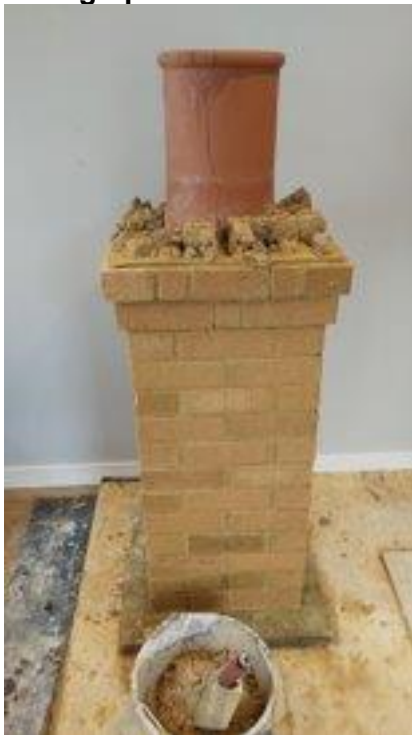
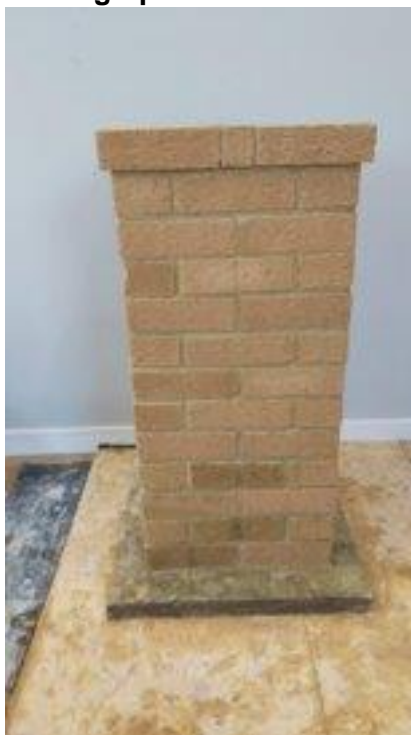
Photographs 34 and 35 showing removal of cracked chimney pot, existing flaunching and brickwork

Photographs 34 and 35 showing most materials removed, sound brush and cleaning work made in preparation for repair

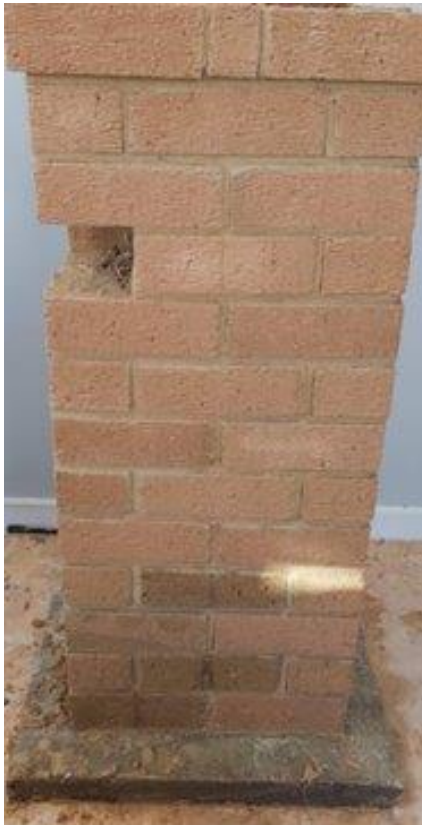
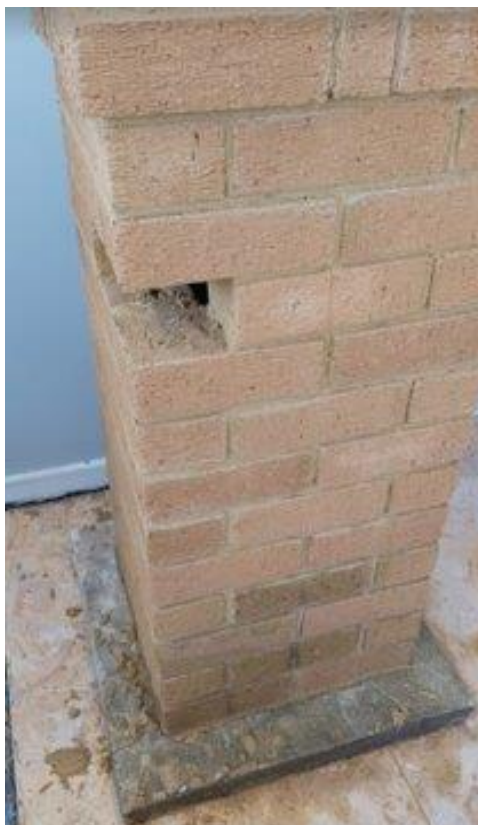
Photographs 38 and 39 showing removal of materials for preparation or repair - chipped brick

Photographs 38 and 39 showing most materials removed, sound brush and cleaning work made in preparation for repair

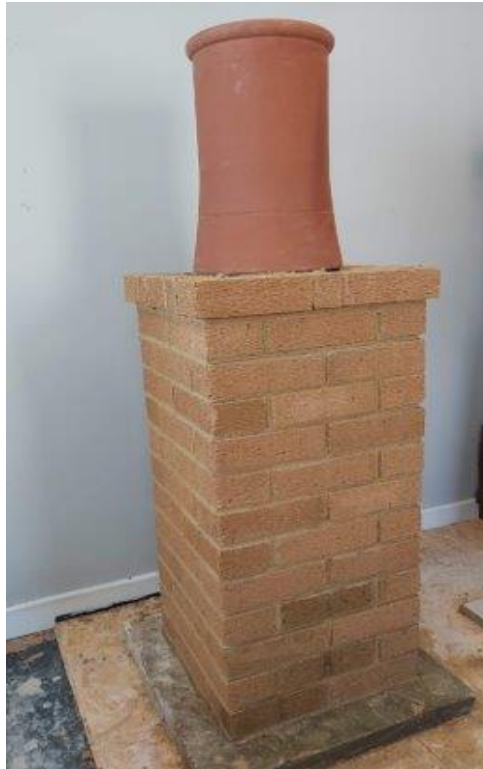
Photograph 40

New clay chimney pot fitted

Photographs 40-42 showing replacement corbelling and clay pot fitted correctly

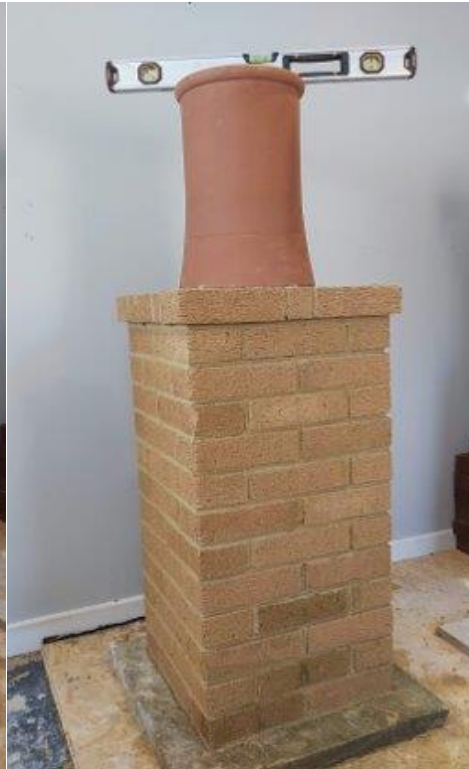
Photograph 41

Levelling new clay chimney pot

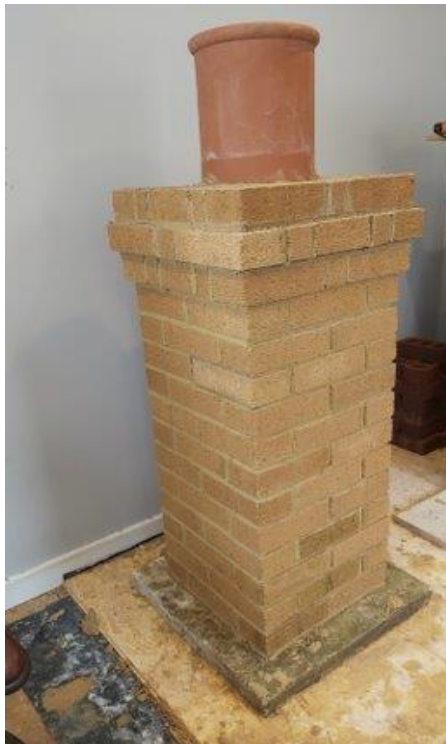
Photograph 42

Two courses of brickwork rebuilt on chimney stack

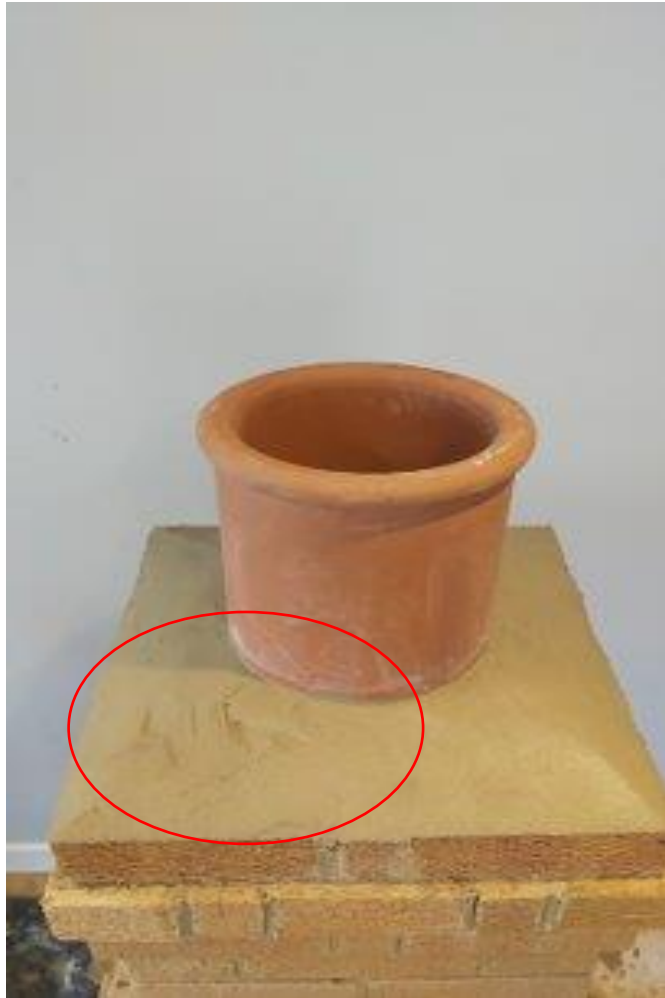
Photograph 43 showing top of stack flaunched in cement mortar

Photograph 43 showing flaunching to the top of the stack is to sufficient fall, but there are trowel marks

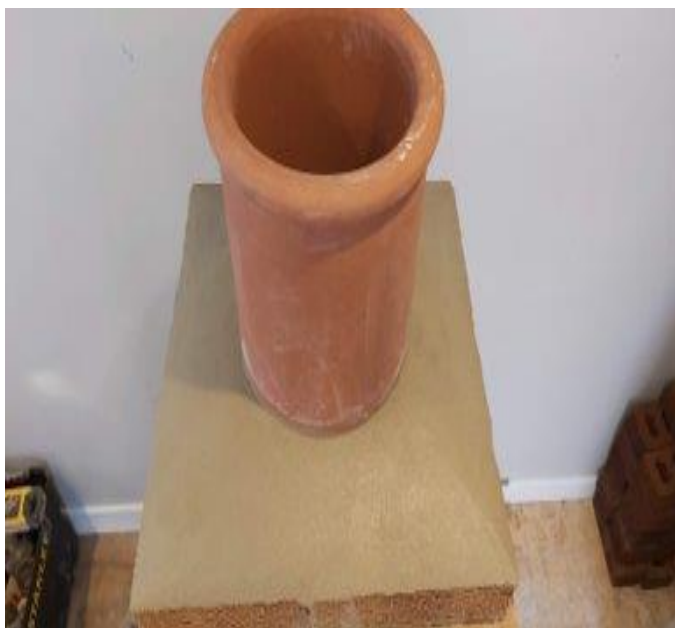
Photograph 44 showing rectification of error of trowel marks

Photograph 44 showing rectification to trowel marks before completion

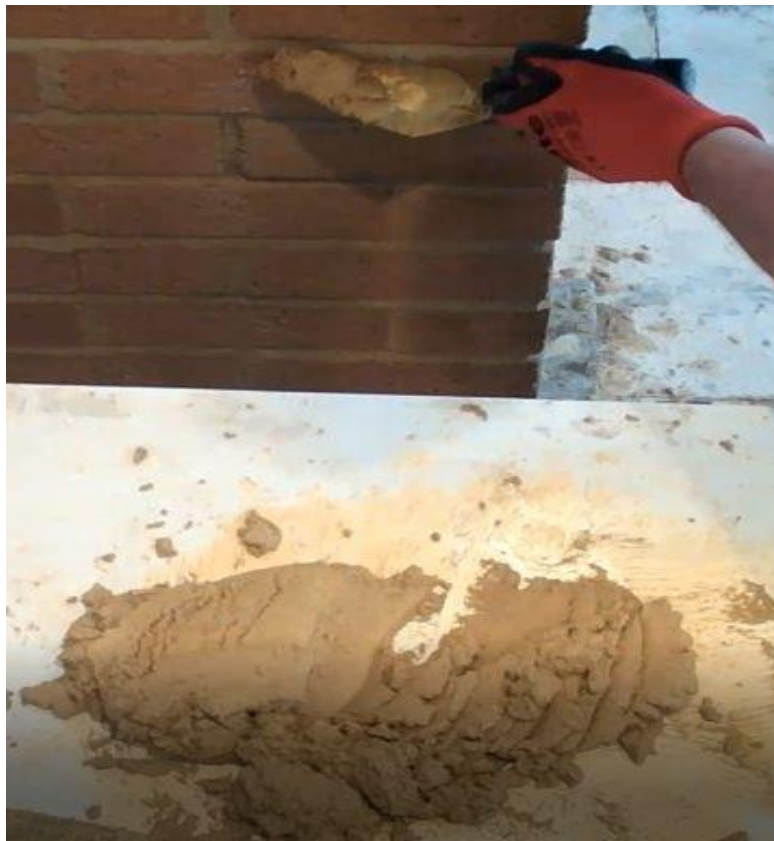
Photograph 45 – showing mortar consistency and texture correct but slight colour variation to existing mortar

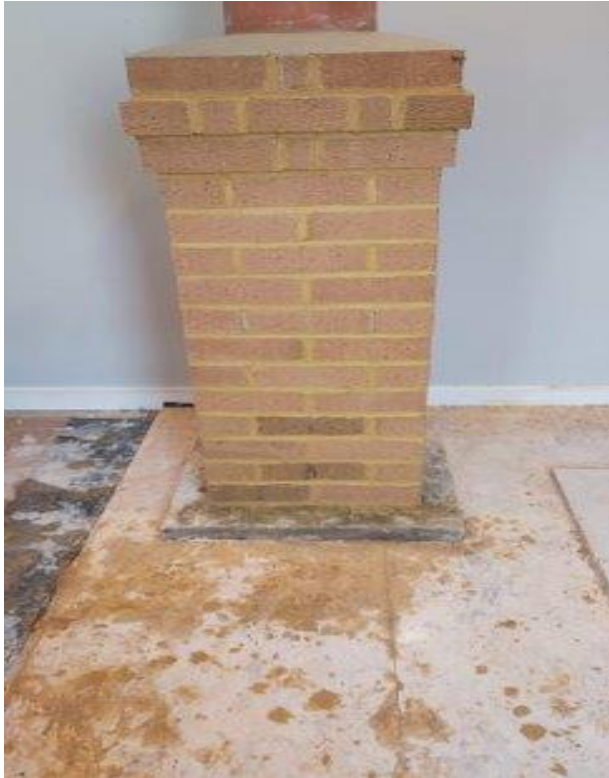
Photograph 46 showing face of stack jointed

Photograph 46 shows face repointed but two perpendicular joints were not completed prior to all the bed joints, leaving two joints with inconsistent edges.

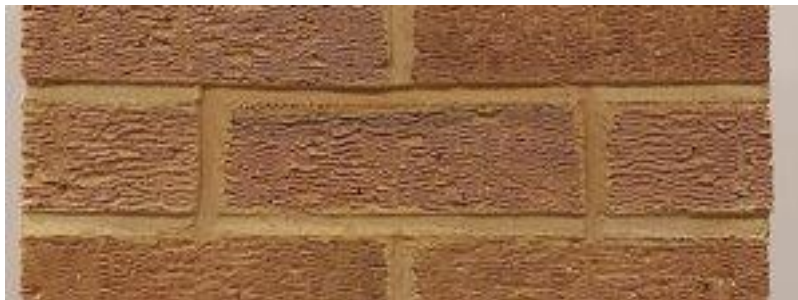
Photograph 47 – showing close up of 2 perpendicular joint error

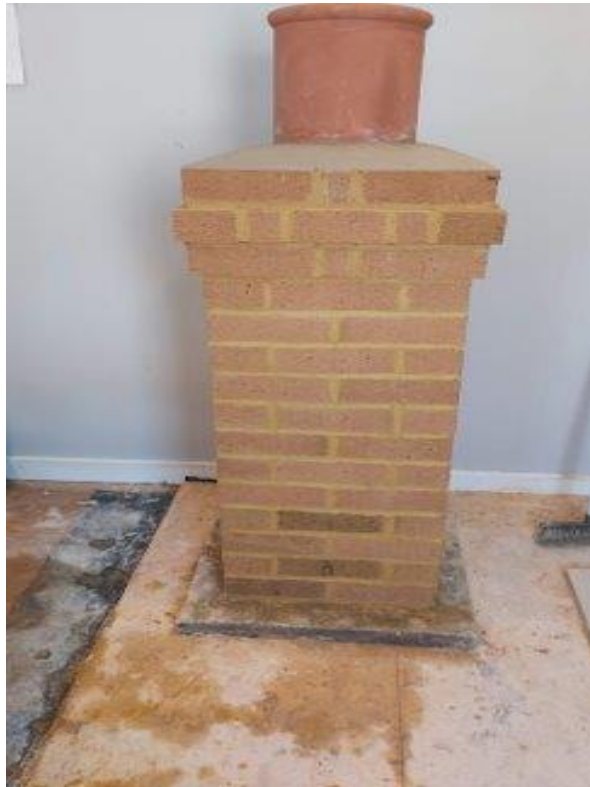
Photograph 48 – showing completed face of stack once jointed

Photograph 48 showing face of stack completed to a good standard bar minor error in 2 perpendicular joints, correctly replaced brick and slight colour mismatch of old and new mortar

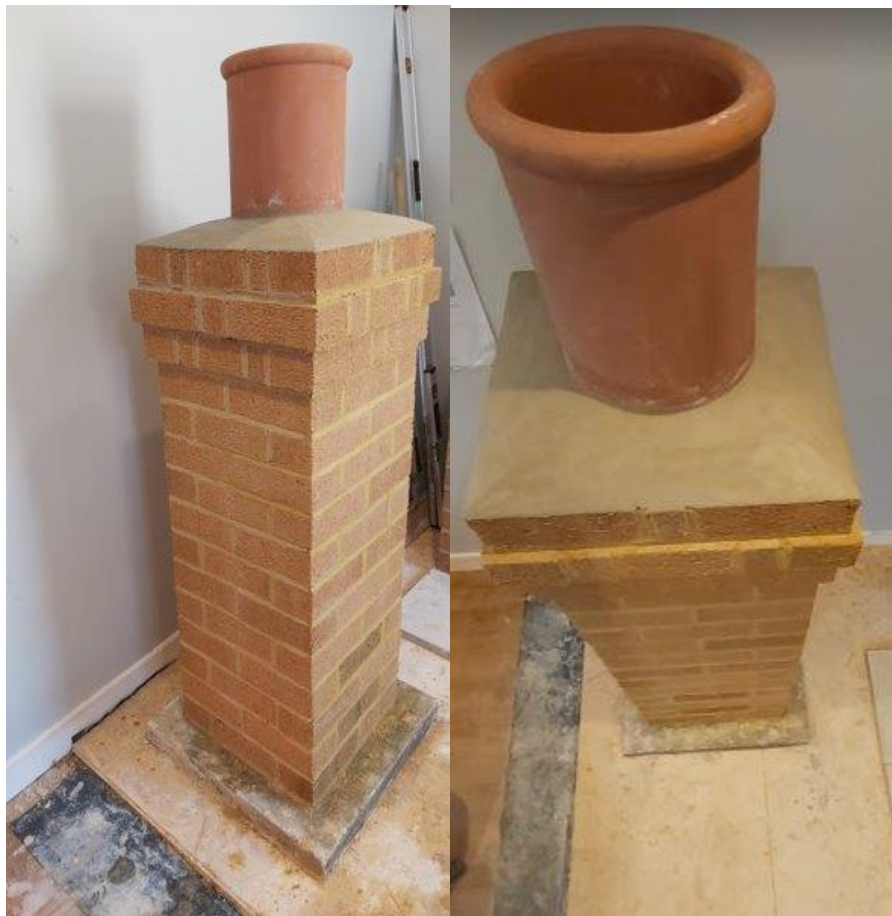
Photographs 49 – 50 showing completed repair of chimney

Photographs 49 and 50 showing completed repair work – finished to a good standard with minor errors as detailed in the colour of mortar and jointing.
