**T Level Technical Qualification in  
Maintenance, Installation and  
Repair for Engineering and  
Manufacturing (8712-35)**

**Light and Electric Vehicles (315)**

**Guide standard exemplification  
material**

**Threshold competence – Sample  
2022**

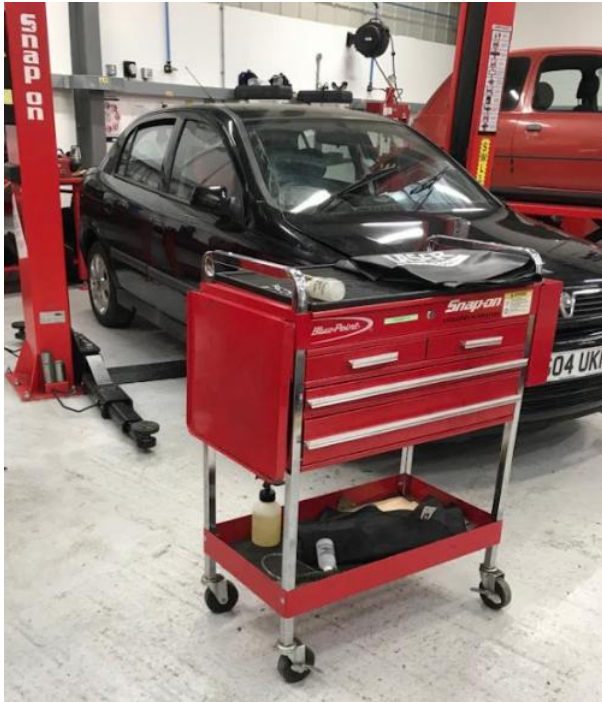
**Photograph 1:** Photographic evidence shows the prepared work area. Tools and equipment have been placed in the work area but have not been positioned in a fully logical sequence. Technical documentation is to hand but has been placed underneath the not yet fitted wing cover.

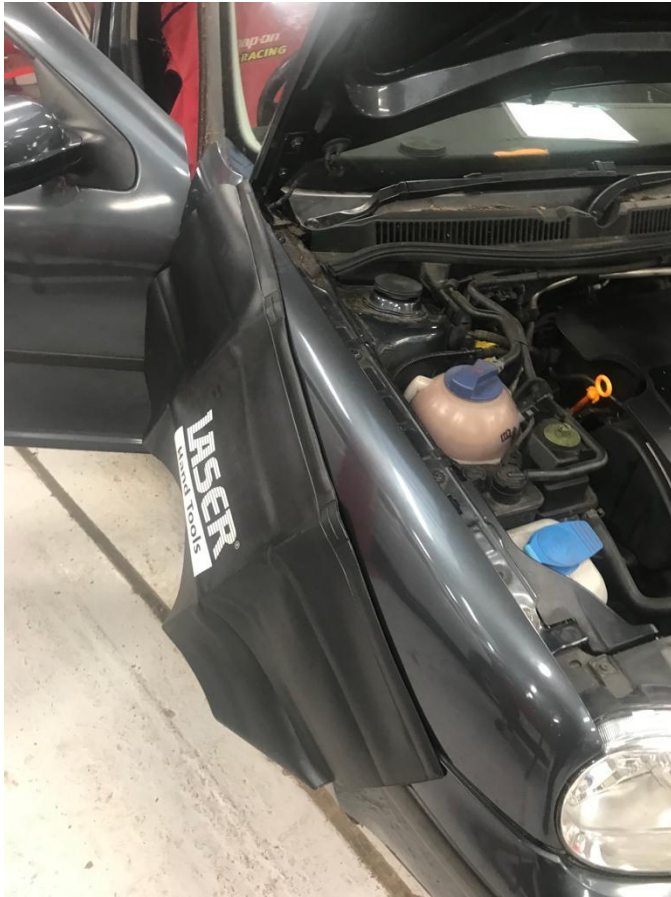
**Photograph 2:** Photographic evidence shows the prepared but not fully accurately fitted VPE on Vehicle 1, the wing cover is noted as sliding off.

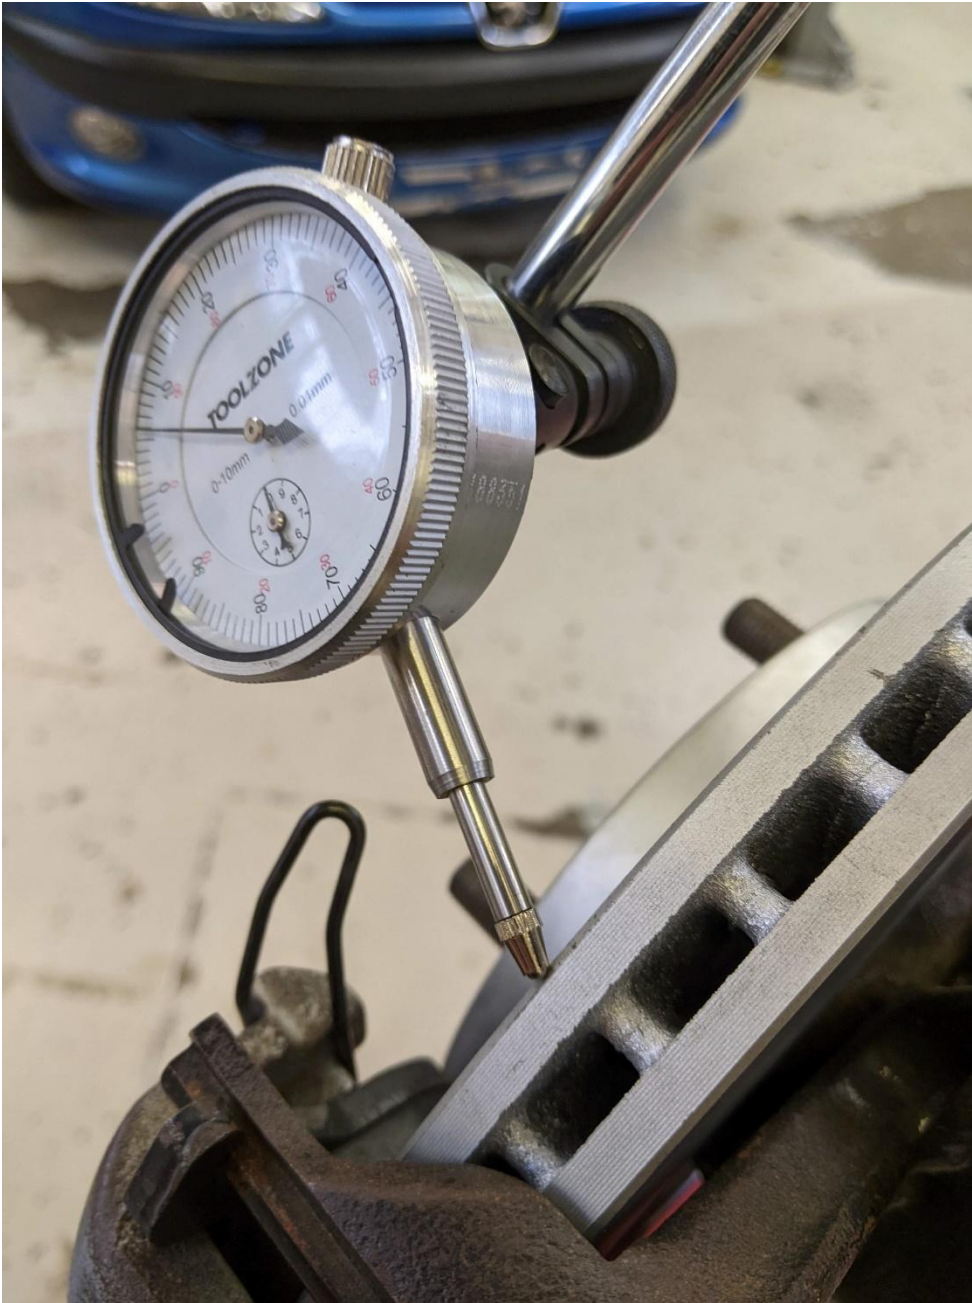
**Photograph 3:** Photographic evidence shows the initial set up and positioned DTI gauge to take brake run out readings, gauge has been set up to touch the outer edge of the disc which will give an inaccurate reading. This was subsequently corrected when the candidate realised the mistake and realigned.

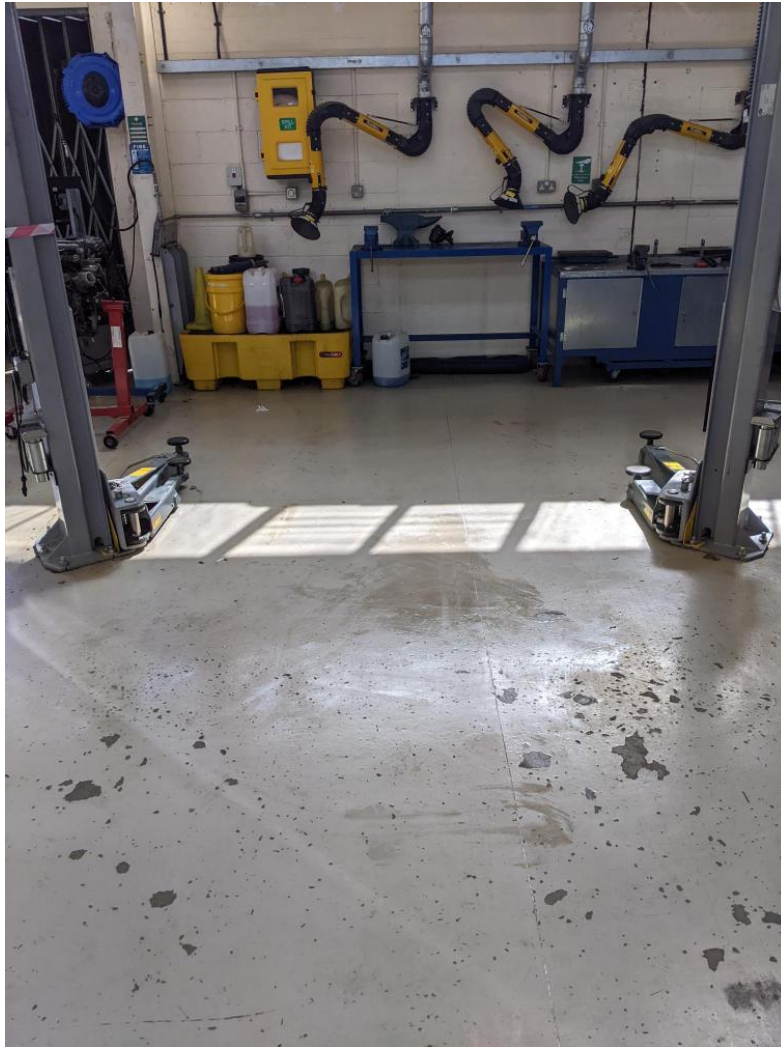
**Photograph 4:** Photographic evidence shows the two pillar working area reinstated correctly. The area has been cleaned, including an attempt to mop up a spillage – however the floor is still slippery so should include a slippery floor sign.

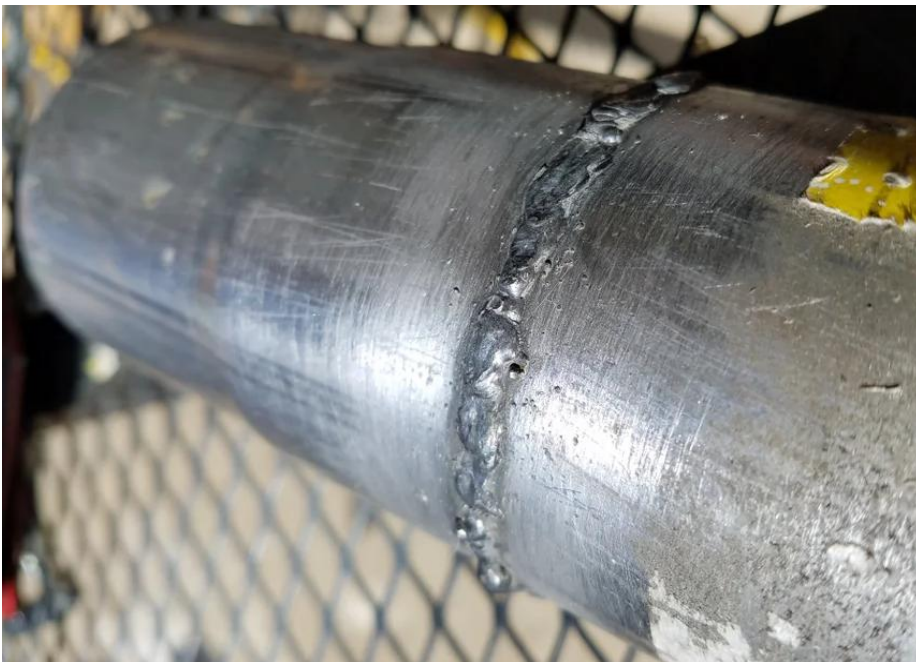
**Photograph 2:** Photographic evidence shows the welded joint between the exhaust pipe and extender, showing the level of quality finish with bubbles and a difference in weld thickness throughout the join.

The candidate was able to demonstrate welding techniques showing adequate hand skills and correct use of tools and equipment, ensuring the weld was completed to a basic standard. For example, producing basic penetrated joints with some consideration for accuracy and finish, allowing the run to cool before the next run. To develop the response further, the candidate could ensure to clean the welded joint to provide a more thorough finish. For example, the candidate did not clean the welding surfaces, before, during or after if this was followed it would have provided the candidate with a more efficient finish. The candidate followed and met basic health and safety requirements throughout the task ensuring to separate waste into the correct bins. To further develop their response, the candidate should have ensured all tools and equipment were fully returned to correct storage, leaving the working area safe and tidy.

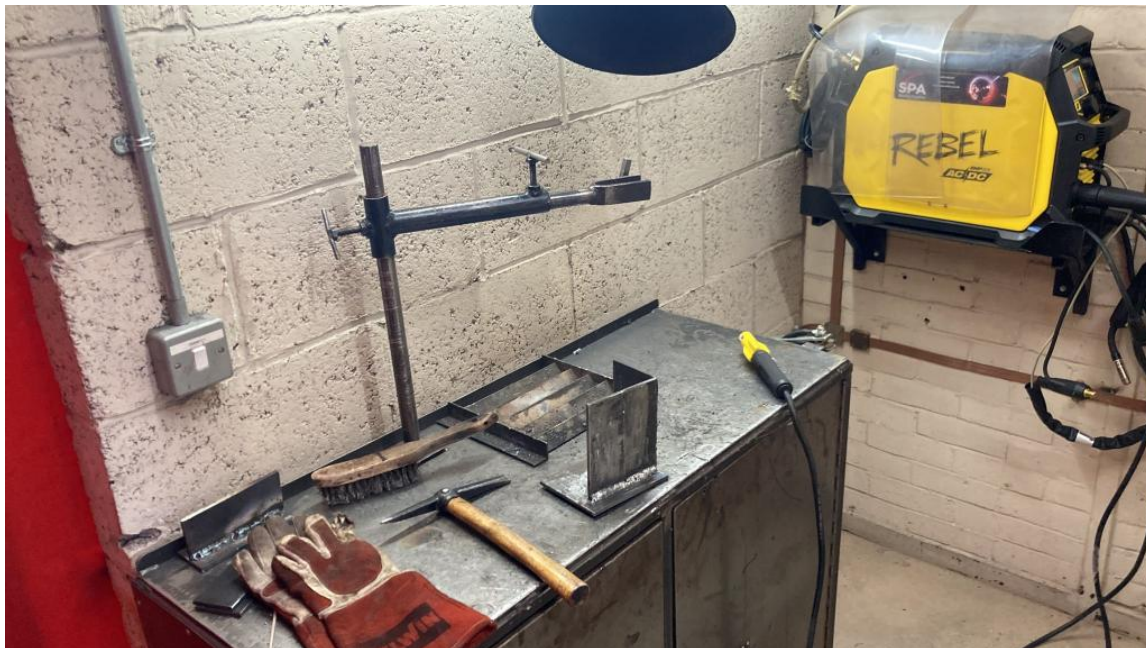
**Photograph 3:** Photographic evidence showing welding bay which has been cleaned to remove weld debris, but tools and equipment have not been fully returned to appropriate storage.

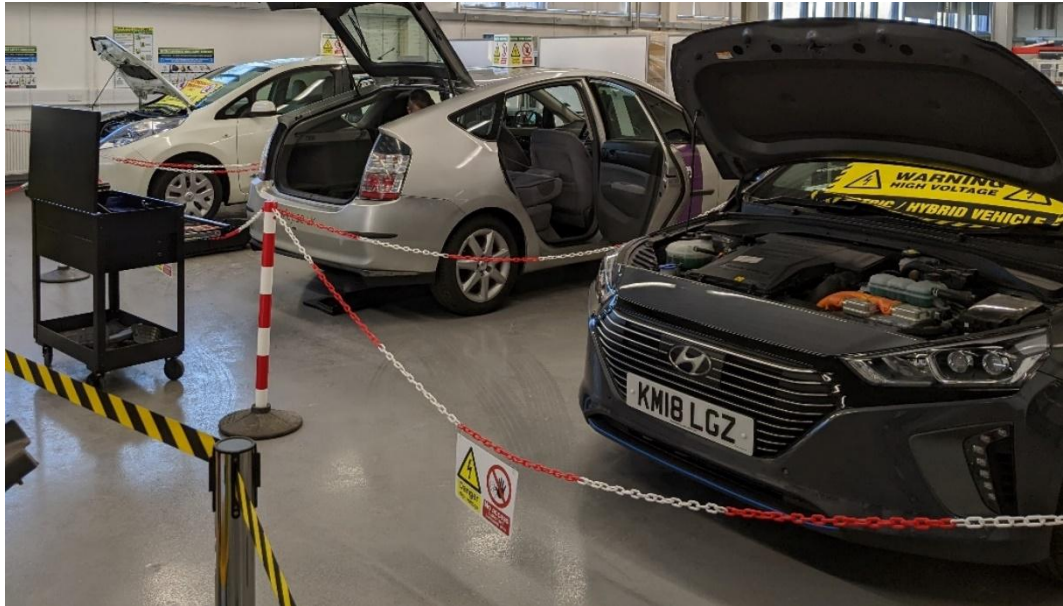
**Photograph 1:** Photographic evidence shows that the work area has been prepared with consideration of the task to be undertaken. Warning signs have been placed on the windscreen to reflect this is a hybrid vehicle, and a barrier has been erected for safety purposes. Tools, equipment and technical documentation have been collected and placed in a toolbox but this has been positioned away from the vehicle in a way that is not most effective for the work to be carried out, with some tools also placed underneath the toolbox and not positioned logically within the toolbox in the order needed.

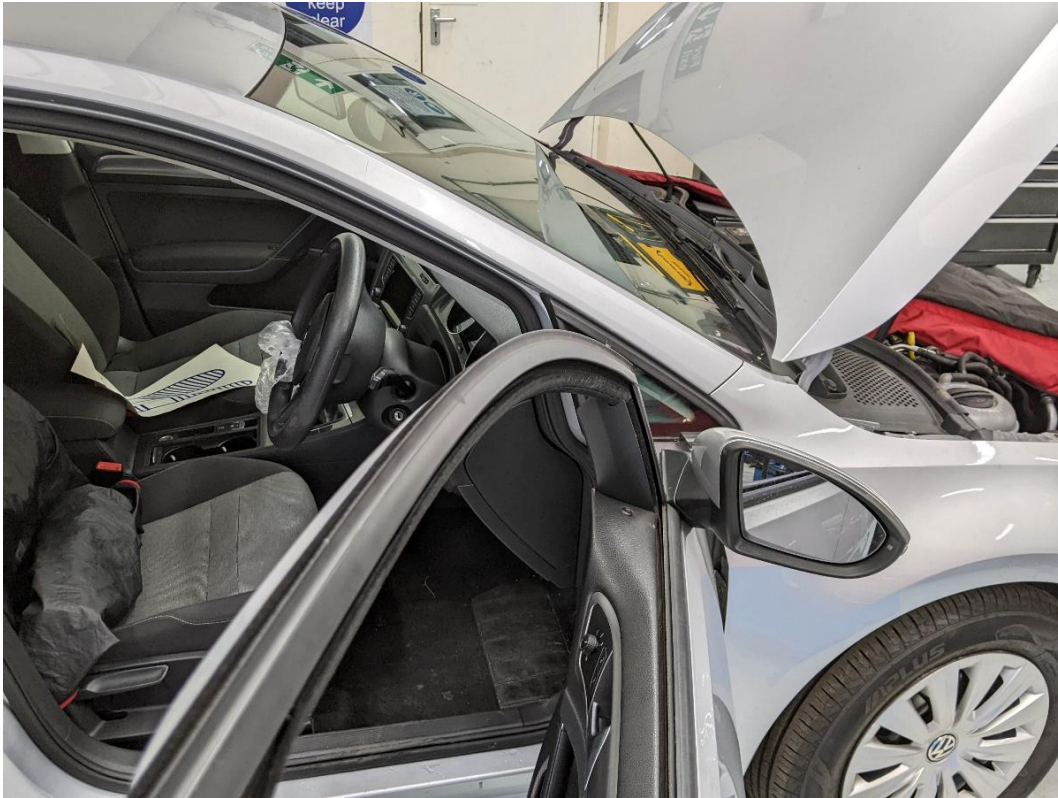
**Photograph 2:** Photographic evidence shows the prepared and not fully accurately fitted VPE. Steering wheel cover has mostly come off, the foot well protection is on the passenger seat rather than the driver's side floor and the seat cover has also partially come off from the seat. Wing cover has moved to under the bonnet instead of the wing.

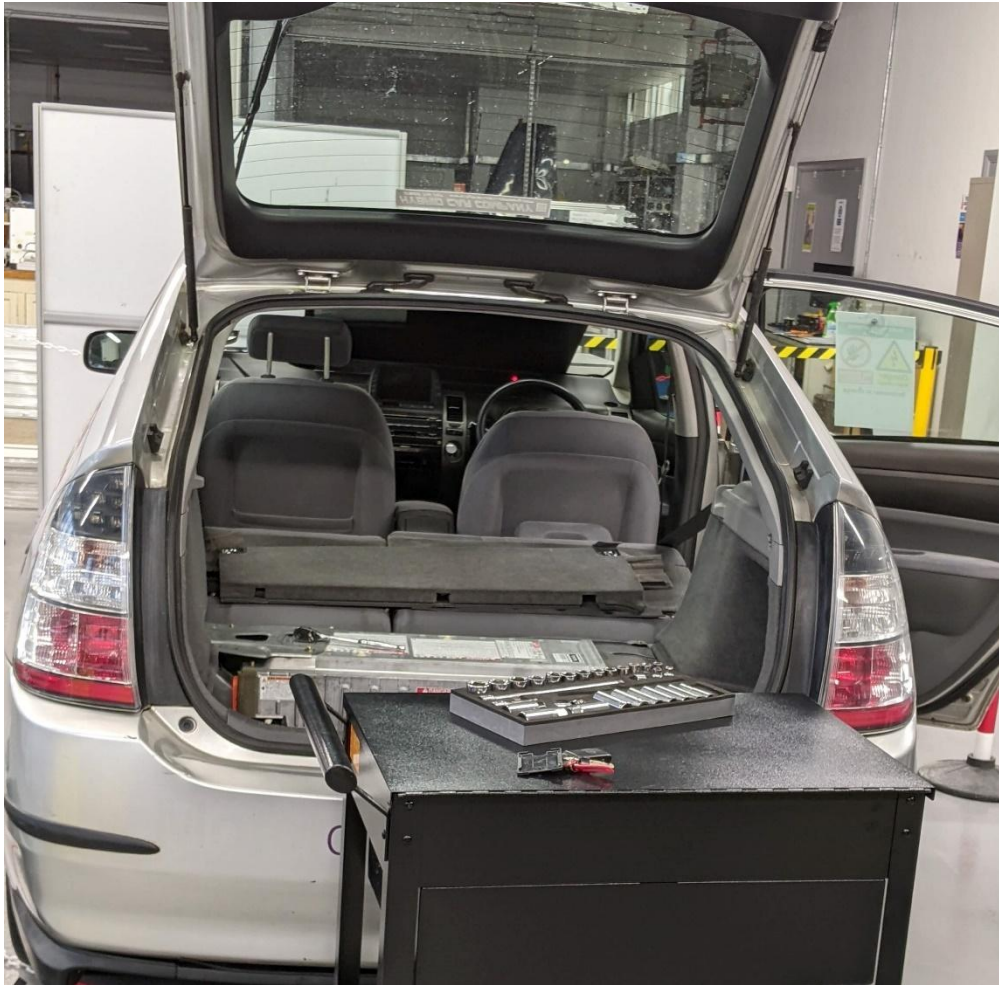
**Photograph 3:** Photographic evidence shows the high voltage battery correctly exposed with tools prepared but placed improperly.

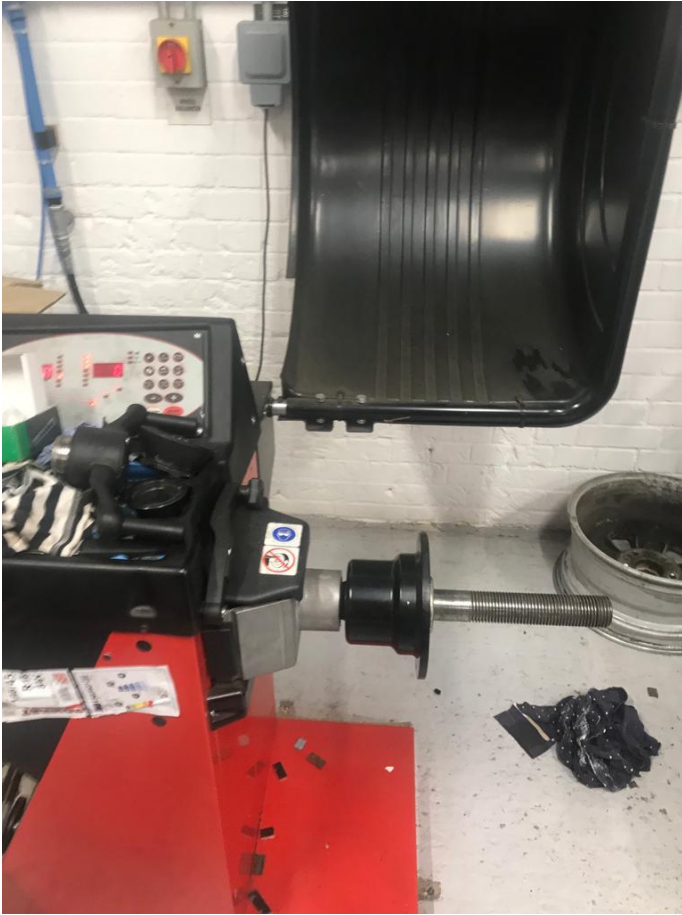
**Photograph 4:** Photographic evidence shows the re-instated wheel balancing work area, but not fully tidy.

The wheel balancing was carried out to industry standard practice and completed in a timely manner.
