**T Level Technical Qualification
in Engineering, Manufacturing,
Process and Control
(8713-32)**

**Machining and Toolmaking
Technologies (332)**

**Guide Standard Exemplification
Material
Threshold Competence - Sample**

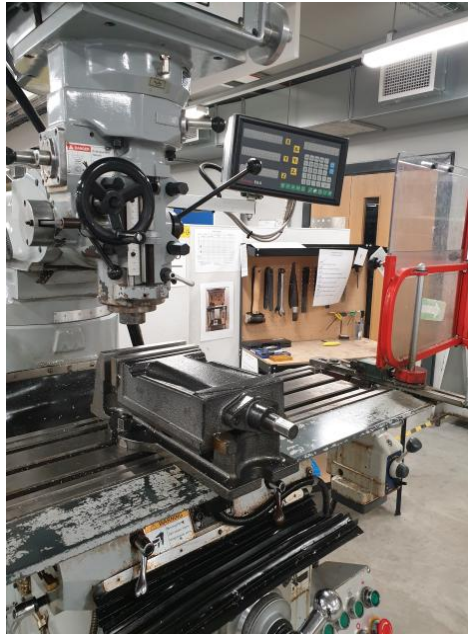
Photograph 1 – showing the prepared mill work area.

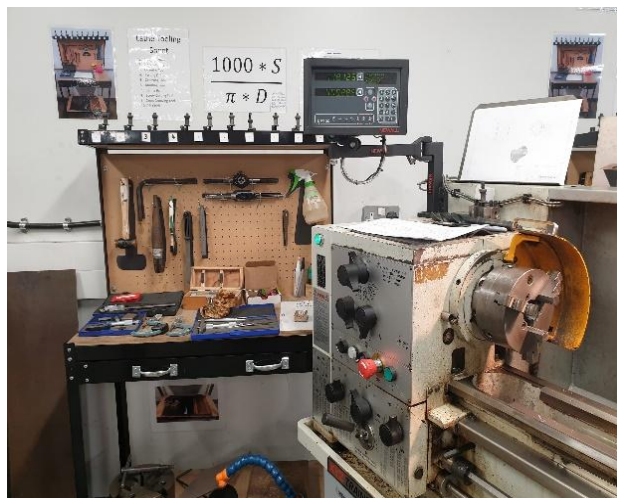
Photograph 2 – showing the lathe area, clear of debris and all tools and equipment are correctly stored on the shadow board next to the machining area.

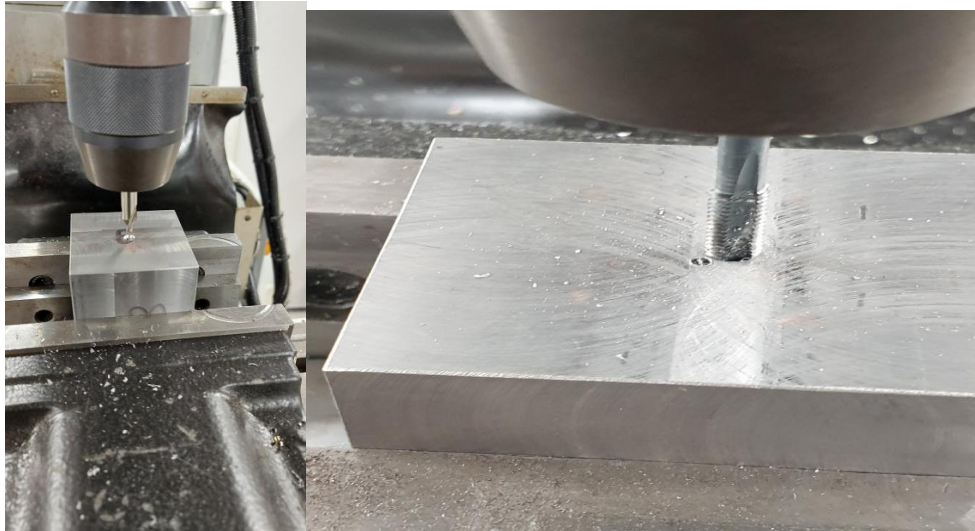
Photograph 6 and 7 – showing the wobble bar into the centre and centre drilled, 13.7 drill and 14 reamer. The wobble bar was used to find the centre of the block.

Note: The wobble bar offset was not taken into account creating the original centre drill to be placed incorrectly, this was rectified before drilling and tapping the M5 tapped hole.

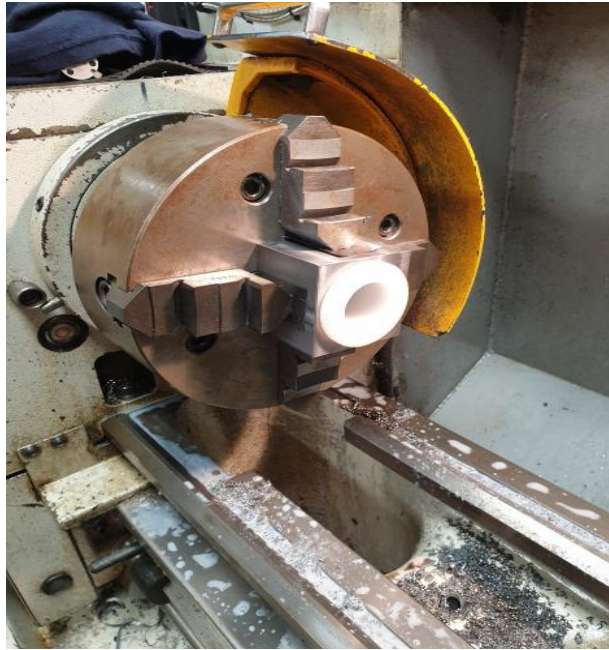
Photograph 9 – showing the bored out bearing housing, some additional adjustment was required until the nylon top hat was a push fit.

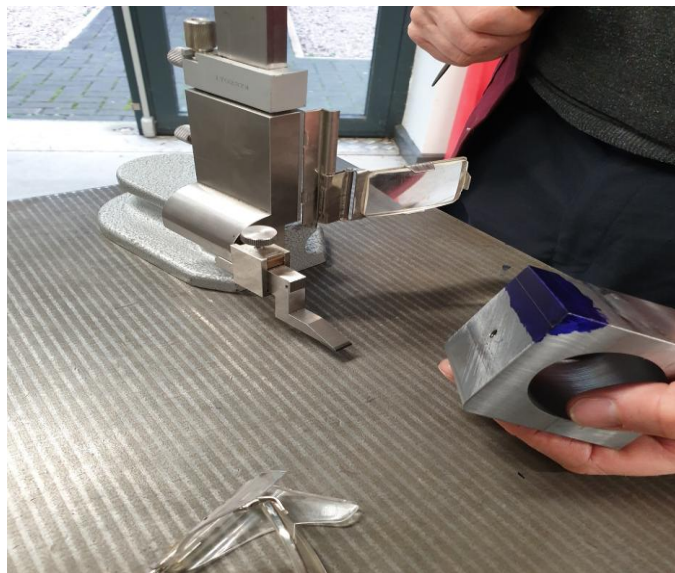
Photograph 10 - showing 8mm chamfer blued and marked with the vernier height gauge.

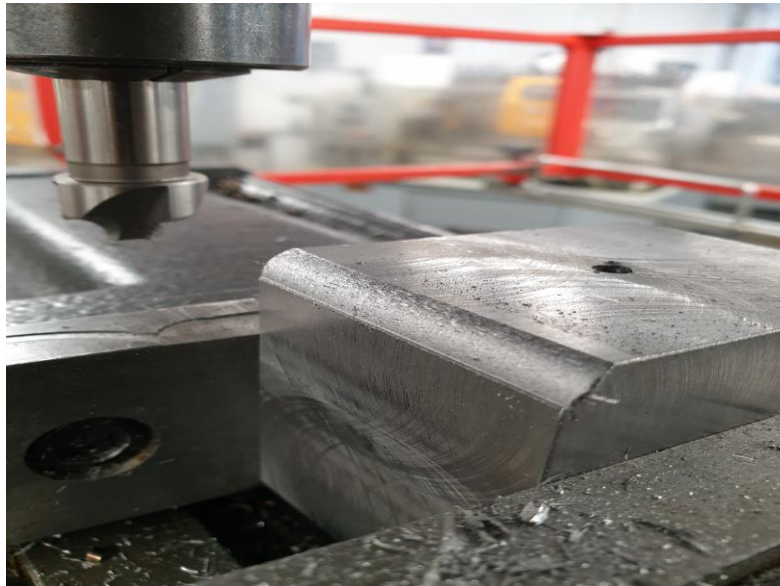
Photograph 11 – showing the chamfer machined using a 45-degree setting piece and a carbide tipped 16mm end mill. The R10 has cut in too deeply on the X axis. This means the form is too far in the block and has created a step.

Task	Notes – detailed, accurate and differentiating notes which identify areas of strength and weakness are necessary to distinguish between different qualities of performance and to facilitate accurate allocation of marks once all evidence has been submitted.
<p>Production</p> <p>The assessor observation should include consideration of:</p> <ul style="list-style-type: none"> the stages of production tool application and usage application of hand skills set up and use of manual and pre-programmed CNC workshop machinery checks carried out before, during and after production performance of safety critical commissioning checks 	<p>The candidate prepared their work area at the beginning of the session, following their risk assessment. The standard workshop SOP was followed to prepare the manual milling machine, manual lathe and CNC lathe for use. Some of the measuring tools were checked for calibration and a quick reference check to a slip gauge or zero was made. Visual checks completed on the tools and tooling selected, not all tools were checked for cleanliness prior to use. Materials were prepared and made ready for the next process; work deburred effectively. They completed some inspection of the work, but this was brief.</p> <p>They proceeded to machine each component, starting with the bearing housing. The part was prepared and squared on the mill. The four faces were cut using a face cutter and checked with a DTI gauge. During the machining, a false cut was made but the candidate stopped in time and the part was machined to size. The wobble bar was used to find the centre of the block, then the centre was drilled. The wobble bar offset was not taken in account, causing the original centre drill to be placed incorrectly. The candidate rectified this before drilling and tapping the M5 hole.</p> <p>The candidate cleared swarf away from the moving parts of the lathe but some material was caught between the workpiece and the hard jaws causing noticeable indentations on the workpiece. The bearing housing was bored out, adjustments were required to achieve the push fit. Chamfers on the workpiece were correctly blued and marked with a vernier height gauge to create the chamfers then machined using a 45-degree setting piece and a carbide tipped 16mm end mill. The R10 cut in too deeply on the X axis, with the form too far in the block, creating a step.</p>

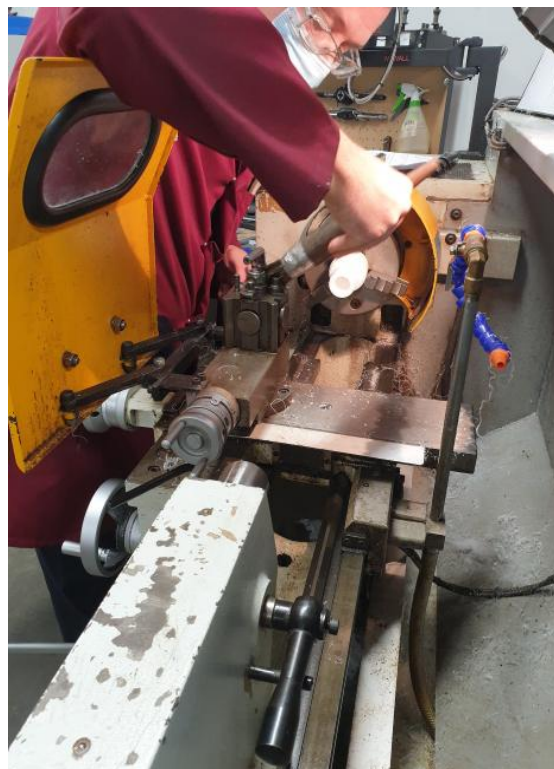
Photograph 12 – showing cleanliness of tool change over maintained throughout manufacturing.

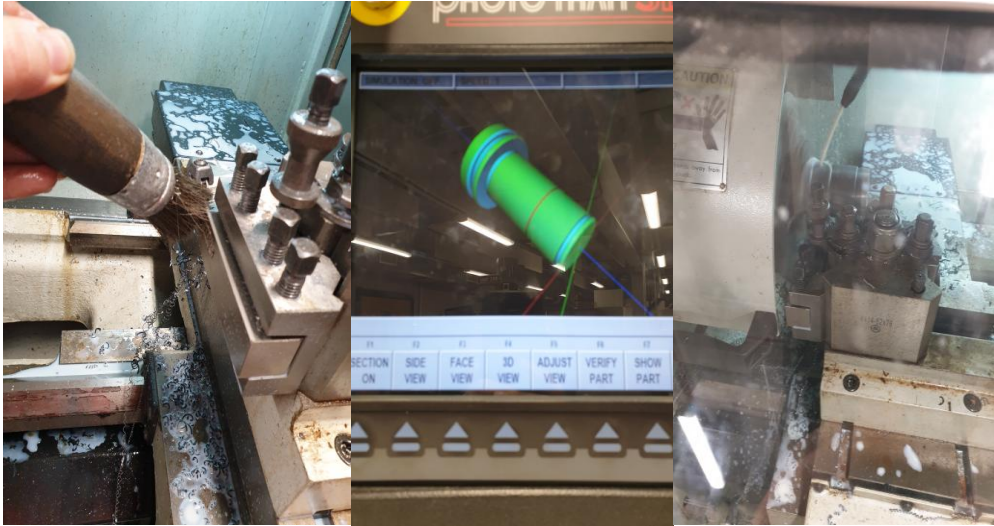
Photographs 15, 16 and 17 – showing the use of the CNC lathe including a tip change.

The tool tip had wear and was changed, the bar was chucked into the right distance from the chuck. The program simulation was run to see the general outlook of the part. The program was then run but in tracking mode to start with to prove first pass. The part was then changed to CNC mode. Coolant was turned on and part run with the 4 tools being changed at the right time.
