T Level Technical Qualification in Engineering, Manufacturing, Processing and Control (8713-34)

Fabrication and Welding Technologies (334)

**Guide standard exemplification
material**

**Threshold competence – Sample
2022**

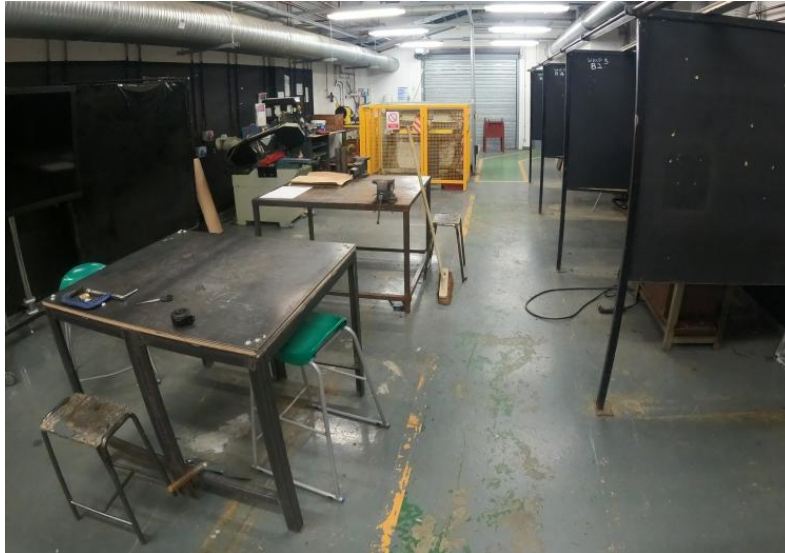
Preparing the work area (Photograph 1)

Photograph 1 – showing the work area prior to activities being started. Photograph shows the area of work has some tools left on bench, with a cable slightly onto the walkway. Stools have not been tucked away or removed completely and the candidate has not stored all tools correctly.

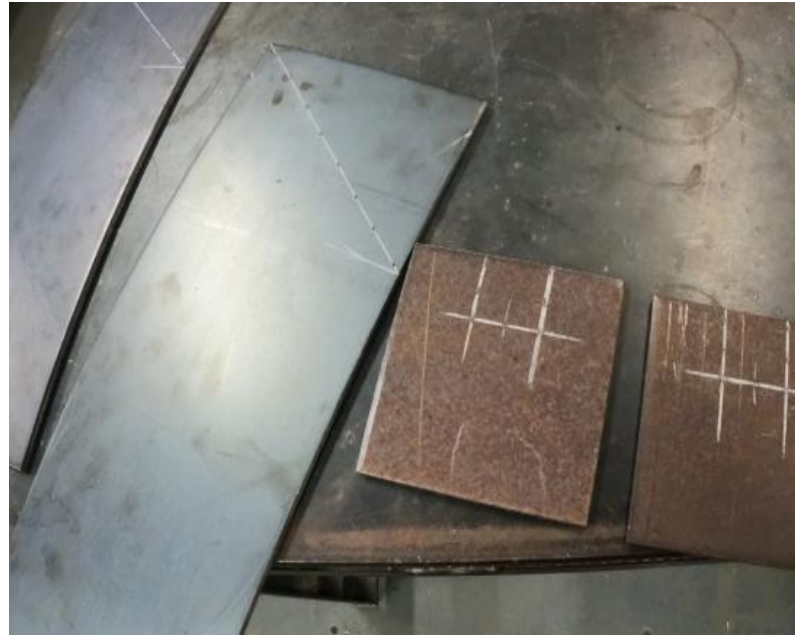
Photograph 3 – showing the markings on the plates, it can be seen there are scribed marks which are inaccurate on the right-hand side. These were eventually corrected by the candidate.

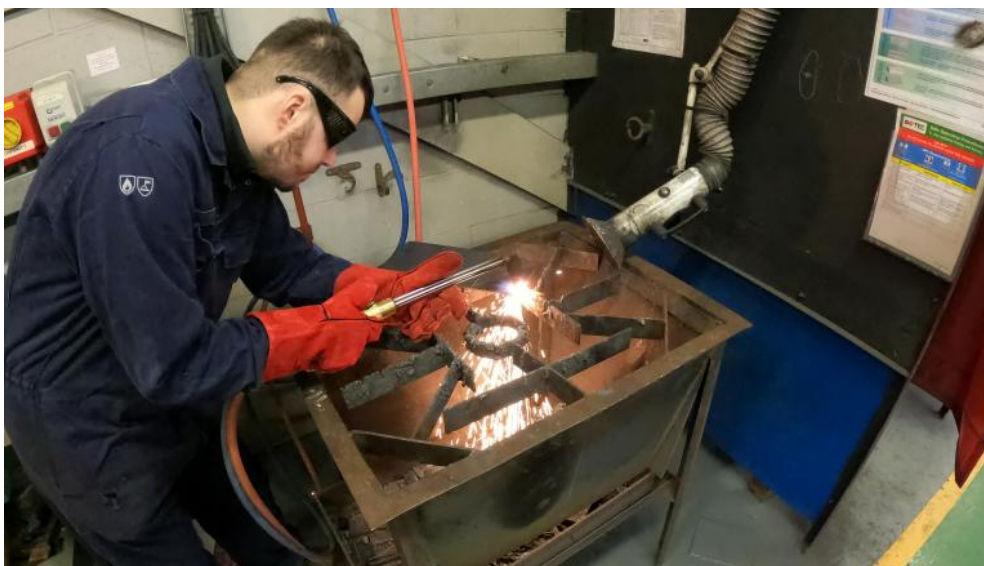
Photograph 4 – showing the cutting of the components using oxy-fuel (acetylene) cutting process.

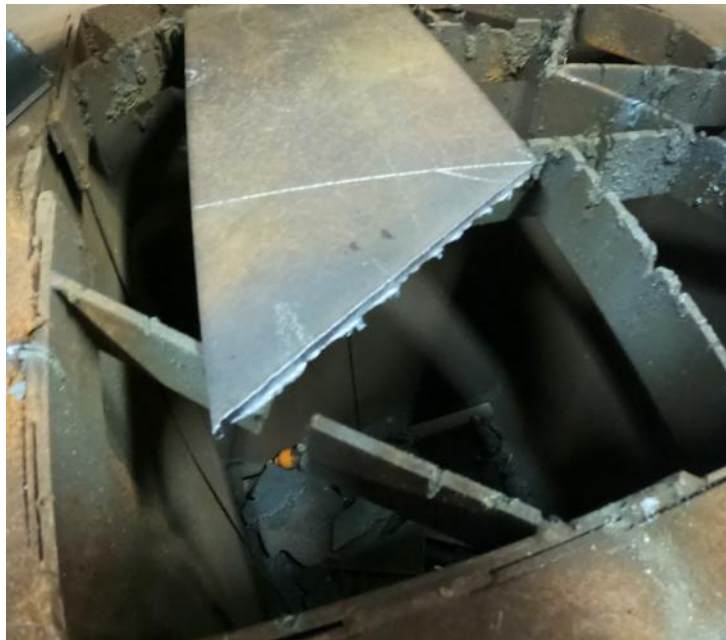
Photograph 6 – showing the cuts before any welding preparation. Cut lines should have been straight to the scribed lines to maintain the dimensions of the component.

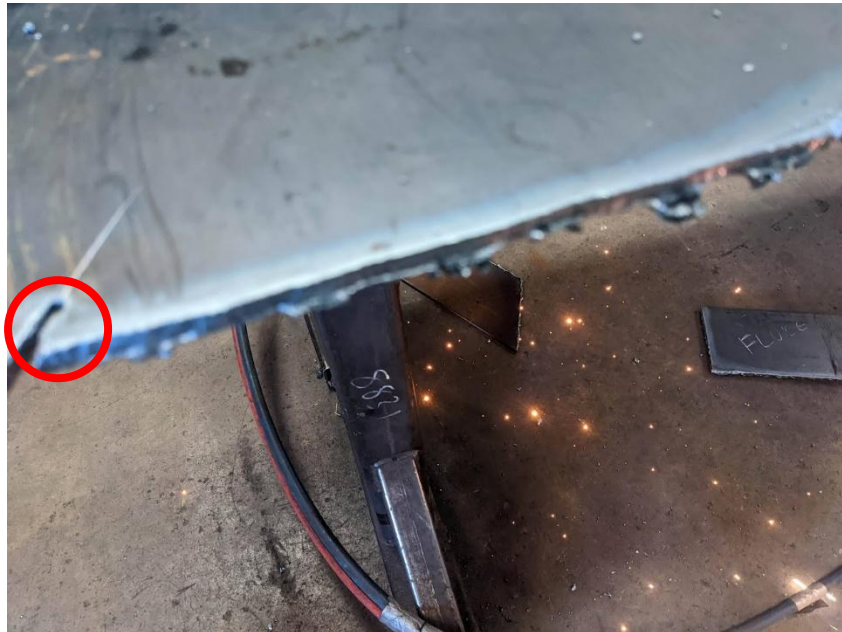
Photograph 7– showing an example of uneven cutting. Cut lines should have been straight to the scribed lines to maintain the dimensions of the component. Note the extra cut made to the left of the picture. Note the trailing gas hoses under the work bench which the candidate should have avoided in order to prevent damage to the hoses from falling debris.

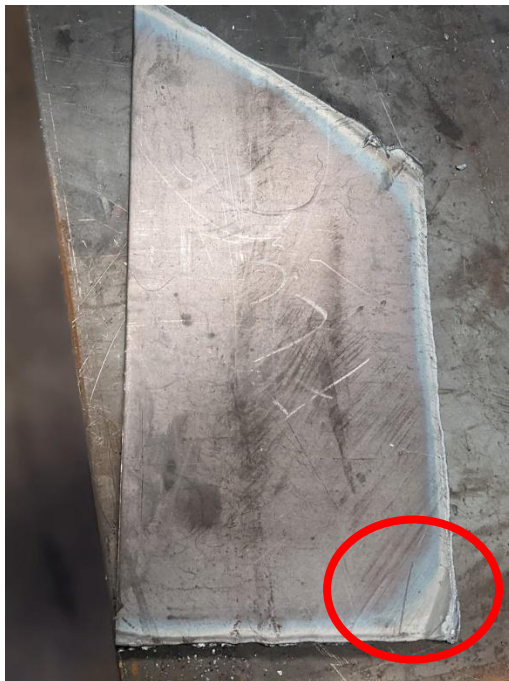
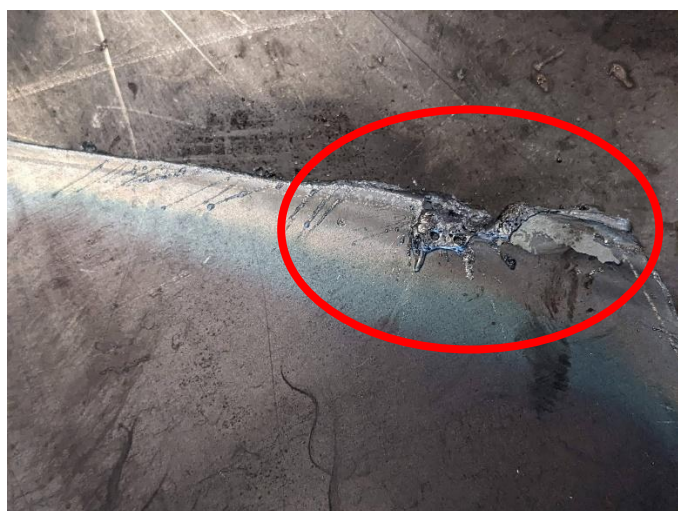
Photographs 8 and 9 – showing an example of uneven cutting and some warping to the bottom left corner. Cut lines should be straight to the scribed lines to maintain the dimensions of the component. Note the defect to the top right of the picture (enlarged).

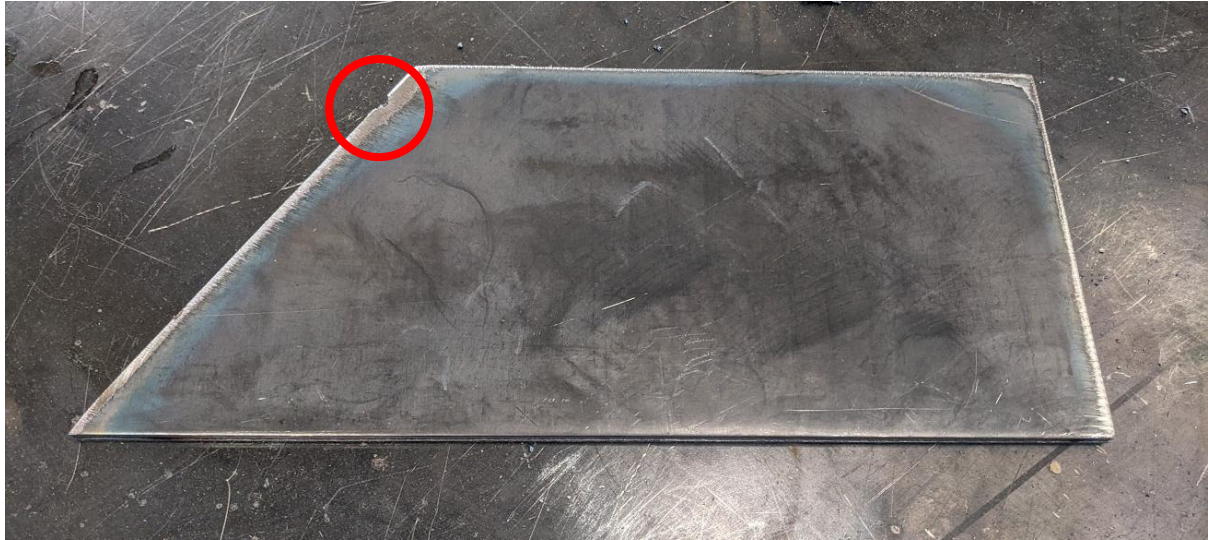
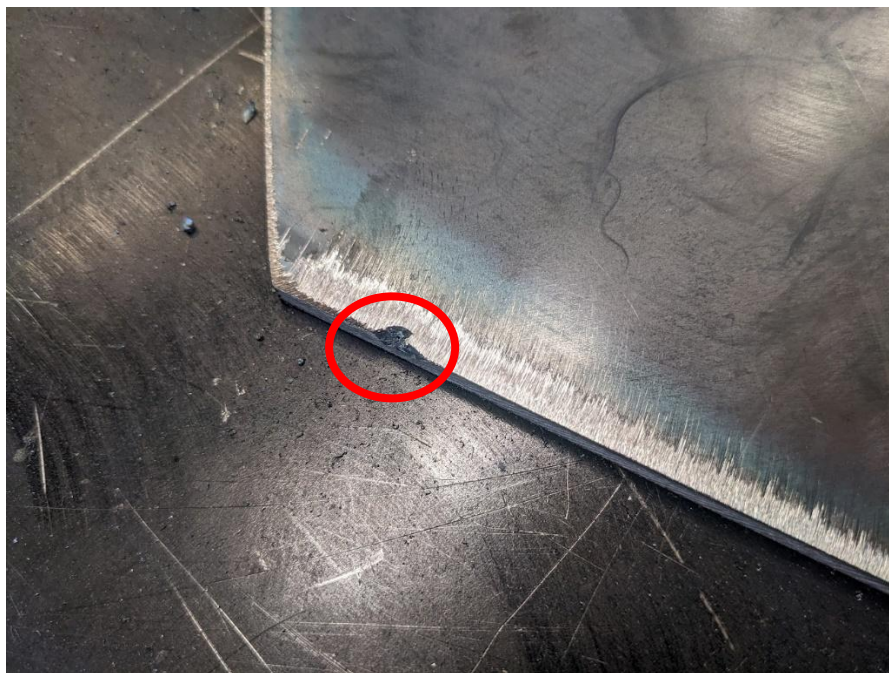
Photographs 10 and 11 - showing the fluke component after grinding and preparing the component for welding. Note the defect in the cut remains and the warped corner has been rectified.

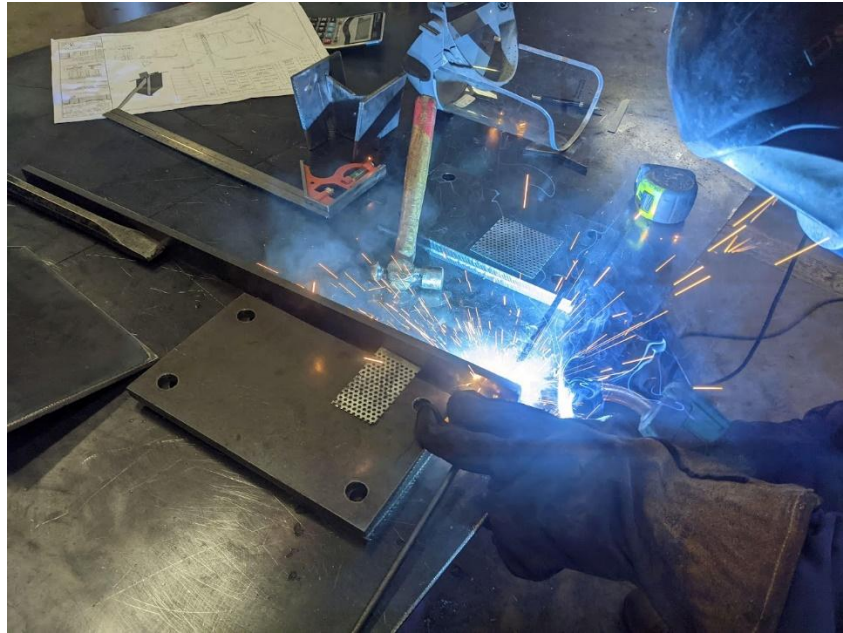
Photograph 15 – showing application of MIG welding the bar through the stock.

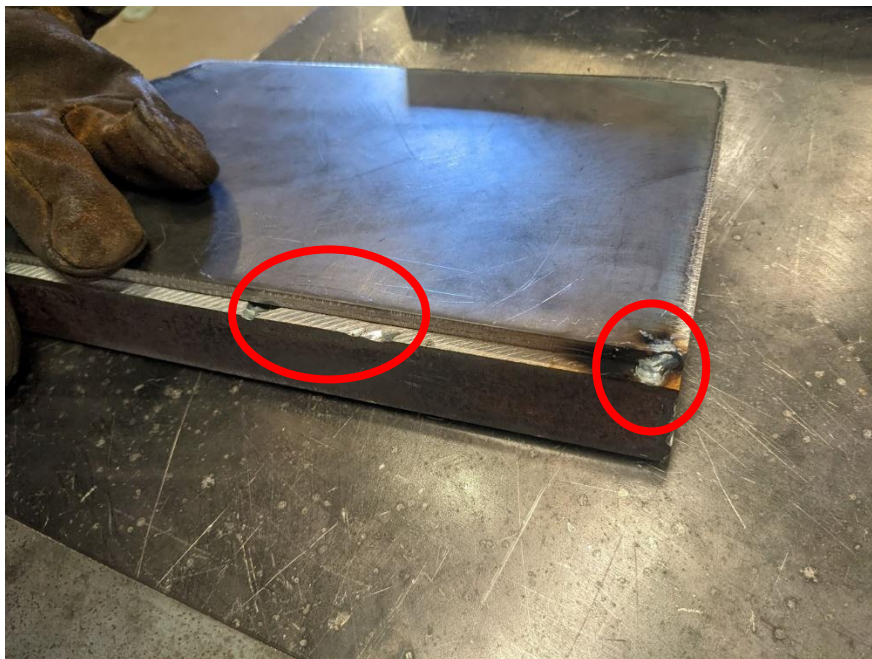
Photograph 16 – showing application of tack welding, note the damage to the component.

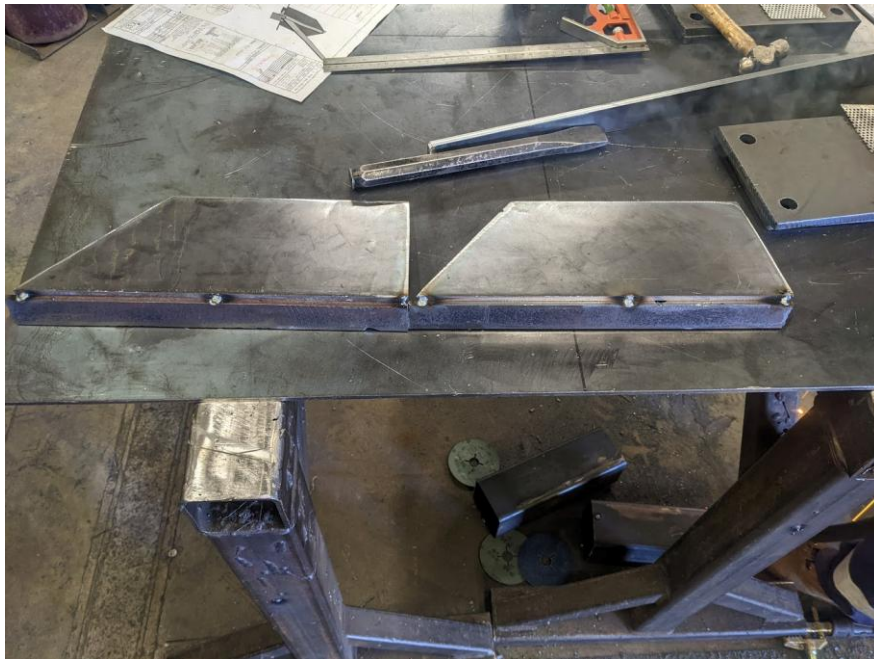
Photograph 17 – showing flukes tack welded to the supports. Note the floor area under the workbench is cluttered with used grinding discs and other waste.

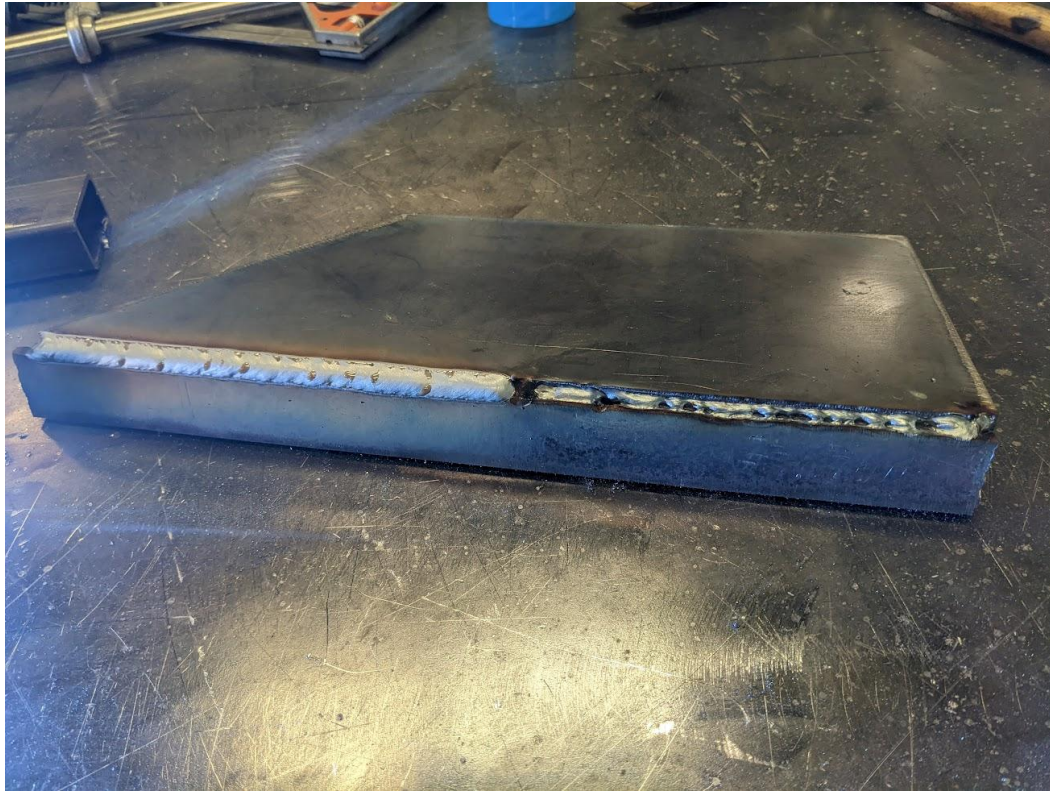
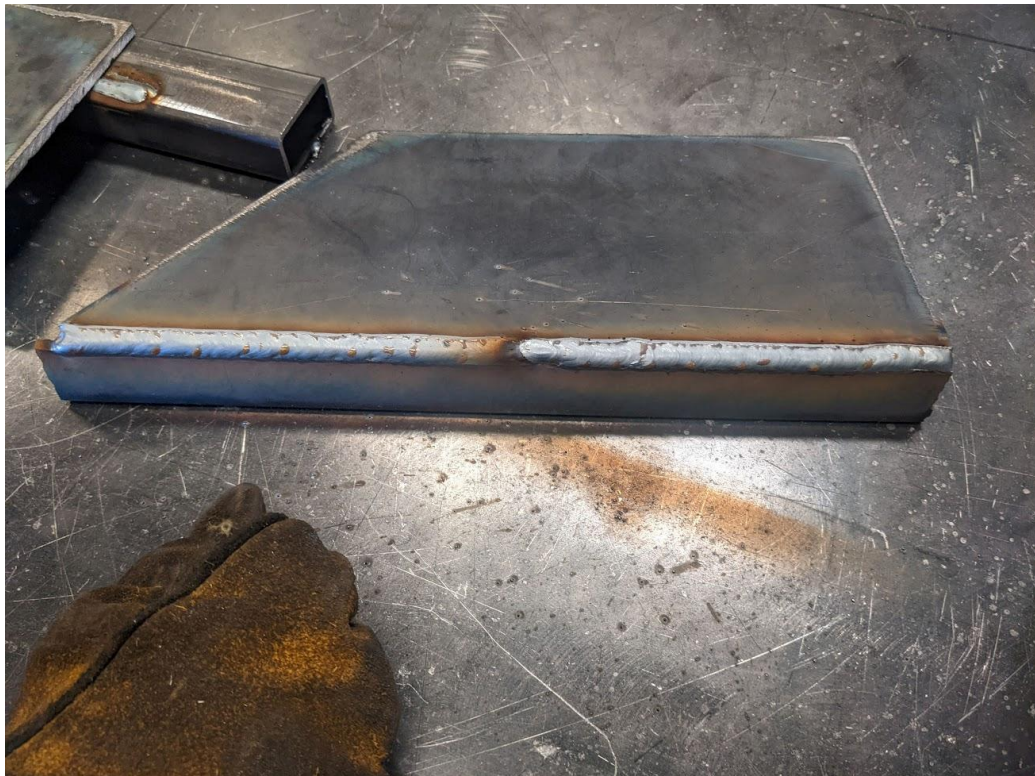
Photographs 19 and 20 – showing the welding of the fluke support to the fluke. The welding application has been unevenly applied and required rectification.

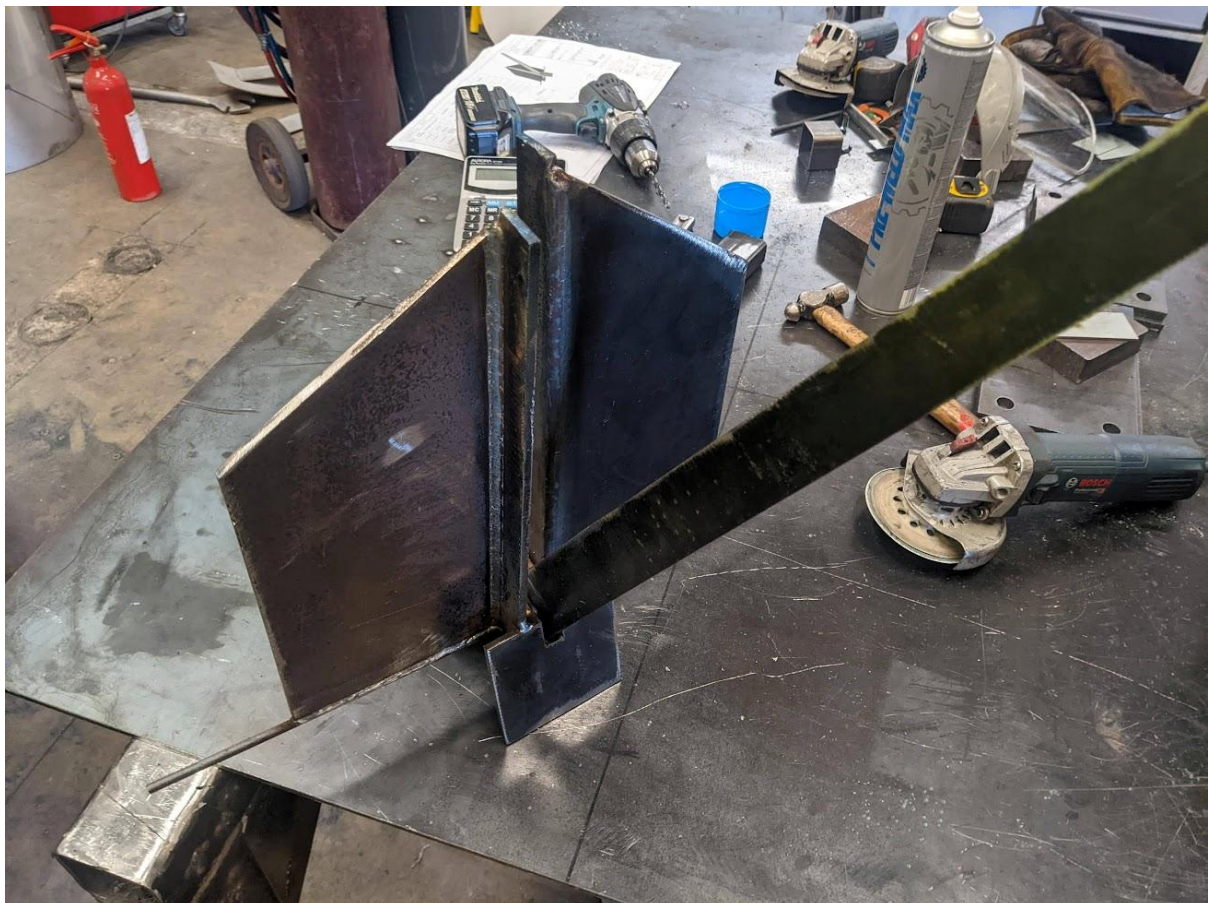
Fabricated anchor (Photographs 21 – 23)

Photographs 21, 22 and 23 – showing the fabricated anchor.

I completed a visual check of the completed assembly to check the finish and identify any visible surface defects. There were no obvious breaks in the welds and some excess weld material was seen on the flukes. The flukes had some areas of warping.

I selected a steel tape to measure the finished dimensions of the individual components. The final dimensions and findings were recorded on the quality check sheet. Most dimensions were within the given tolerances except the flukes. The flukes were more than the required tolerance which was caused by the component being larger than the required dimension and there was some warping.

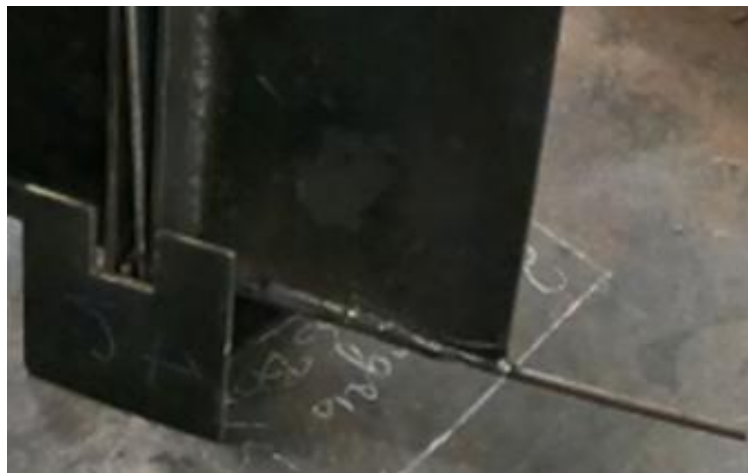
Photograph 26 – showing close up of the welding, some uneven weld can be seen.

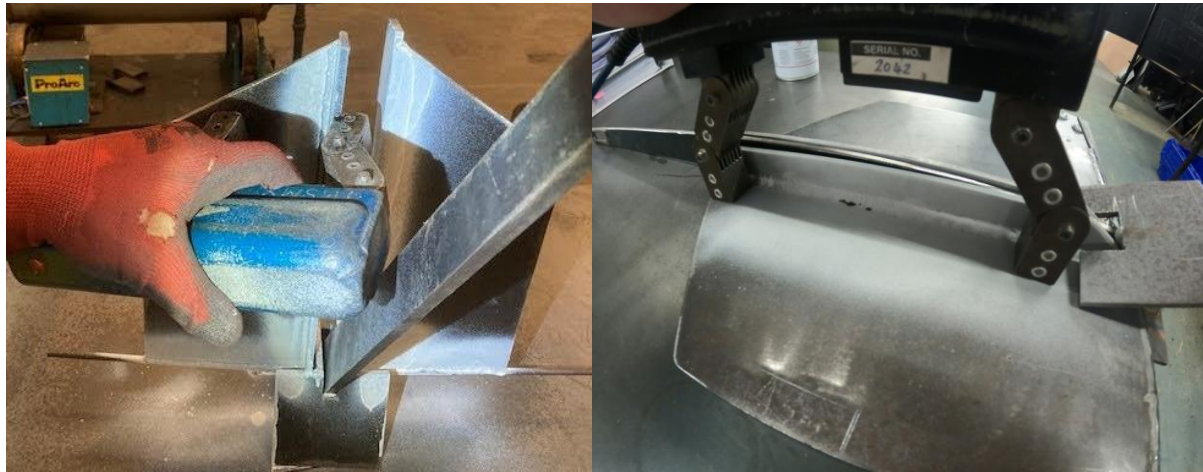
Photographs 27 – 28 show the application and result of using the magnetic particle inspection (MPI) non-destructive testing method.

Photographs 27 and 28 showing the application of the magnetic particle inspection method process. The MPI test showed small surface defect (crack along weld-toe). This could be rectified by grinding and then re-welding. Incorrect use of the magnet shown, welds need to be sprayed with white magnetic particle powder before applying the magnetic. An even coverage should be applied but care should be taken to not saturate the workpiece or the work area.

The candidate demonstrated Magnetic Particle Inspection (MPI), a Non-Destructive Testing (NDT) method on three welds to check for sub-surface defects or flaws. Detectable defects were identified, recorded and attributed to a process or procedural deficiency, for example, the NDT process revealed a sub-surface defect in the fluke support. The candidate demonstrated a basic understanding of NDT procedures, for example, as a result of poor technique using the testing equipment during the testing of the Crown weld, an equipment fault was encountered, resulting in the candidate having to do a retest.

where a defective weld is detected and give a visible indication. This process is used for all three selected welds. Once tested the anchor is demagnetised and the anchor is cleaned of all MPI fluid and residue.

The MPI test result showed that the two selected welds on the crown had passed and were to BS EN ISO 5817 standard. The weld on the fluke failed the test. The test showed a sub-surface break in the weld. The fluke weld failed due to a defect within the welding process, where the base metal and weld metal had not properly fused. A copy of my quality check sheet is included below:

Three welds selected and tested using MPI method. Fluke weld failed due to incomplete fusion between the base metal and weld metal. Crown welds passed minimum pass criteria.
One of the welds tested did not pass the quality required due to a defect within the welding process. Rectification would be grinding down and re-welding.
The final appearance was acceptable, some surface markings that were slightly inaccurate, leaving marks on the surface, detracting from the final appearance.
