**T Level Technical Qualification in  
Engineering, Manufacturing,  
Processing and Control (8713-33)**

**Composites Manufacturing  
Technologies (333)**

**Guide Standard Exemplification  
Material**

**Threshold Competence – Sample  
2022**

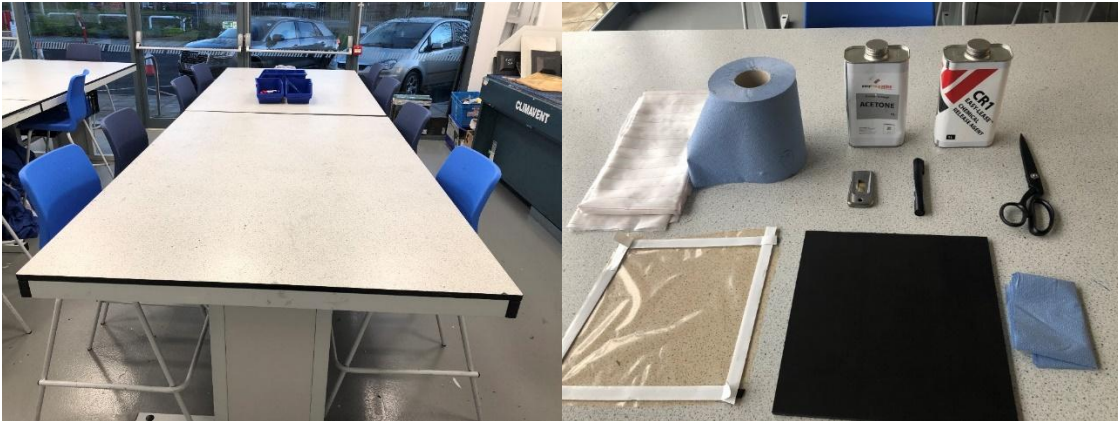
### Work area (photographs 1 – 2)

Photographs 1 and 2 – showing the prepared work area cleaned and the resources selected. The resources selected should be for the first task only to prevent overcrowding the workstation. Note: No additional PPE has been selected (gloves, mask).

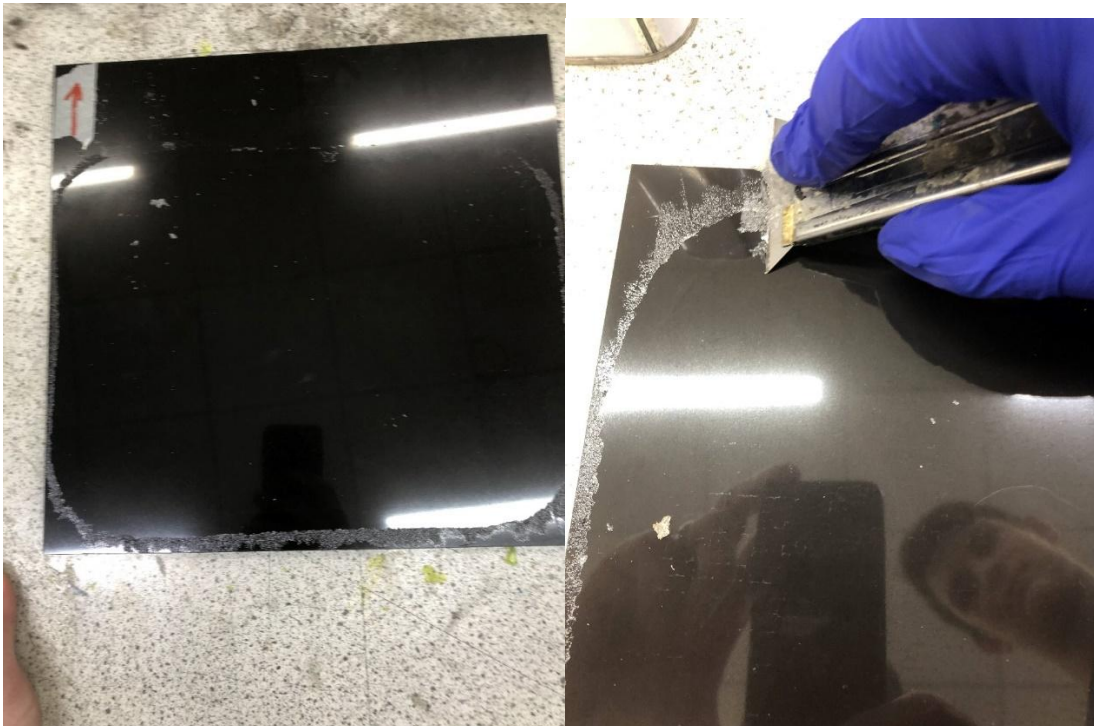
Photographs 3 and 4 – showing mould prior to preparation and cleaning. Residue from previous moulding activities is present and needs to be removed without damage to the mould occurring. Candidate is seen using a scraper to remove the residue.

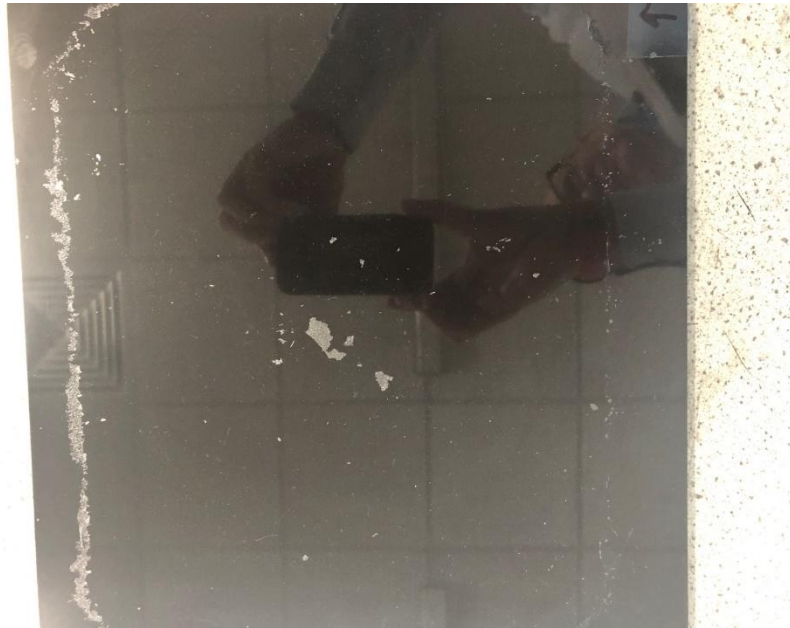
**Photograph 5** – showing a prepared mould but with some residue still showing on outer edge. The residue left on the mould will create adhesion issues during the creation of the vacuum bag. The candidate should remove all residue to prevent this from arising later in the consolidation process.

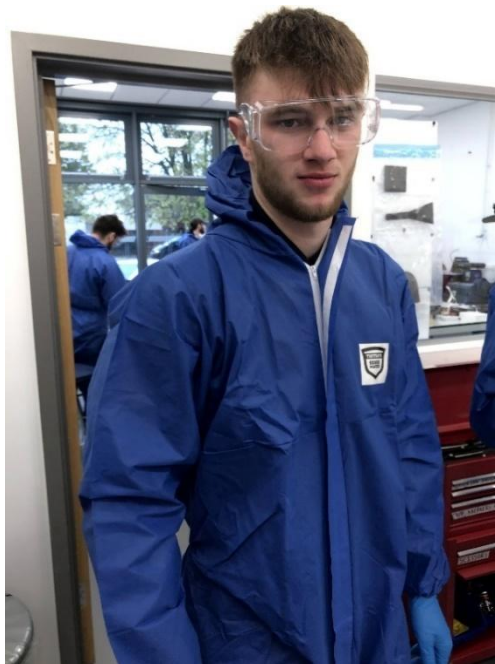
Photograph 6 – showing candidate wearing suitable PPE which has been checked for integrity. The candidate is safe but did not put the hood up and apply the zip cover to prevent FOD occurring within the production of the spacer block components and assembly which is required when simulating a clean room environment.

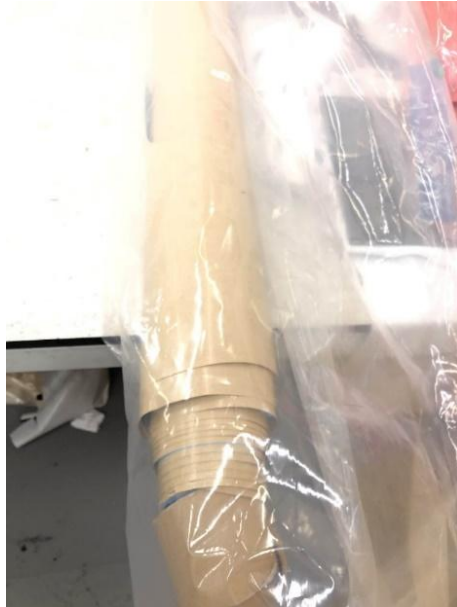
Photograph 7– showing composite material removal from storage (freezer). The material is kept in its bag and allowed to thaw for a period of time at room temp, before being unwrapped and rolled out to cut to size.

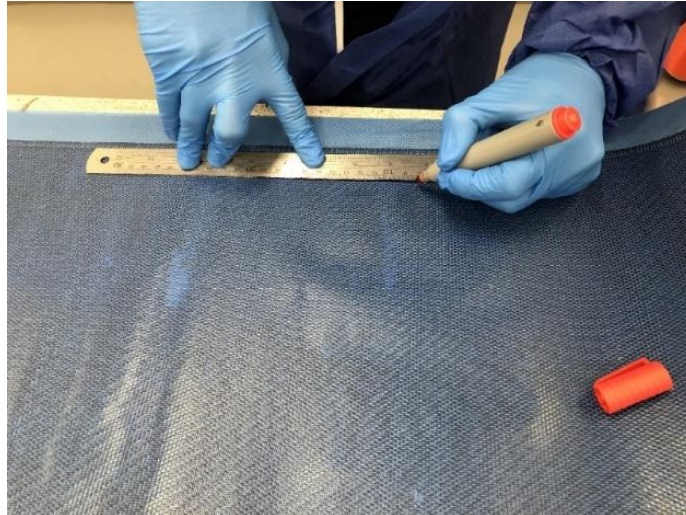
Photograph 8 – showing the material unrolled, being marked out before being cut to usable size. Note: At this point the remaining pre-preg material would be returned to the freezer.

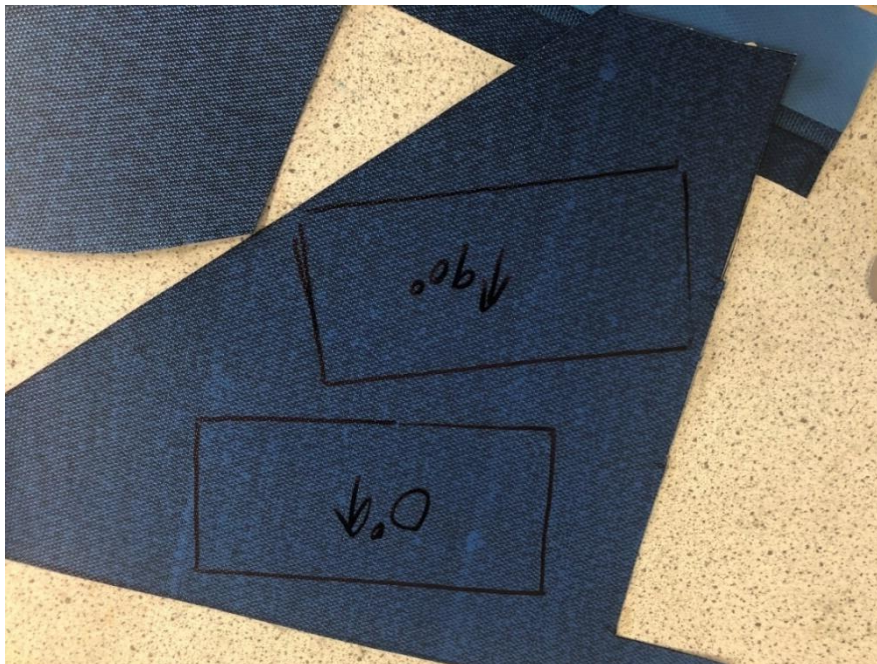
Photograph 9 – showing the material marked out ready for cutting. Orientation of plies is identified and marked on the backing film. Material to be cut-out to form the “kit” of parts using scissors.

Note: some poor marking out and wastage of material as it is some way from the edge of the sheet and the positioning of the marked out plies should be closer together and not angled.

The candidate demonstrated a basic understanding and awareness of the need to maintain accuracy, for example the marking out and cutting of the components from the material was not carefully done to maintain the dimensions and created excess waste material. For example, the candidate had not considered the drape of the top layer and the edge of the material, see photograph 9.

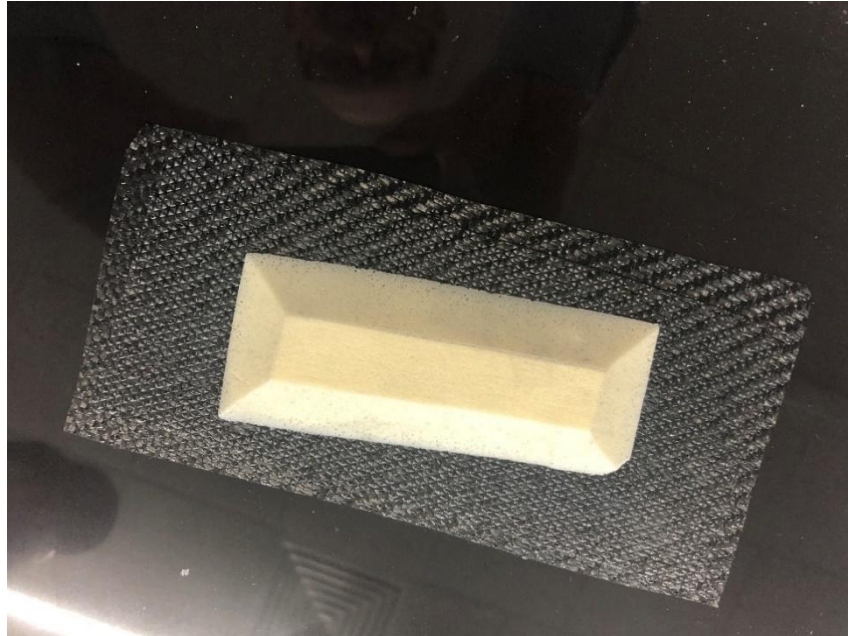
Photograph 10 – showing the core material cut to near shape ready for final reduction to dimensions. Note: Poor cutting of the foam material, there is some damage to the core edges, the dimensions are not square and the angles are not as per specification. One corner is rounded.

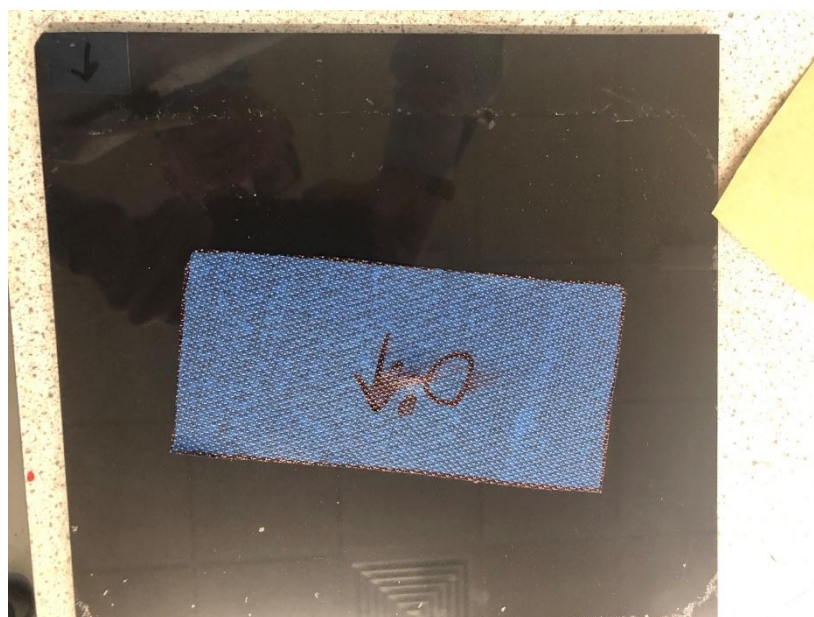
Photograph 11 – showing the first ply laid onto the prepared mould surface. Some waviness of cutting of materials and blemishes on the mould surface.

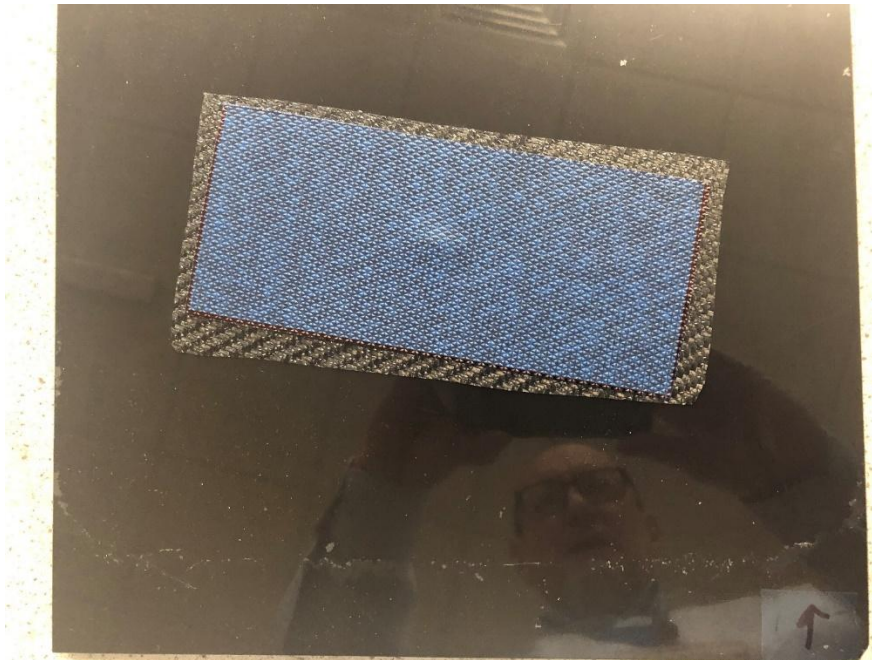
Photograph 12 - showing subsequent plies laid up onto the mould and the core placed on the upper sheet. Some evidence of "out-of-square" and disruption of the warp and weft pattern.

The laminating process was followed with some reference back to their method statement. Materials were applied to the mould some of the time, correctly understanding the layering process but were not accurate when piling up the layers, with some layers seen to be out of square, see photograph 12 in the photographic evidence section. The plies were layered following a procedure, but the candidate did not fully understand the need to perform a count back to ensure the plies were placed according to their plan to avoid Foreign Object Debris (FOD) during the laying up and consolidation process.

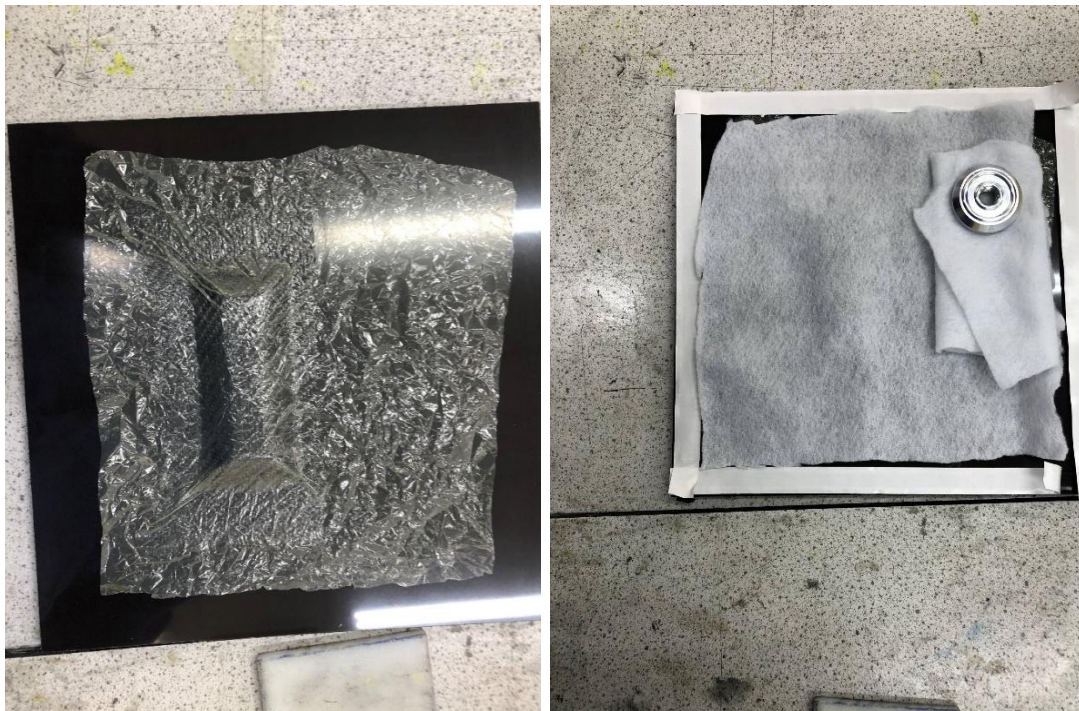
Photographs 13 and 14 - showing the upper plies applied and consolidated using a moulding tool. De-bulk applied according to method statement. Release film has been wrinkled and placed on top of the final ply. Peel ply applied on top of the release film with additional breather fabric cut to make an air passage out of the moulding. VBU lower portion placed on top of breather fabric but on the moulding. Some issues with adherence to the mould surface.

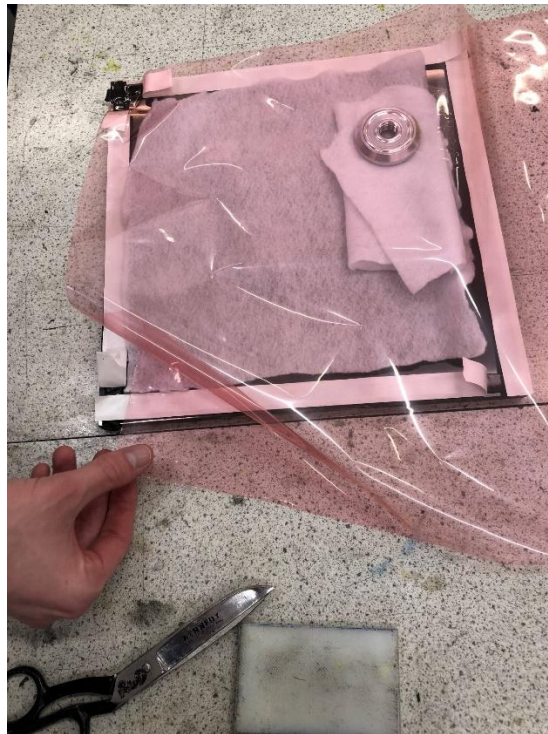
Photograph 15 - showing one corner sealed and the adjacent corner is stuck down leaving (in this case, too much material) slack to allow the bag to drape across the laminate.

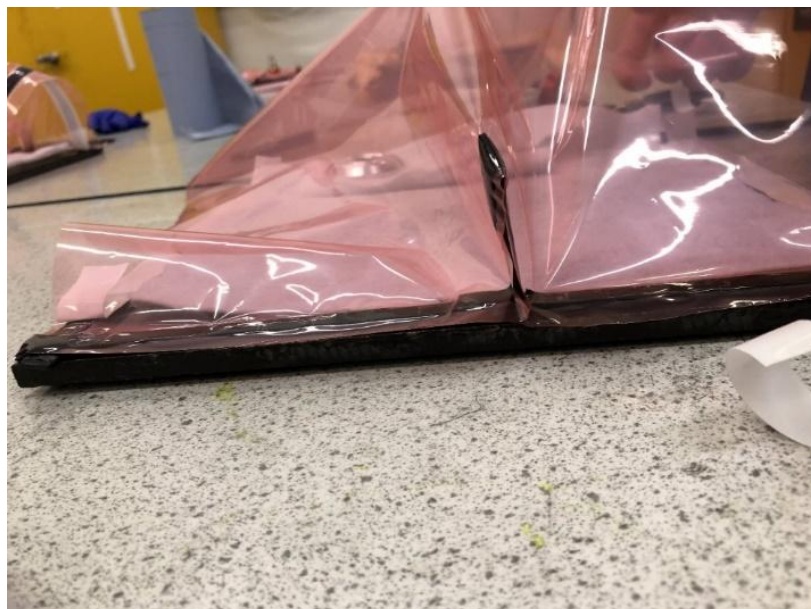
Photographs 16 - showing the first pleat created to create the vacuum tight seal to ensure good application of consolidation pressure. Some issues with the adhesion of the film to the mould.

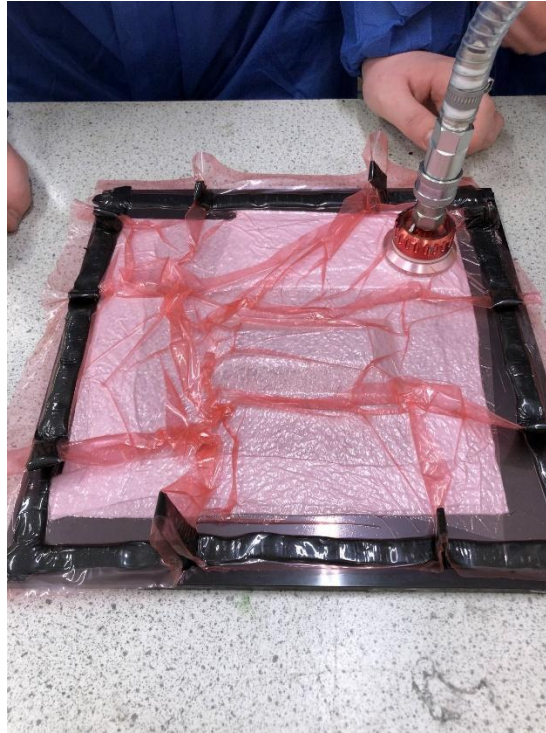
Photograph 17 – showing the vacuum bag is airtight. A hole has been created for the VBU and placed on top of the vacuum bagging material. With vacuum applied to the VBU to consolidate the laminate. Candidate checking for, and rectifying any leaks, to ensure the wrinkles are spaced equally around the moulding. Some leaks were present and were eventually remedied.

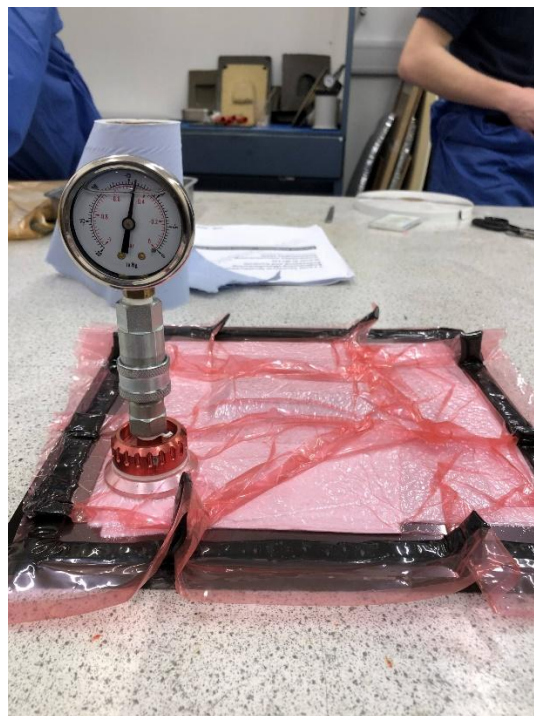
Photograph 18 – showing a drop test has been performed with a loss of vacuum, no less than specified in the method statement. Some remedials required.

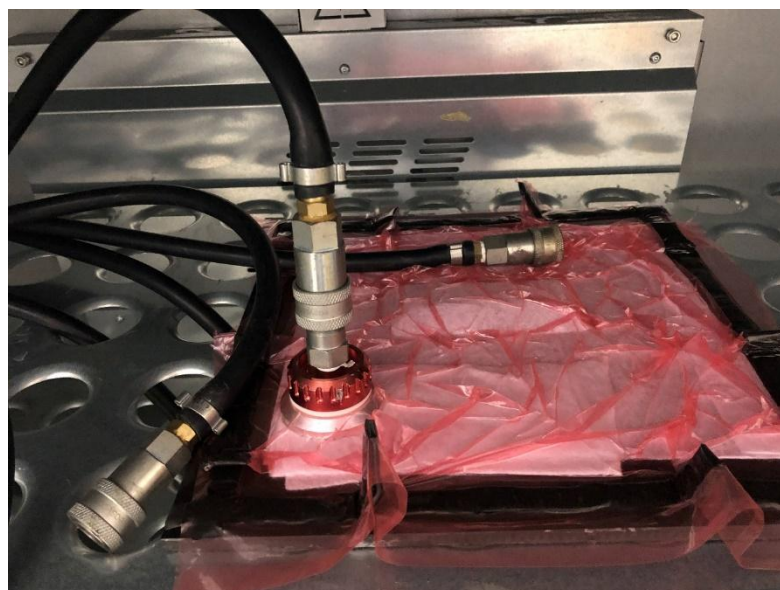
Photograph 21 - showing the mould placed in the oven, not touching the sides, with the vacuum applied to the VBU in the oven. A vacuum hose has been left draped across the mould which is not best practice.

The candidate correctly referred to the manufacturer's data to obtain the information for curing and equipment set up. This could have been improved if the candidate had followed a stepped procedure when pre-heating the oven and by checking the position of the mould within the oven. For example, removing excess hoses or to check hoses were not encroaching on the mould, see photograph 21. This could affect the distribution of heat during the curing, resulting in some unevenness in the curing.

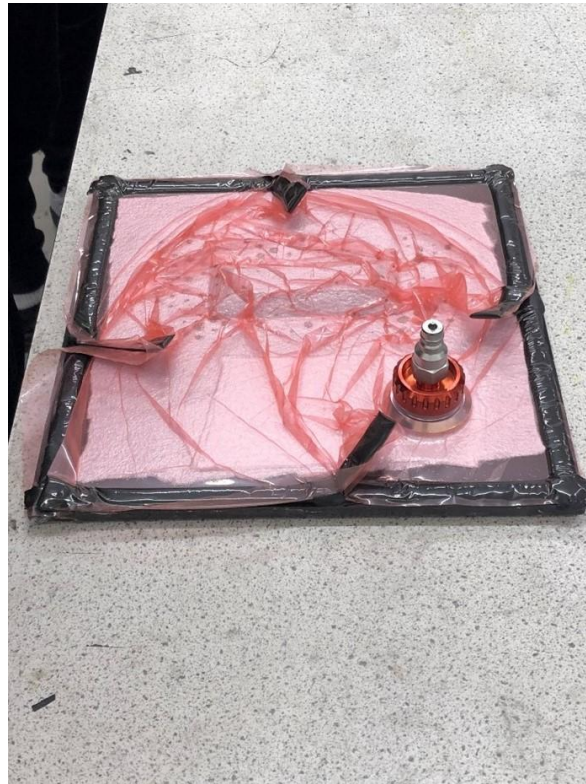
Photograph 22 – showing the mould removed from oven after curing and allowed to cool. Wrinkles are present across the mould surface.

The result of the consolidation and curing was acceptable however this could be improved. For example, there was some wrinkling observed across the top of the mould which could leave some marks on the top layer. If the candidate had adjusted the vacuum bag before curing and removed or better distributed the creases this could have been avoided.

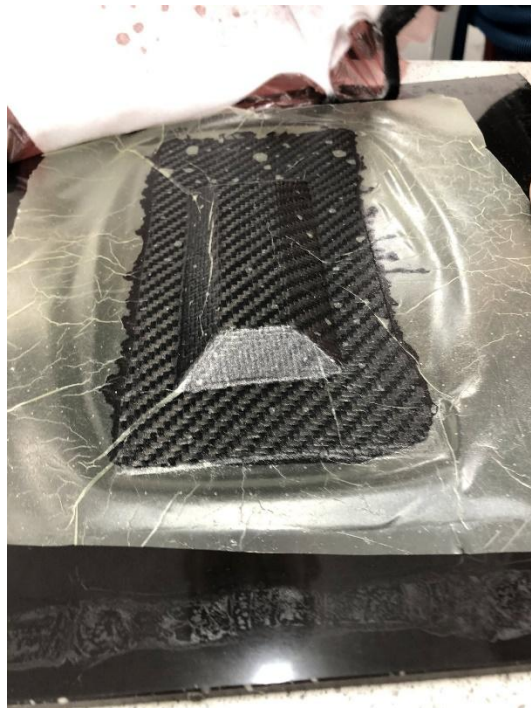
Photograph 23 - showing bagging film being removed to reveal the release film. Evidence of good consolidation and curing. Some wrinkling of release film but the surface of the moulding is acceptable. Some resin bleed identified.

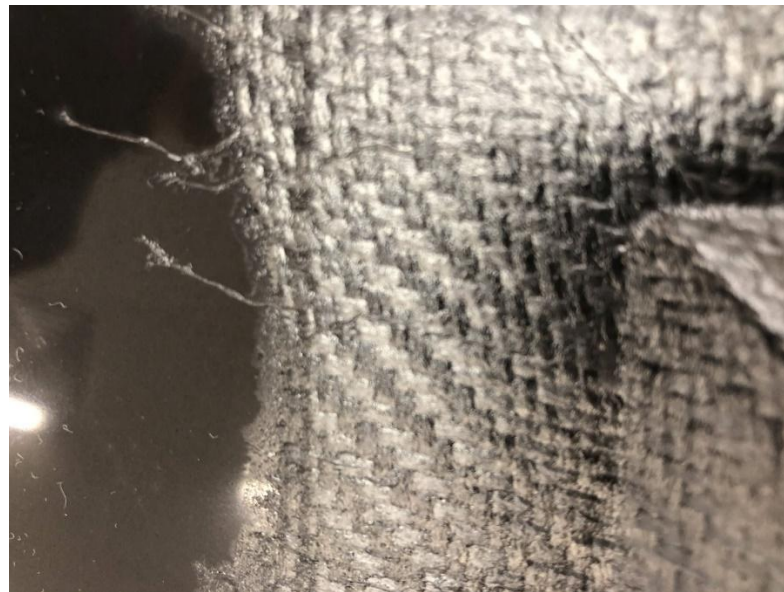
Photograph 24 – showing detail of edges, corners and transitions showing inconsistent definition and orientation of fibre.

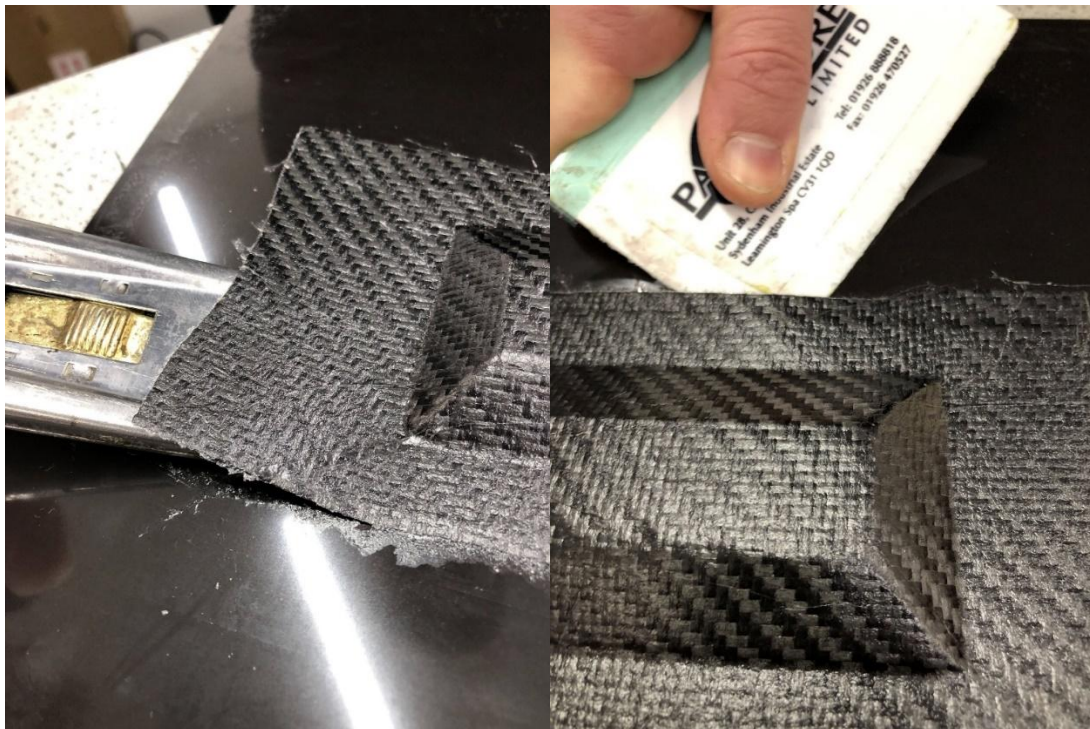
Photographs 25 and 26 – showing a scraper being used to lift one corner at the beginning of the demoulding, followed by a plastic wedge to complete the process of demoulding, ensuring that the lift is not too abrupt to overstress or crack the laminate.

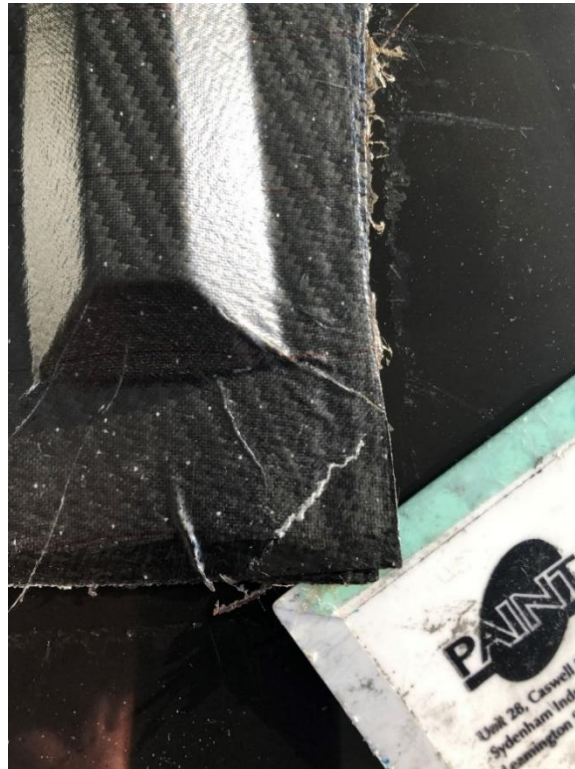
Photograph 27 – showing the lower corner has been cracked because of poor mould preparation and inserting a wedge that was too large. Some evidence of surface imperfections caused by the wrinkling of the moulding consumables.

The candidate's lower level of understanding of the material properties is demonstrated by their approach to demoulding the cured laminate. They followed the correct procedure to remove the laminate from the mould, using the correct tools for the job and for the type of mould used but the excess pressure applied to the lifting tool caused the corner of the material to crack, see photograph 27.

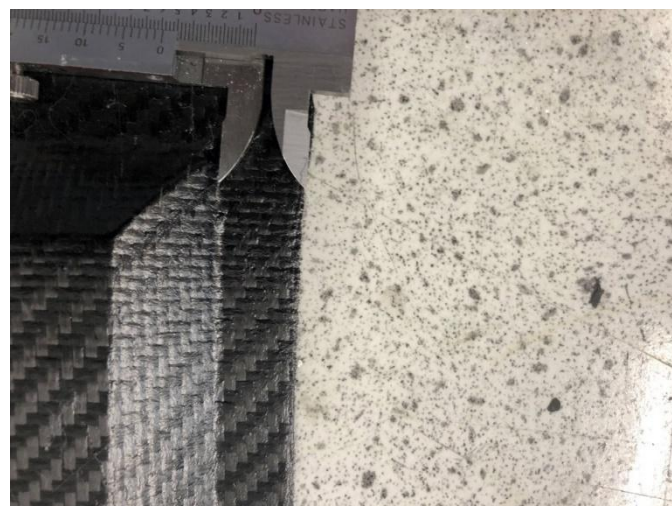
Photograph 28 – showing candidate performing measurement checks to ensure dimensions meet specification prior to safe edging. Correct tools were utilised however calibration checks were not thorough.

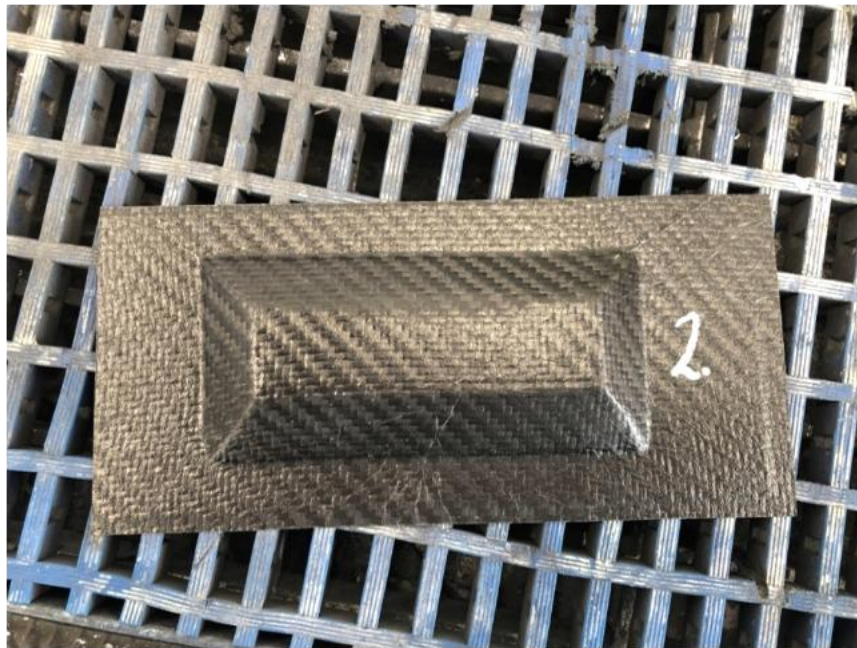
Photograph 29 – showing finished component safe edged prior to final dimensioning. The photo depicts some non-conformities and issues with squareness and dimensions of the core, surface imperfections resulting from the peel-plies and consumables.

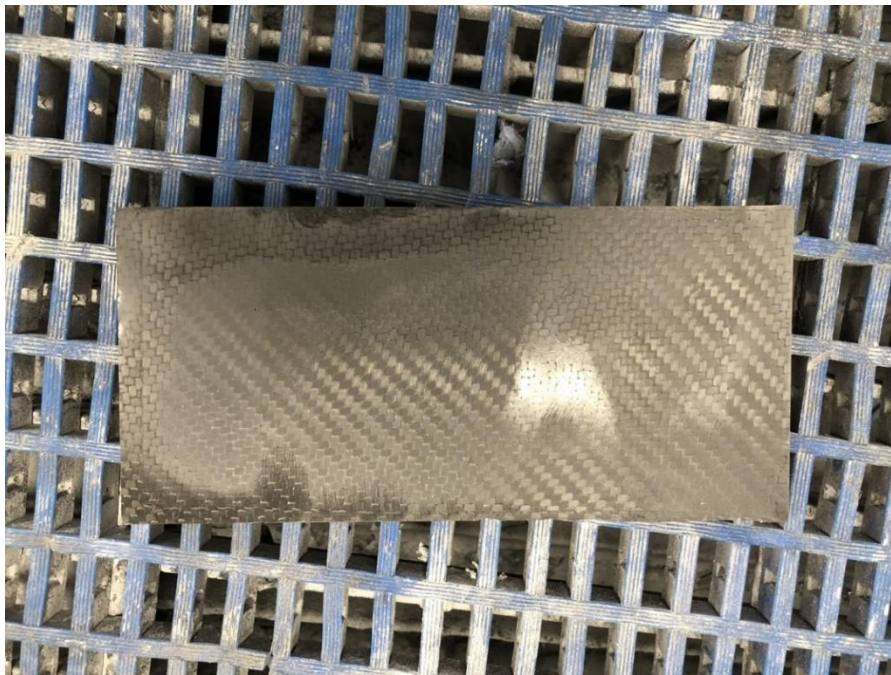
Photograph 31 – showing the underside of the spacer block on completion of being abraded. Abrasion of the lower surface showing signs of inconsistent application of abrasive medium and a lack of consistent colouration and texture.

The consolidation process could have been improved. For example, if the candidate had abraded each component equally, by achieving a consistent colouring and texture to the surface, enabling the bonding agent to adhere more evenly and creating a stronger bond when fully cured. See photograph 31.

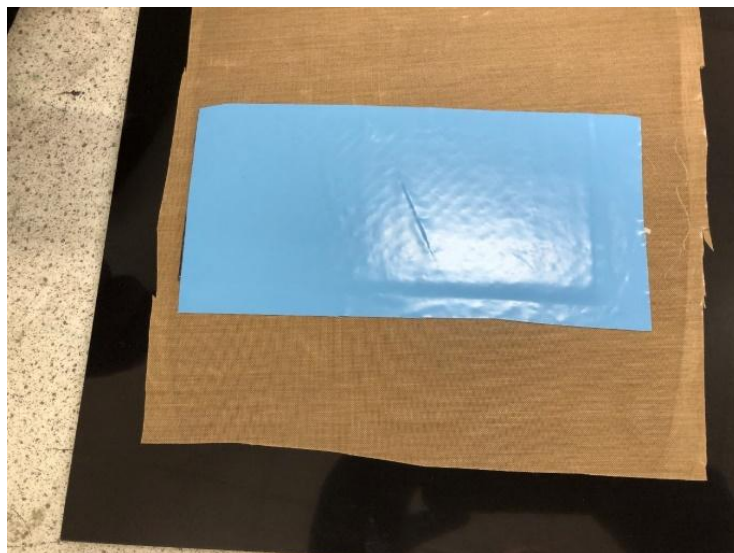
Photographs 32 – showing the film adhesive placed onto the second ply and consolidated with the backing film still applied.

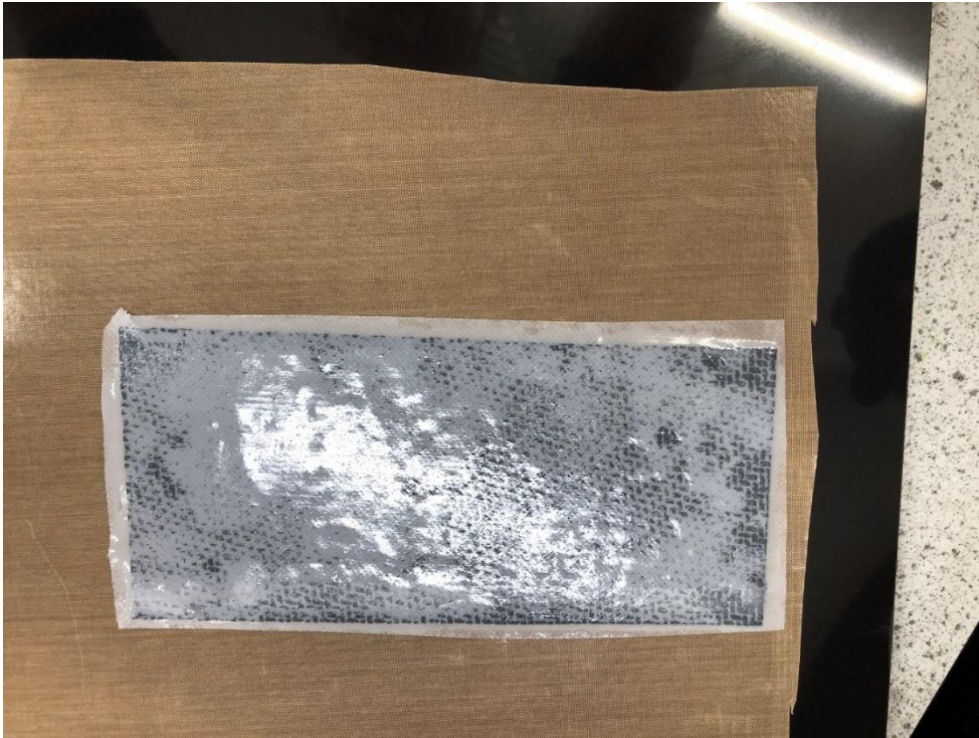
Photograph 33 – showing the backing film removed from the adhesive film and cut to size to ensure minimum bleed out.

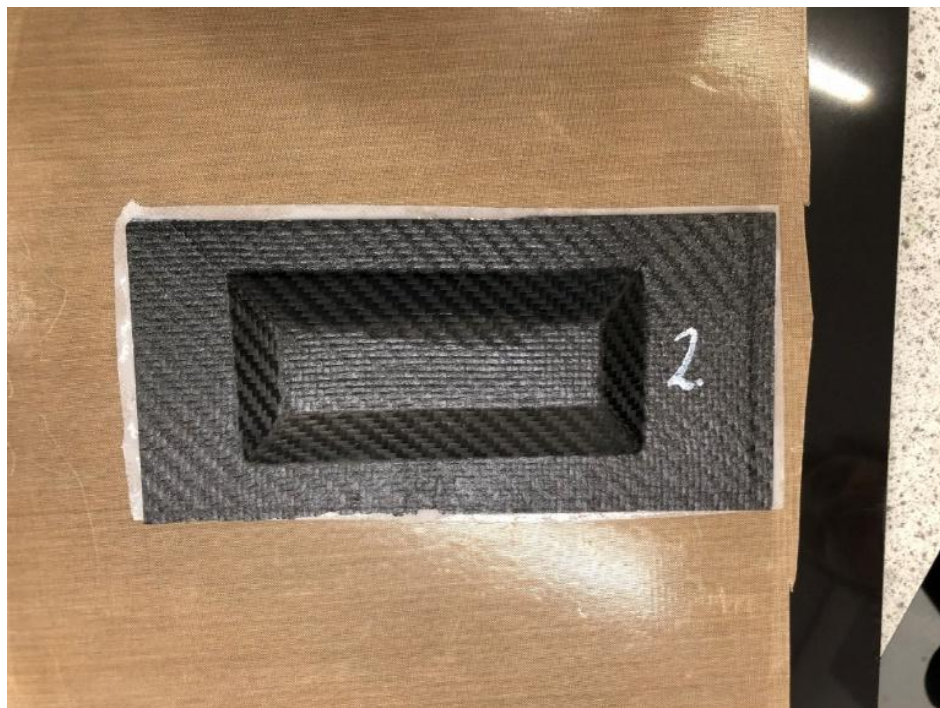
Photograph 34 – showing the spacer block component placed on top of release film. Note bottom left corner has no adhesive film overlap. The film should melt into this area during curing, but it is not good practice. Bottom edge showing some signs of inconsistent trimming activities.

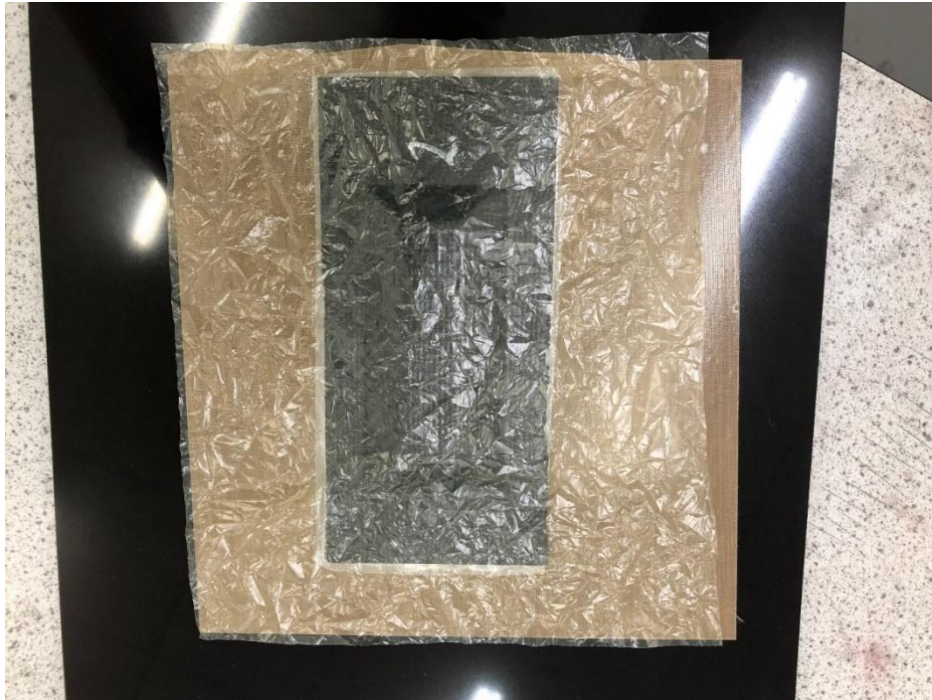
Photograph 35 – showing release film placed on top of the moulding. Note: wrinkled to aid draping.

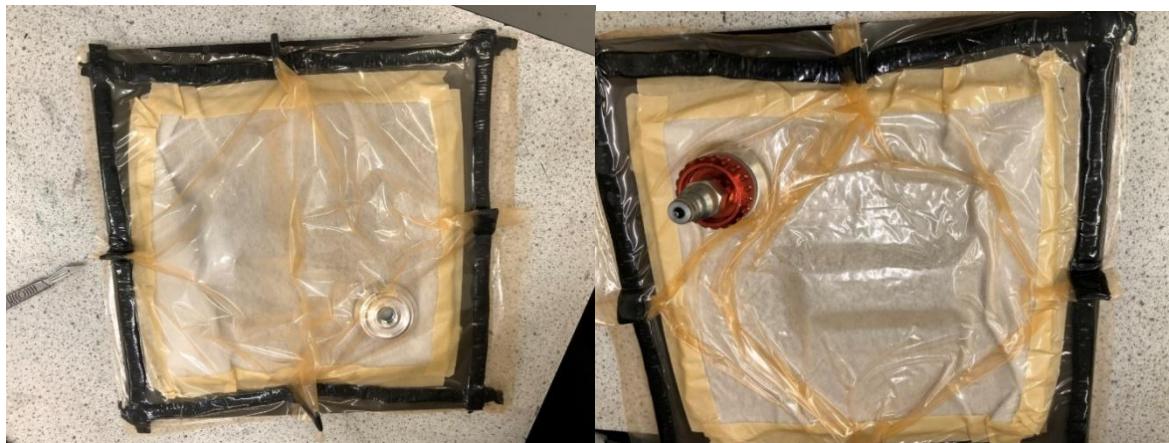
Photographs 36 and 37 – showing breather fabric placed onto moulding and taped down with VBU being trial placed to ensure no interference with the moulding. Vacuum bag created. Pleats allowing for effective consolidation. Vacuum applied.

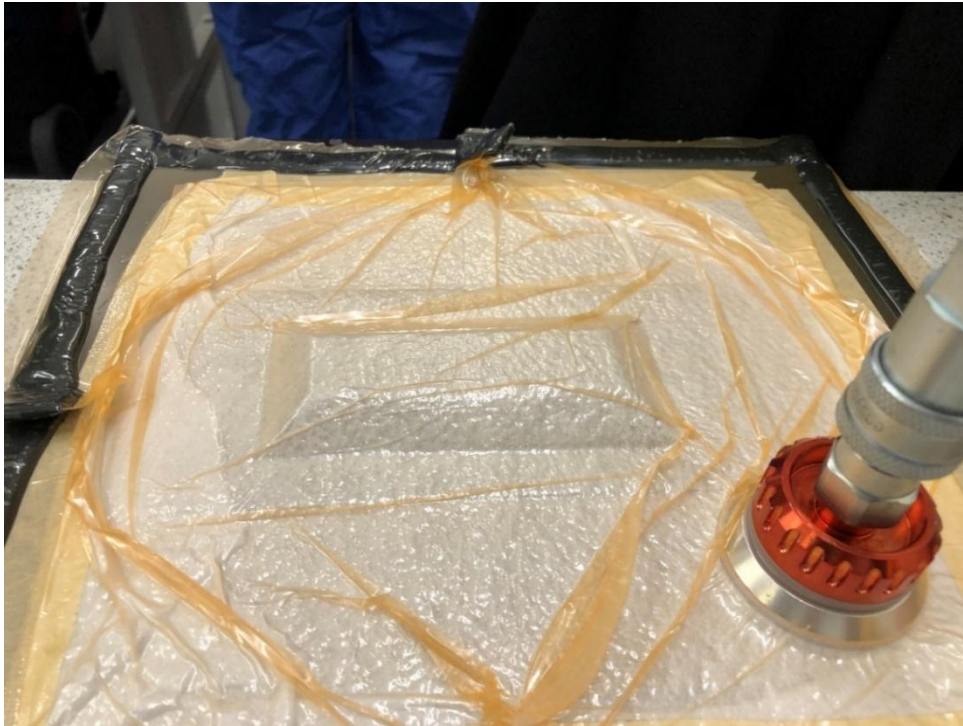
Photograph 38 - showing full consolidation pressure applied and wrinkles or pleats spaced out ready for curing in the curing oven. Some are still left across the surface which should be removed for best practice, but it should be remembered that the upper half is already cured.

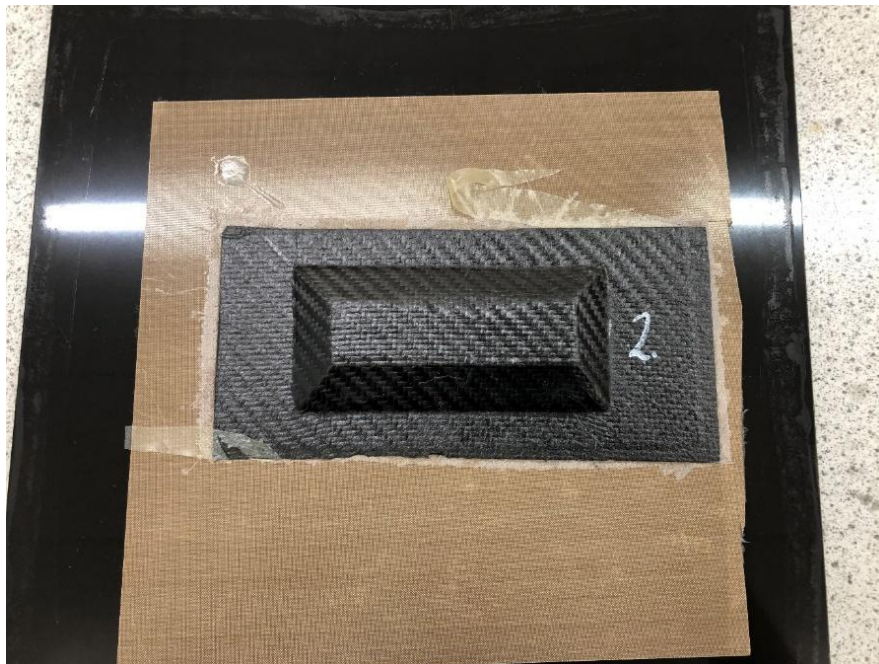
Photograph 39 – showing result of the curing. Assembly sitting on top of PTFE release layer. Evidence of complete bonding as a result of resin bleeding out evenly from the upper and lower sections.

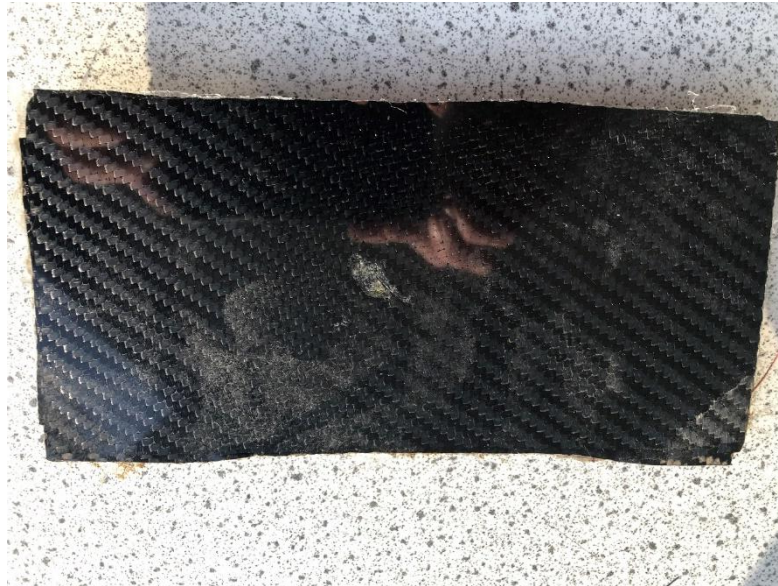
Photograph 40 – showing the checking of “A” side for defects or FOD. Some inclusions present.

The response could further have been developed if the candidate had demonstrated a higher level of cleanliness throughout. This would have prevented the foreign object debris (FOD) from being trapped during the manufacturing process and causing the visual defects in the spacer block, see photograph 40. In addition, the candidate could have demonstrated cleanliness through cleaning their tools and workstation more thoroughly.

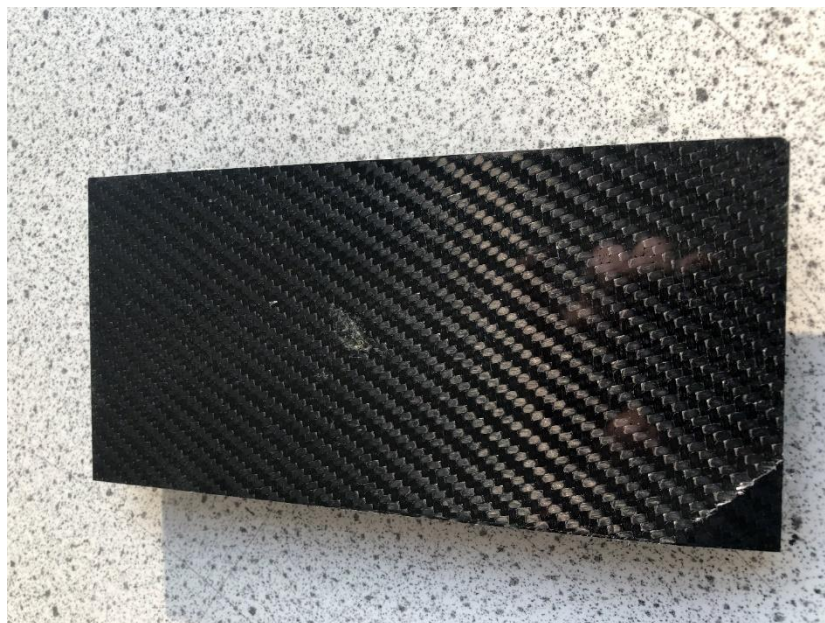
Photograph 41 - showing the final assembly which has been safe edged and ready for machining to final dimensions. Note the cracking of the bottom left corner and the presence of FOD embedded in the laminate that was present as a result of not cleaning the mould sufficiently.

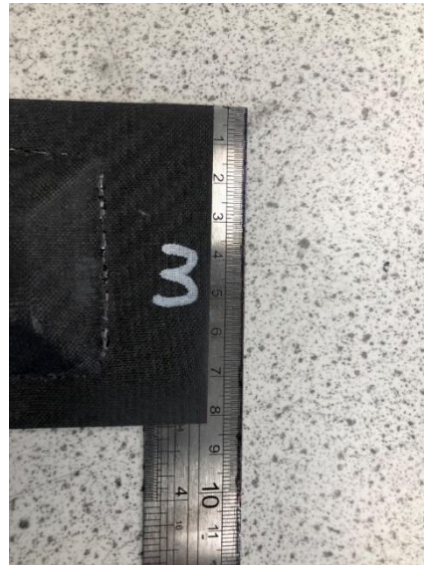
Photograph 42 – showing candidate checking the width of the assembly. Note: some run-out of the core in terms of not being parallel with the edge. Dimension not consistent with drawing.

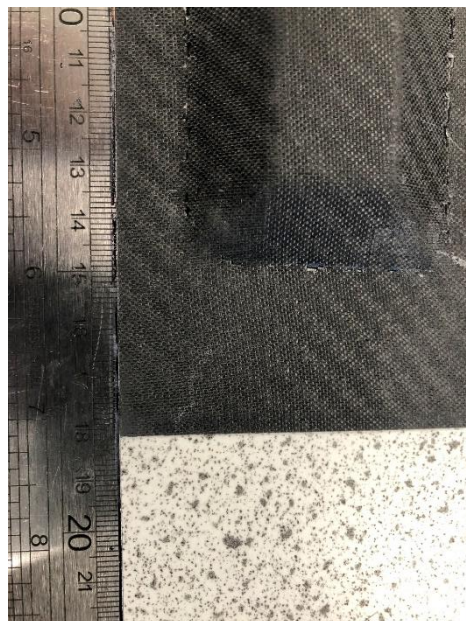
Photograph 43 – showing dimensional check of length. Some more material removal required. Note poor definition of edge or core and evidence of poor consolidation over the core and in the transitions.

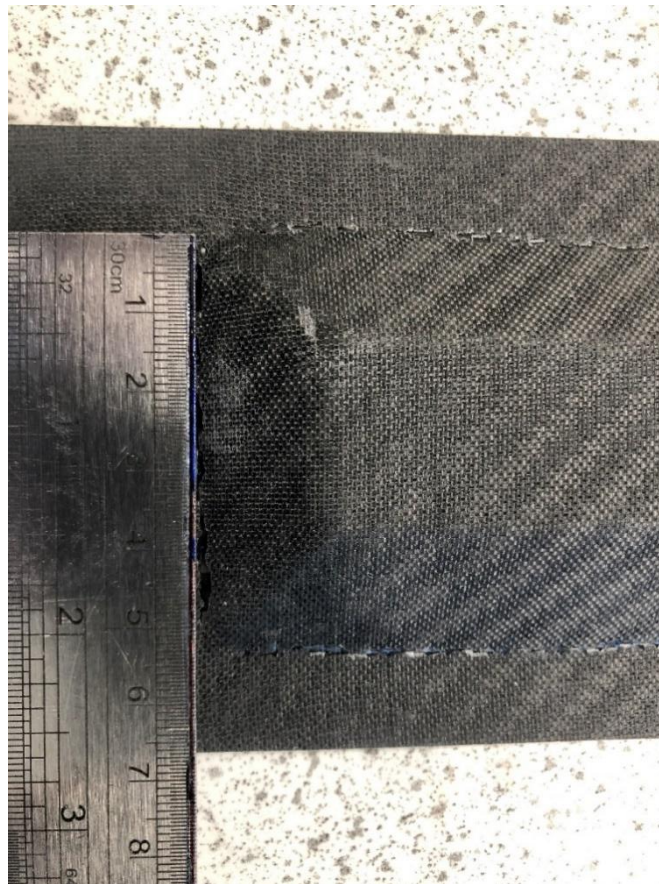
Photograph 44 – showing the candidate checking the core width. Note: poor consolidation of laminates around the core to laminate transition.

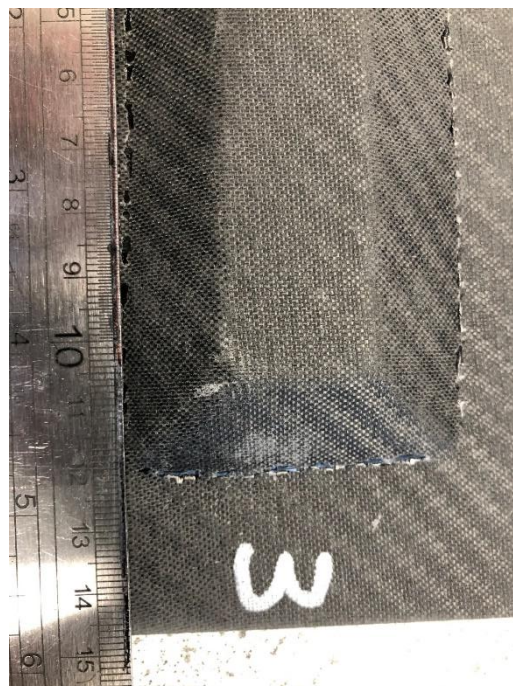
Photograph 45 – showing candidate checking straightness of long core length dimension.

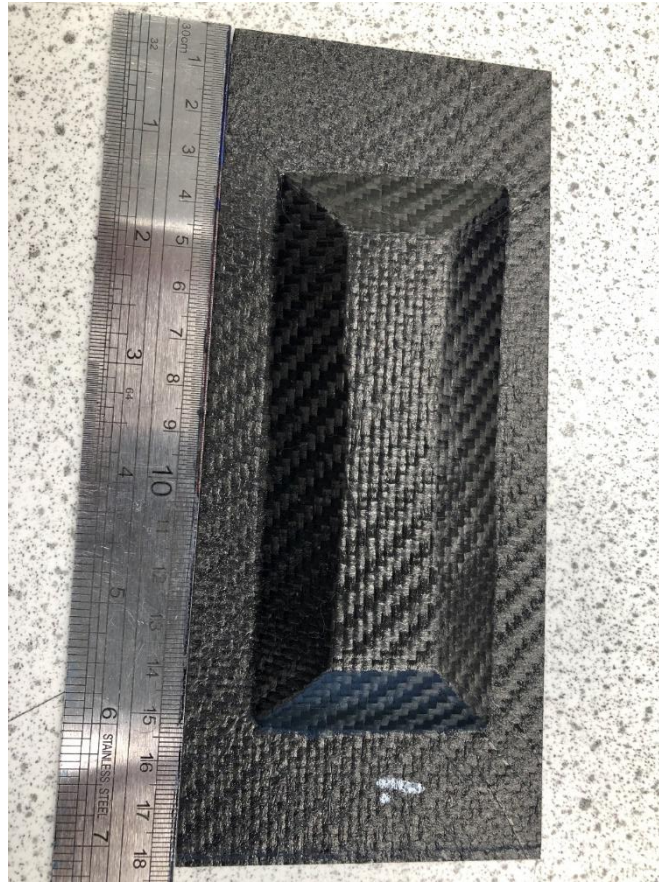
Photograph 46 – showing candidate checking straightness of long edge. Note: some taper of the laminate at the top edge. The core is also not sat straight onto the lower laminate.

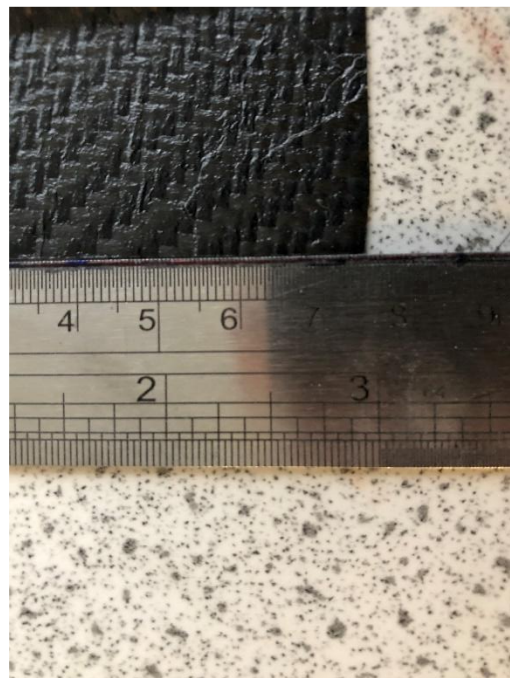
Photograph 47 – showing candidate checking straightness of short edge. Note: the tapering of the edge and lack of straightness.
