**T Level Technical Qualification in  
Engineering, Manufacturing,  
Processing and Control (8713-33)**

**Composites Manufacturing  
Technologies (333)**

**Guide Standard Exemplification  
Material**

**Threshold Competence – Sample  
2022**

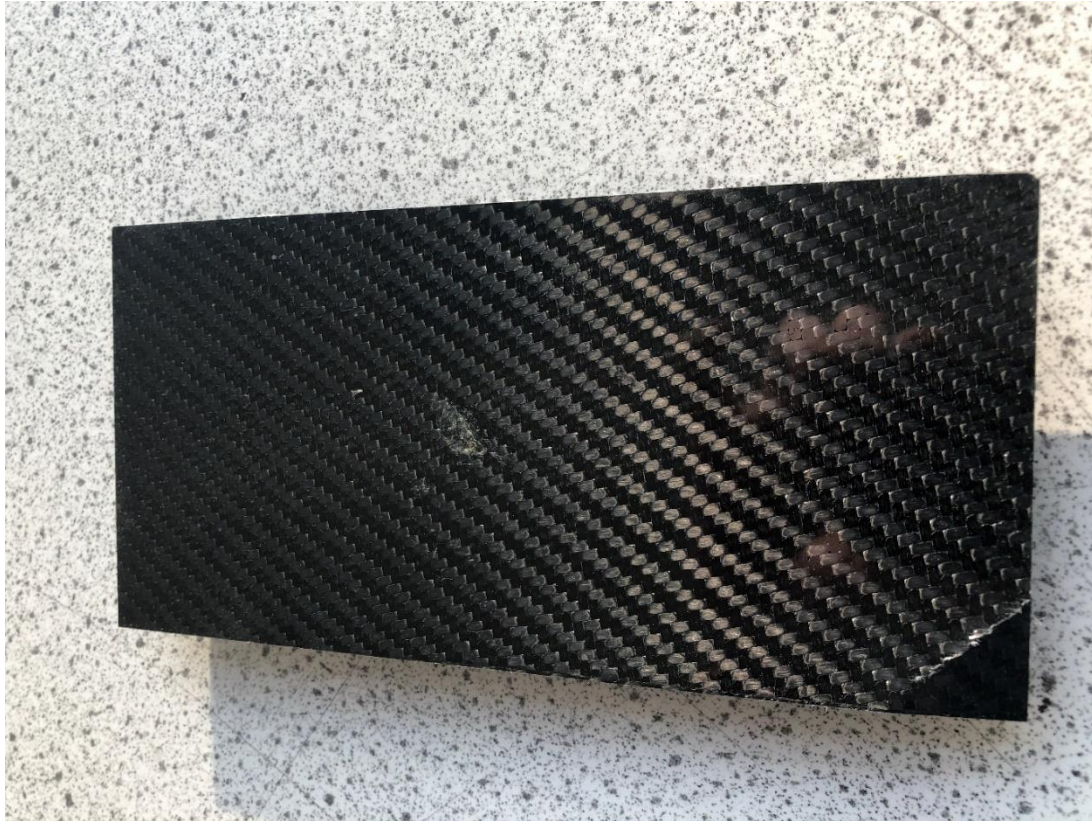
Photograph 48 - showing check of surface finish and warp and weft patter. Note: a warp or weft position is selected, and a check is made to ensure that the feature remains constant along the length of the assembly. Some tapering of this is evident.

I completed a visual check of the completed assembly to check the finish and identify any visible defects. The edges were not square with the top and bottom sections giving an uneven appearance to the spacer block. The core angles were not as clean as expected but the orientation was within tolerance. The "A" side contained some FOD, mostly likely dust debris which is a defect.
